STAINED GLASS

WINTER 2020 / 21

Stained Glass Conservation: Lessons from History

Preserving windows from
opposite ends of the last millennia

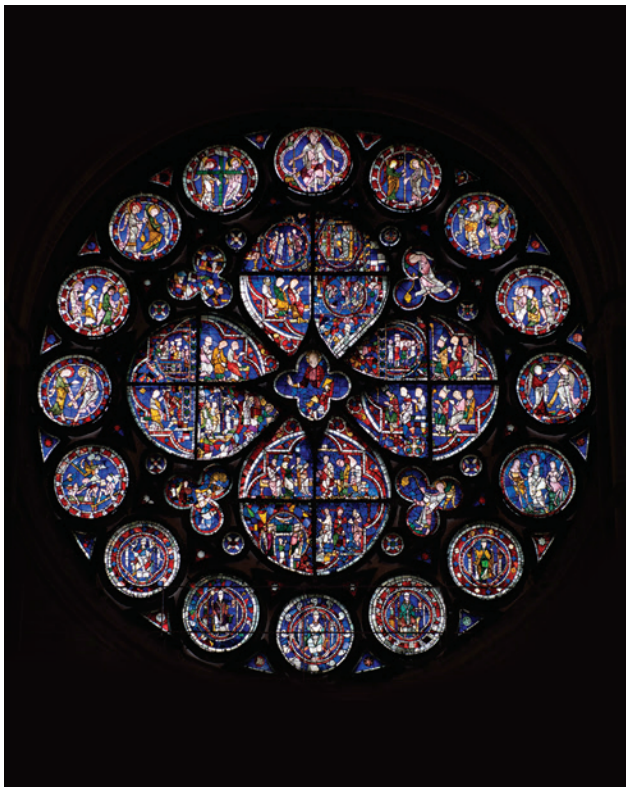
Figure 1: The Deans Eye, Lincoln Cathedral; Photo: Lincoln Cathedral Stained Glass Conservation Department, 2019
 Figure 2: The Sunburst skylight, Buffalo City Hall, New York, USA; Photo: Bedson, 2019

This approach is exemplified by the preservation needs of two stained glass windows from very different eras. In the first instance the 13th-century Gothic Dean’s Eye Rose Window from Lincoln Cathedral in the U.K. [figure 1]. This represents a highpoint in Gothic stained glass manufacture and has survived for nearly 800 years. In contrast to this is the Art Deco Sunburst skylight window, suspended above the council chamber in the City Hall of Buffalo, New York, U.S. for 88 years [figure 2]. Both windows are considered amongst the finest examples of stained glass in the world from their relevant eras.

The Dean’s Eye [figure 1] is one of the few examples of Gothic English 13th-century stained glass that still exists in situ. The stained-glass windows of this time were heavily influenced by the rituals and teachings of the Christian Church designed to help spread the word of God. In 1192 Lincoln Cathedral was rebuilt following a fire. The Dean’s Eye was its crowning glory, a Gothic masterpiece. However, with the passage of 800 years, the window we see now is not a true reflection of the original. Following the accession of Henry VIII to the throne, the dissolution of the monasteries (1530–40), and the English Civil War (1643–51), much of the stained glass was damaged or destroyed. Most of the major repairs to The Dean’s Eye took place from the mid-18th century and were undertaken by plumbers

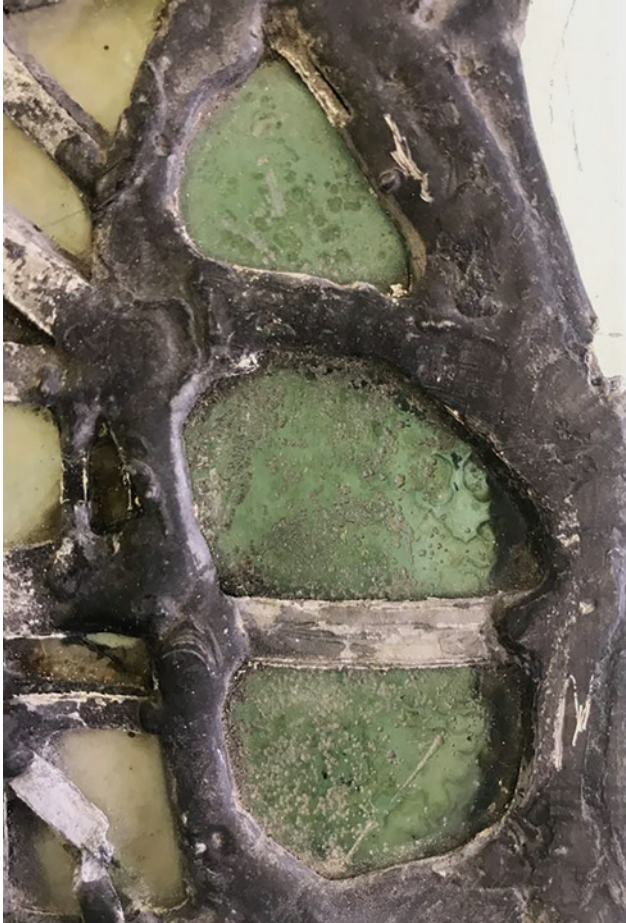
Figure 8: Loss of paint is evident in the central panel of the Dean's Eye
Photo: Lincoln Cathedral Stained Glass Conservation Department, 2019

Figure 9: Original Dean's Eye stained glass showing pitting, linear fissures and lead strap repair in the middle
Photo: Bedson, 2019

forest trees such as Beech. It is very susceptible to surface erosion and paint loss because of errors in its application [figure 8]. The paint was made with finely ground glass mixed with metallic oxides, flux (potash) and Gum Arabic (a fixing agent). After painting, it was fired again. If too much flux was added this created a soft enamel which dissolved on contact with moisture. If underfired, the enamel did not bond with the glass and again is affected by moisture. If overfired the enamel would develop pitting in which moisture could sit. Exposure to the weather led to further surface erosion. Eight hundred years of weathering was followed by hyperhydration of the glass surface and rapid drying after storage in humid conditions during World War II, which led to fissuring on the surface [figure 9]. Degradation was mainly external, but internally accumulated grime was problematic. This was aggravated by the window's inaccessibility due to its height, and lack of cleaning.

Early conservation of The Dean's Eye used corrosive cleaning chemicals that were not thoroughly removed. These caused damage to the enamel from the initial chemical attack, and left remnants that continued to make surface pitting worse.

Preservation of the Dean's Eye relies on techniques appropriate to the damage. Minimal intervention was employed, including cloth, soft and bristle brushes for general cleaning, scalpel and air abrasion for accretions and external damage. White spirit was used to remove grease. Where glass was lost, glass inserts were used but distressed to be faithful to the original. To carry out reinstatement of the painted detail, radiography was used to reveal the image of the enamelling retained below the glass surface. X-rays reveal remaining traces of metal oxides within the glass. This allowed painting of a new copy of the image onto a backing plate and placed onto the reverse side of the original medieval glass.

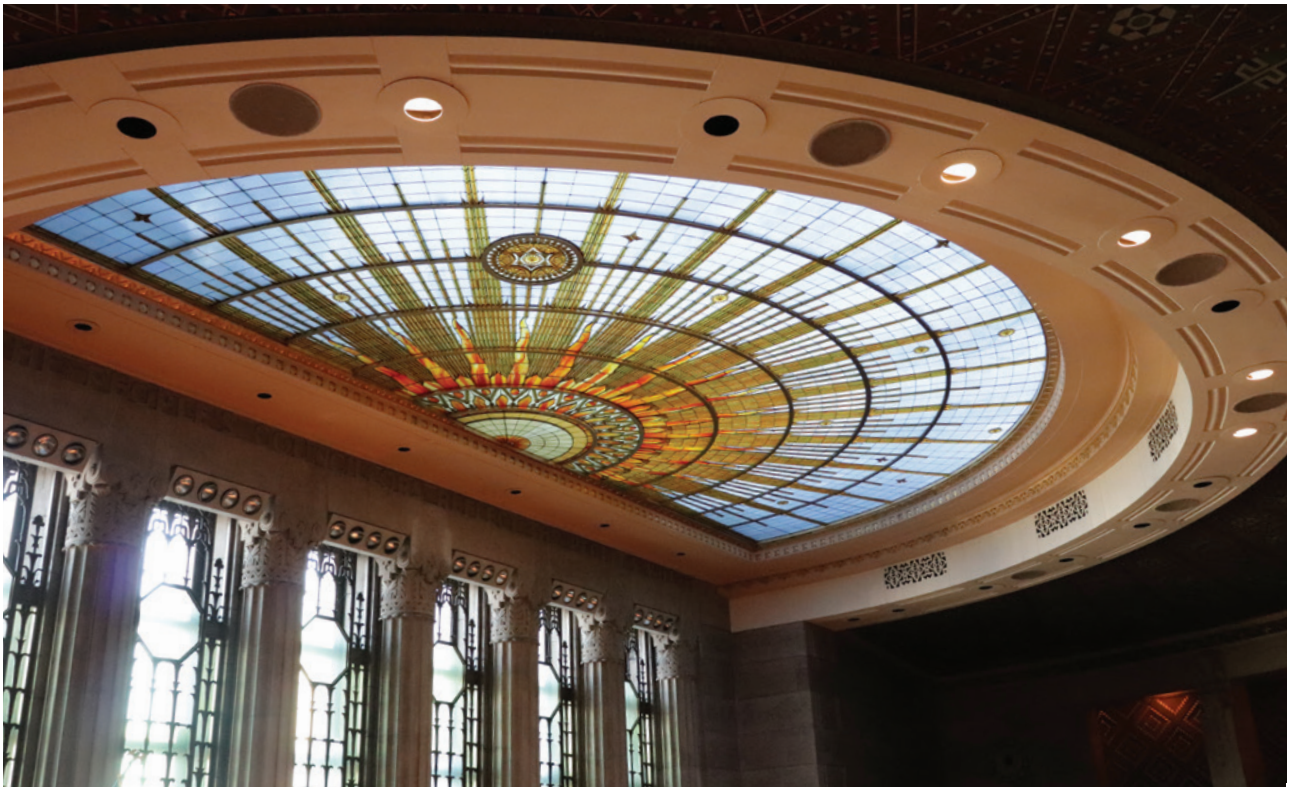
Figure 13: Semi-circular steel bands can be seen supporting the Sunburst above the council chamber in City Hall; Photo: Bedson, 2019

The supporting steel work in The Sunburst would have been made using the Bessemer process to remove impurities making it extremely strong. The window is suspended on a set of seven semi-circular steel bands [figure 13]. This steel has a high carbon content and low level of impurities making it less likely to rust. With immense strength and less susceptibility to rusting, the steel in the Sunburst allowed it to be suspended horizontally above the council chamber. These semi-circular bands are in turn supported by a web of steel struts above the window [figure 14]. Further protection against rusting was provided by “red lead and oil paint” on all steel supports ordered by John Wade.

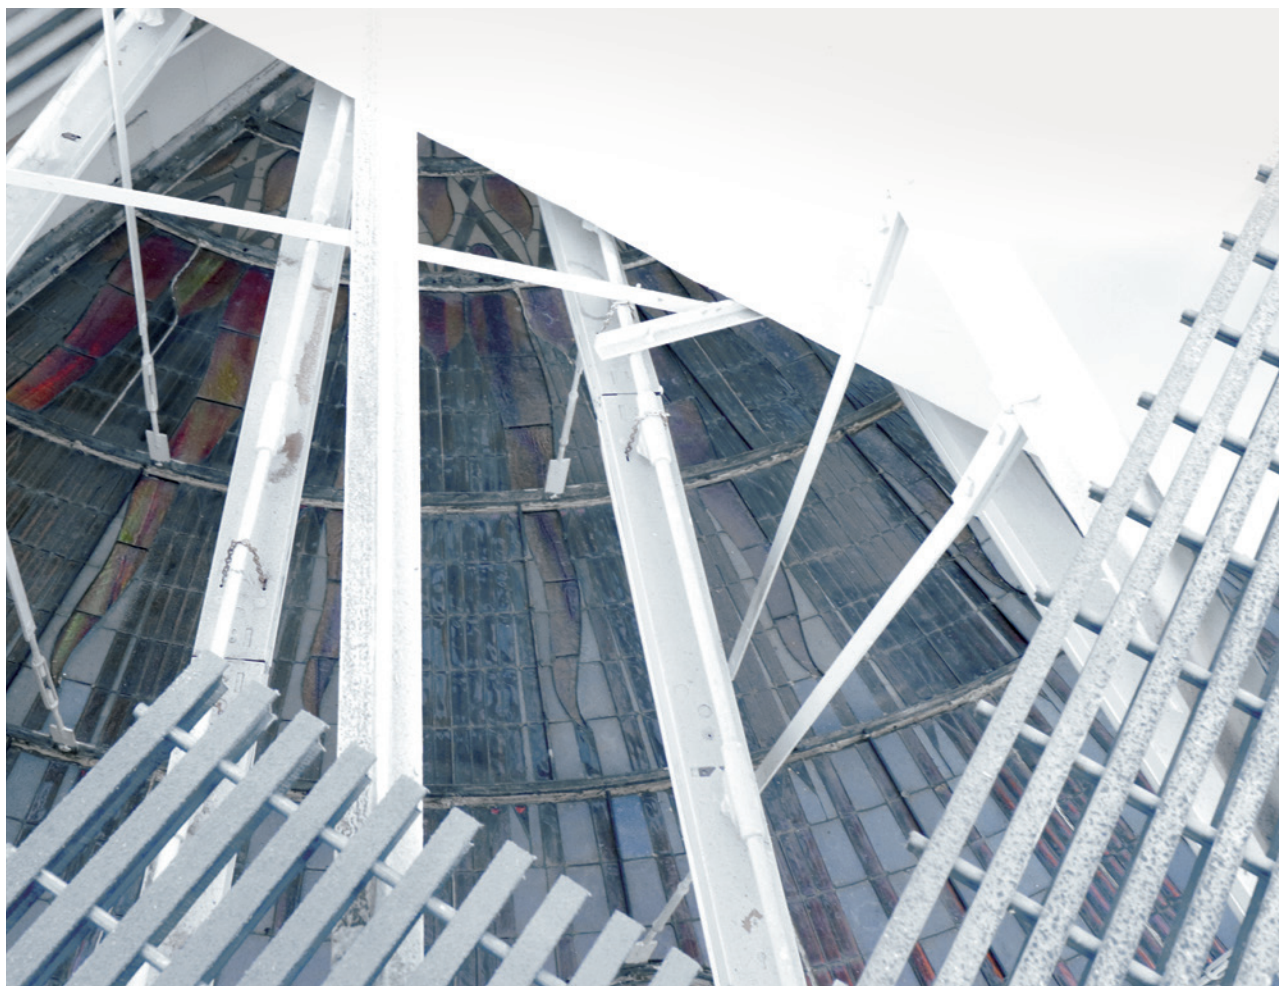
Figure 14: The Sunburst strut support for the steel bands; Photo: Bedson, 2019
