Reconnaissance Level Historic Resources Survey of Forestville

Town of Hanover, Chautauqua County, NY
October 21, 2019

CBCA 19-013

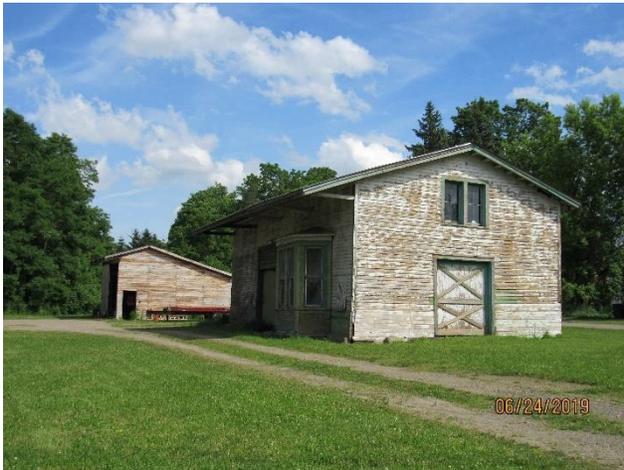
Figure 2-7: (left) Former Railroad Depot at 3 Erie Street Source: CBCA

By 1854, the Erie rail line connected to major railroads in adjacent states via the Meadville and Franklin & Warren rail lines as a result of their merger to form the Atlantic and Great Western Railroad. This marked a major connection in the northeast, with a line from New York City to St. Louis that was recognized as “one of the most extensive and successful railways on this continent.”¹² This resulted in Forestville gaining direct access to new markets in the west, resulting in a growth in agricultural and industrial activities. Currently, the sole remaining structure related to this is the former railroad depot that residents could travel by, located at Erie Street.

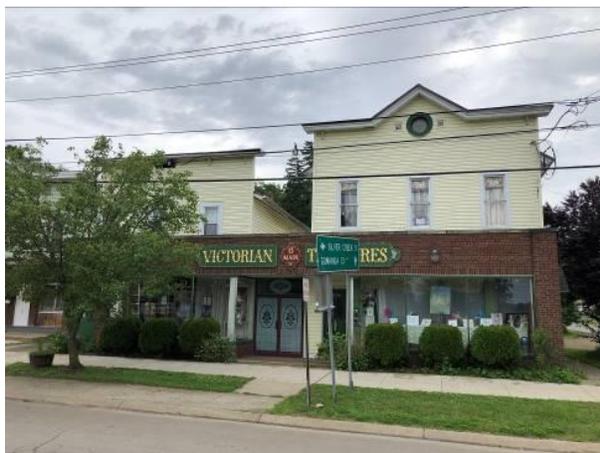
Figure 2-16: 6 Main Street built ca. 1880 Source: CBCA

The two-part block is the most common form for small and moderate-sized commercial buildings in the United States. This type of building is generally limited to two to four stories and is characterized by a horizontal division into two distinct zones. The two-part division of the exterior zones typically reflects differences in its interior use. The street level indicates public spaces for commercial enterprises, while the upper section suggests more private spaces reserved for offices, meeting halls or apartments. Most of these display decorative elements and materials characteristic of either the late 19th or early 20th century commercial style. There are several extant examples of this form situated along Main Street, such as the building located at 6 Main Street and 27 Main Street (the former Forestville Hardware store).

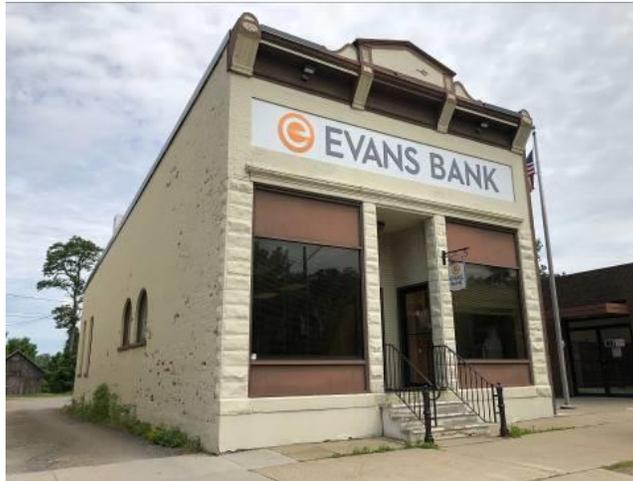
Figure 2-18: 25 Main Street built 1881 Source: CBCA

Another type of commercial building present in the survey area, the one-part block is a one-story, free-standing building that was a popular commercial design in small cities and towns during the late 19th and early 20th centuries. It was adapted from the lower part of the more numerous two-part commercial block during the Victorian period. The one-part block is a simple rectangular building with an often ornate façade. It is most often used for retail or office space. An example of this form is the Levi Pierce Hardware store building located at 25 Main Street, now home to now Evans National Bank.

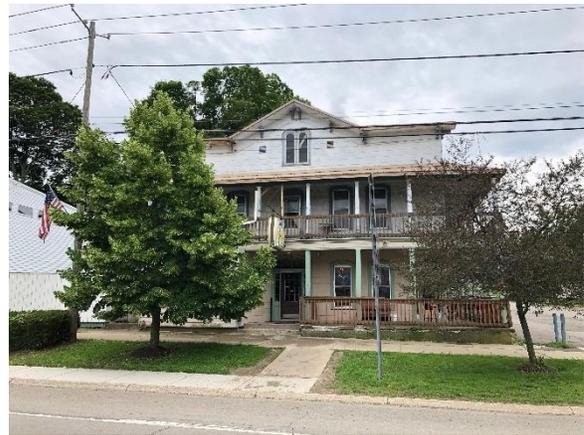
Figure 2-20: Main Hotel at 14 Main
Source: CBCA

One of the more distinct commercial buildings, situated on the corner of Main and Park Street, is the Main Hotel. Originally known as Morrison House, it was built ca. 1854 and was operated by Orrin Morrison. Following a fire in 1873 that leveled it, the current structure known as Harrison House was built 6 years after. The 3-story structure operated as Main Hotel until summer of 1959.²⁷ It is also worth noting that the bar which is currently present was featured in the Columbia Building at Buffalo's Pan American Exhibition.

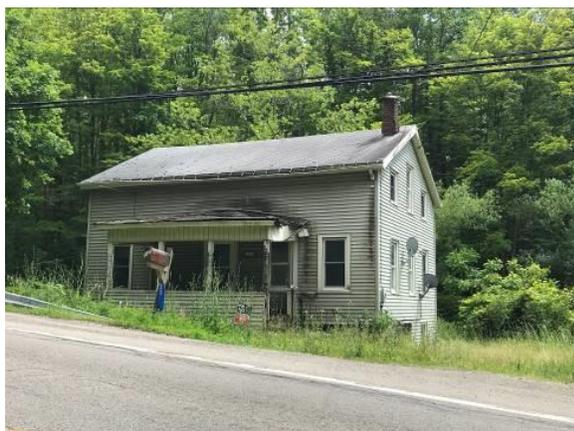
Figure 2-25: (left) Hall and Parlor Subtype House at 33 Lodi Street built ca. 1835 Source: CBCA

Folk houses are the simplest and most straight forward housing type. They are built to provide basic shelter and most effectively meet domestic needs. Little initial regard is paid changing fashions or excessive styling, the purpose being primarily diverted toward stalwart construction. Early folk houses were built of readily available local materials gathered and prepared by the builders themselves with, if the circumstances allowed, help of a local craftsman. This type of building shows relatively little change over the period of time during which it was predominant. However, it shows much regional variation, as the geography and environmental complements of a locale greatly affected the initial type of building stock it could support. Here in the Northeast, dwellings were most commonly plain, side gabled, heavy frame constructed, rough-hewn clapboard or thick shingle covered houses of linear (I-house), transitional (saltbox), or massed (box) plan. After the popularity of the Greek Revival style, some front gabled houses were introduced. This first period of American folk architecture spanned the long interval between the earliest permanent Colonial settlements and the growth of the railroad as a national transportation network in the second half of the 19th century.

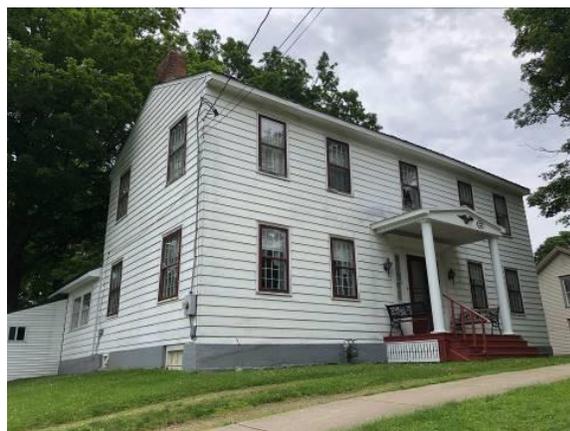
Figure 2-26: (right) Extended I-House Subtype at 43 Main Street built ca. 1780 Source: CBCA

Once a familiar dwelling on the American landscape, only limited numbers have survived intact. Forestville is fortunate in having a handful remain.

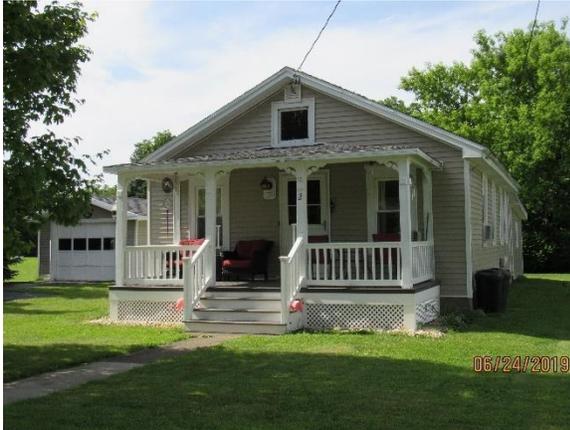
Figure 2-27: (left) Gable Front Subtype at 2 Swan built ca. 1890 Source: CBCA

several new shape innovations comprised six distinctive families of house shapes: gable-front; gable-front-and-wing; hall-and-parlor; I-house; massed plan, side-gabled; and pyramidal. Together these would dominate American folk building trends through the early 20th century. Of these types though, the front gabled and the added gable-front-and-wing houses remained the most common in the Northeast, influenced by New England tradition.

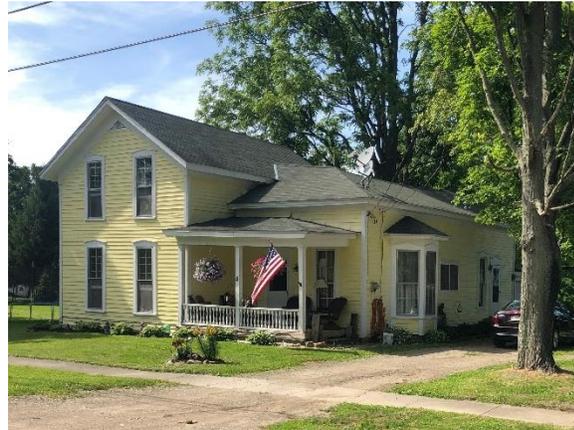
Figure 2-28: (right) Gable Front and Wing Subtype at 4 Eagle Street built 1906 Source: CBCA

Forestville retains a good number of these Folk National Style dwellings, though many have suffered later modification and/or alteration.

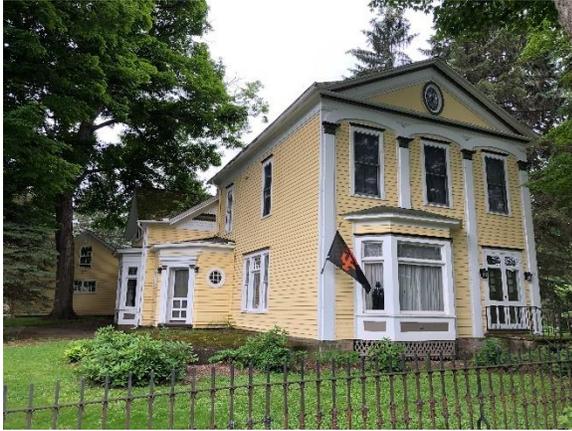
Figure 2- 29: (left) 26 Main Street built 1862 Source: CBCA

In Forestville, extant examples of the Greek Revival style are primarily reserved for more modest, residential buildings. The gable front and wing variation appears to be the most prominent, although there are several examples of the front-gabled type as well. Several buildings of this type remain, however the majority of these appear altered by later modifications and are not easily discernable. One of the key identifying traits of these houses is usually a front-gabled massing with a two-bay or three-bay fenestration pattern. Of those buildings which are good examples of the Greek Revival, several reflect minor changes from later in the 19th century such as Victorian-era porches, shaped shingles and other alterations which generally do not obscure the earlier architectural styling.

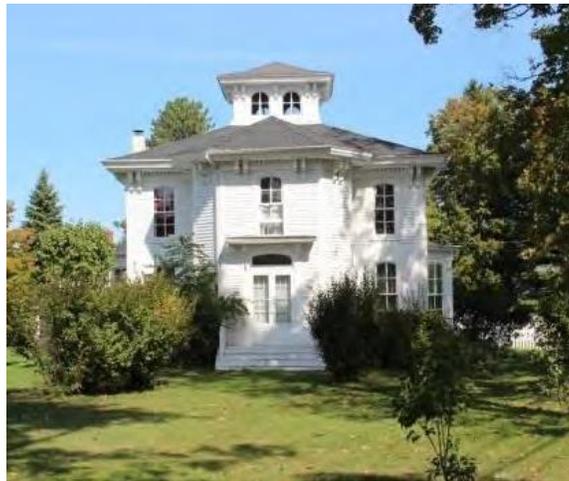
Figure 2-33: Sherman House at 1 Center Street built 1865
Source: CBCA

Forestville retains relatively few Italianate dwellings and these representative examples of the style are concentrated near the Pearl Street and Center Street intersection. These houses represent the Towered subtype of the Italianate Style characterized by a square tower, often centered on the façade, with narrow windows and a low-pitched hipped roofs, like 1 Center Street.

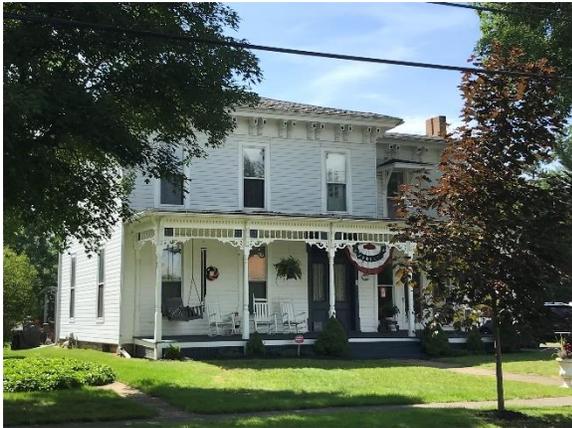
Figure 2-34: (left) Daniel Sherman House / Levi J. Pierce Homestead at 10 Center Street built 1840
Source: CBCA

exterior structure. This mass produced, woodwork detailing inspired from the Queen Anne and Italianate styles, could be applied at the time of construction or, as was often the case, a number of years after in an attempt to update and embellish the structure. Though generally less elaborate and clearly discernable from the high Victorian styles they mimicked, the application of said ornamentation was a conscious choice that made a distinct statement. As such, these fashion-consciously embellished vernacular dwellings fully capture and represent the indulgent and frivolous spirit of the period.

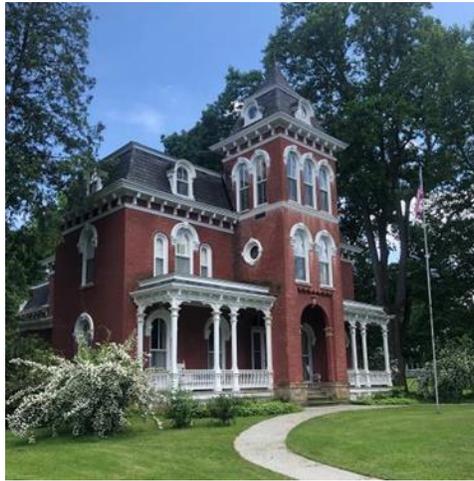
Figure 2-36: 21 Pearl Street built 1871 Source: CBCA

dormer windows to allow for interior illumination. An outstanding example of this style is located at 21 Pearl Street, displaying a prominent mansard roof and dormers.

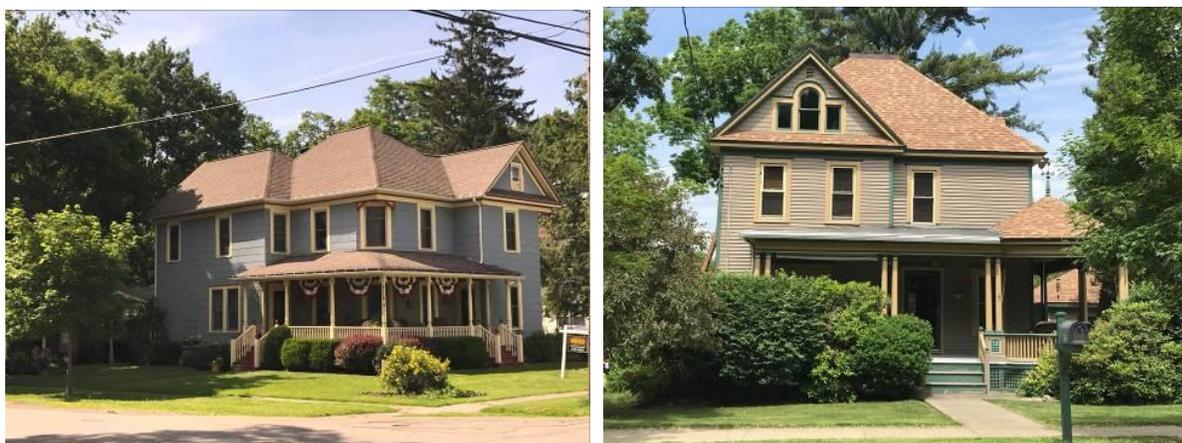
Figure 2-37: (left) 20 Center Street built ca. 1912 Source: CBCA

Examples of the Queen Anne style in Forestville reflect the wide-ranging diversity found within the style. Several examples are of wood-frame construction, containing defining characteristics such as spindlework and classical columns in a modest, vernacular tone. Numerous properties in the survey area reflect modification and alteration over time, and feature replacement windows, altered porches, vinyl siding and other changes which detract from the spirit of the original Queen Anne-style vocabulary. Among them are the properties at 20 Center Street and 12 Lodi Street.

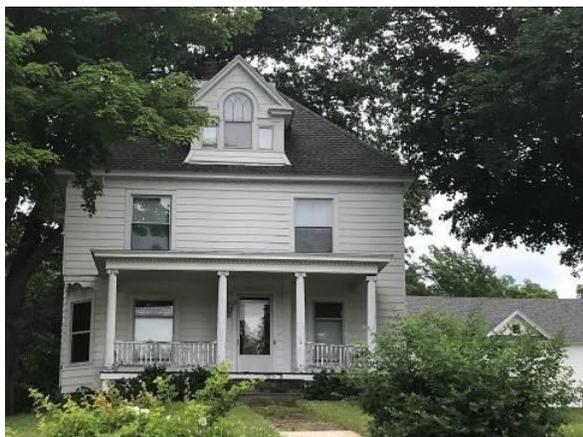
Figure 2-39: (left) 8 Prospect Street built ca. 1900 Source: CBCA

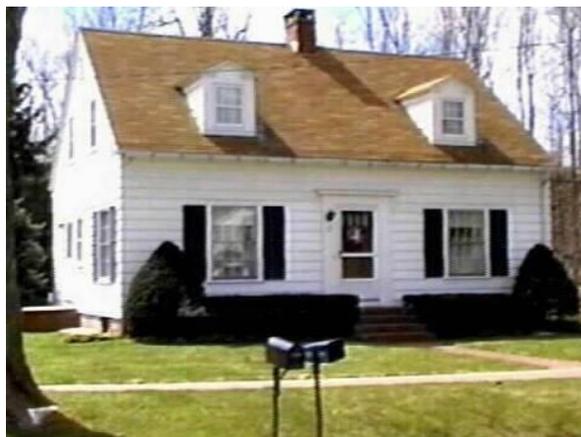
Figure 2-40: (right) 17 Lodi Street built ca. 1940 Source: CBCA

Forestville has a few representative Colonial Revival houses, dating primarily to the early decades of the 20th century, and constitute domestic/residential examples. The Cape Cod subtype, such as 17 Lodi Street, were included in this survey due to their pre-1969 construction date, however, they maybe outside the period of significance for proposed historic districts. This should be evaluated further when the period of significance of proposed districts are established.

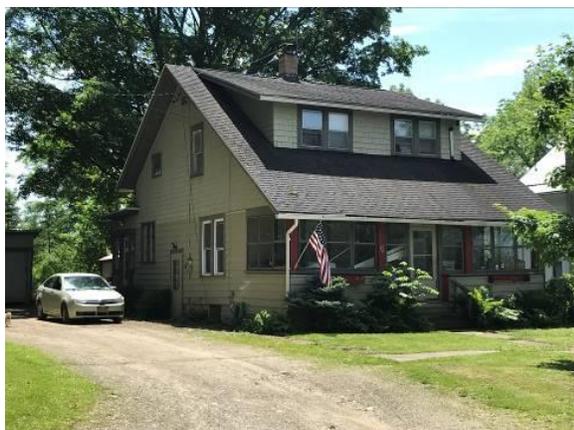
Figure 2-41: (left) 6 Academy Street built ca. 1930 Source: CBCA

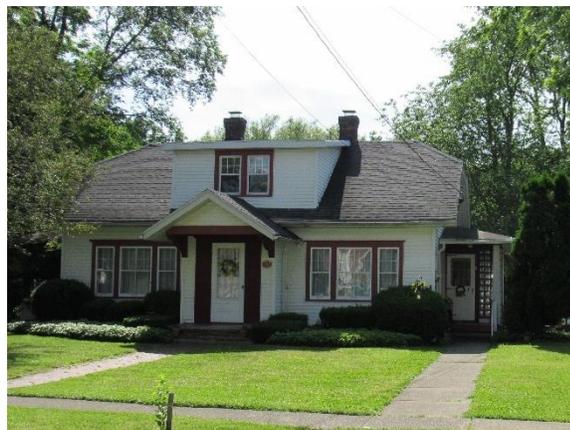
Figure 2-42: (right) 30 Center Street built ca. 1908 Source: CBCA

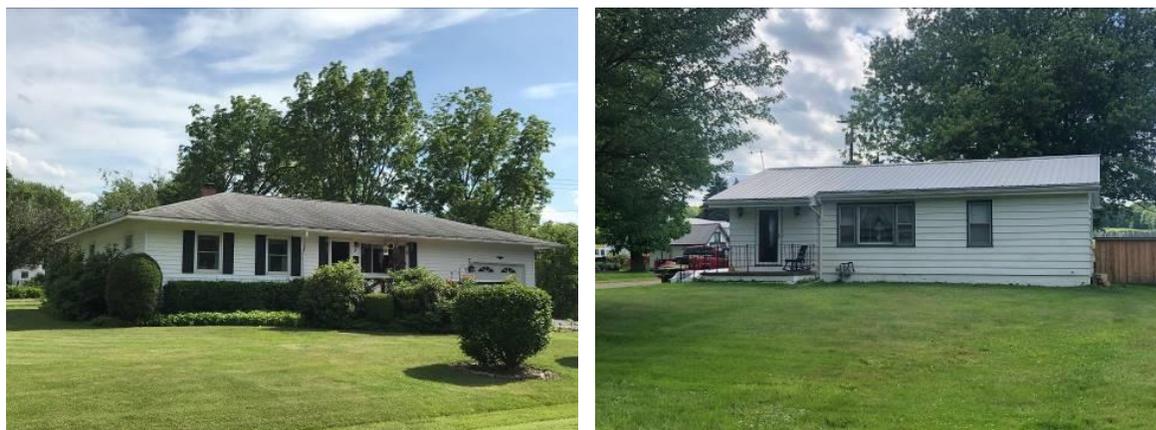
Figure 2-43: (left) 7 Swan Street built in ca. 1960 Source: CBCA

Figure 2-44: (right) 16 Walnut Street built in ca. 1960 Source: CBCA

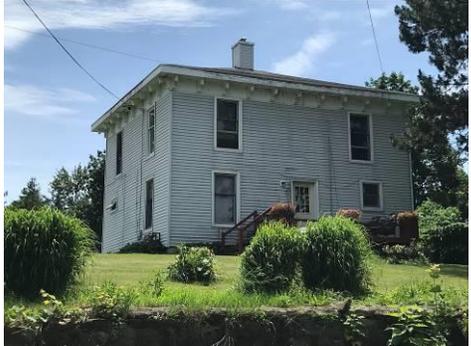
ADDRESS: 2 Academy Street	TAX ID: 100.13-1-2	DATE OF CONSTRUCTION: Ca. 1850	SIGNIFICANCE: I/D (local) - Contributing
CONDITION: Fair		NAME: Justus H. McEwen House

DESCRIPTION: <i>Former residence of Dr. Eleanor E. Burnside who operated Forestville Sanitarium.</i> 2-story low-hipped roof Italianate single-family frame house; parged foundation, vinyl siding, asphalt roofing, and moderate overhanging eaves supported by decorative brackets. 1/1 double-hung vinyl windows. Roof ridge chimney. Partial width open front porch.	
ADDRESS: 4 Academy Street	TAX ID: 100.13-1-1	DATE OF CONSTRUCTION: Ca. 1927	SIGNIFICANCE: I (NR) – Individually Eligible I/D (local) - Contributing
CONDITION: Good		NAME: Forestville High School

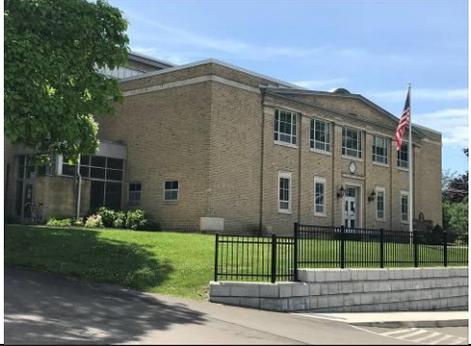
DESCRIPTION: 2-story parapet on flat roof brick masonry school; prominent centered pediment, 5 bay, semi-circle details in parapet, and brick chimney. Multi-light vinyl windows. Contemporary expansion/additions. NR CRITERION: A, C

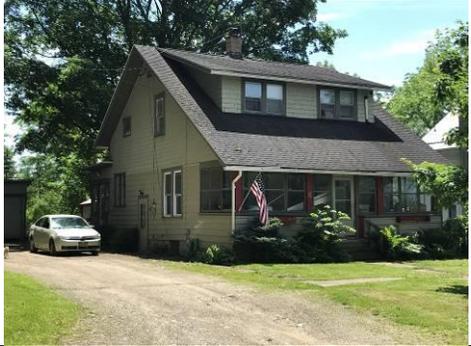
ADDRESS: 6 Academy Street	TAX ID: 99.12-2-26	DATE OF CONSTRUCTION: 1930	SIGNIFICANCE: D (local) - Contributing
CONDITION: Good		NAME:

DESCRIPTION: 1½-story side-gabled roof Craftsman Bungalow style single-family frame house with a prominent front-facing shed roof dormer; concrete block foundation, clapboard lower/ shingle siding upper, and asphalt roofing. Single and paired 1/1 double-hung wood and vinyl windows. Full-width 1-story enclosed porch with ribbon 1/1 double-hung windows and a centered door.

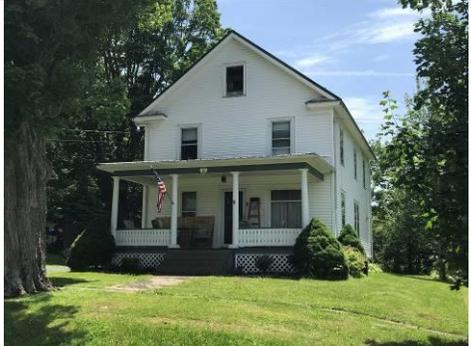
ADDRESS: 8 Academy Street	TAX ID: 99.12-2-25	DATE OF CONSTRUCTION: 1932	SIGNIFICANCE: D (local) - Contributing
CONDITION: Good		NAME:

DESCRIPTION: 2½-story front-gabled roof Colonial Revival single-family frame house; concrete block foundation, vinyl siding, metal roofing and cornice on pediment. 1/1 double-hung vinyl windows. Full-width open front porch; balustrade with geometric patterns, Doric columns and low-hipped roof.	
ADDRESS: 10 Academy Street	TAX ID: 99.12-2-24	DATE OF CONSTRUCTION: Ca. 1880	SIGNIFICANCE: D (local) - Contributing
CONDITION: Good		NAME: E. Stiger House

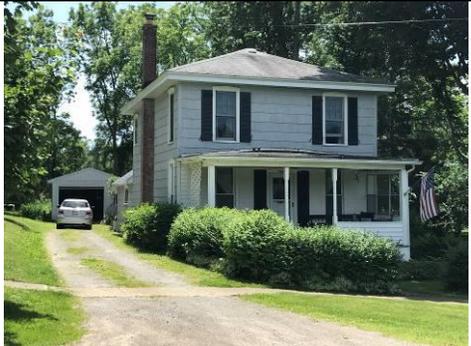
DESCRIPTION: 2-story hipped roof with full-width porch National Folk single-family frame house; clapboard and composition siding, and asphalt roofing. Single 1/1 and 6/1 double-hung wood windows; triangular pediment and shutters. Brick chimney on east elevation. Full-width open front porch; solid balustrade, simple square columns at corners and turned supports at centered entrance, and low-hipped roof.

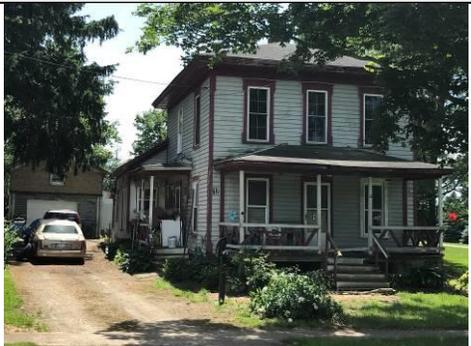
ADDRESS: 12 Academy Street	TAX ID: 99.12-2-23	DATE OF CONSTRUCTION: Ca. 1880	SIGNIFICANCE: D (local) - Contributing
CONDITION: Fair		NAME: D.H. Griswold House

DESCRIPTION: 2-story hipped roof with full-width porch National Folk single-family frame house; stone foundation, clapboard siding, asphalt roofing, and wide overhanging eaves. 1/1 and 4/4 double-hung replacement vinyl windows; pediment and ornate frame. Full-width open front porch; balustrade with geometric patterns, simple square columns, and hipped roof.

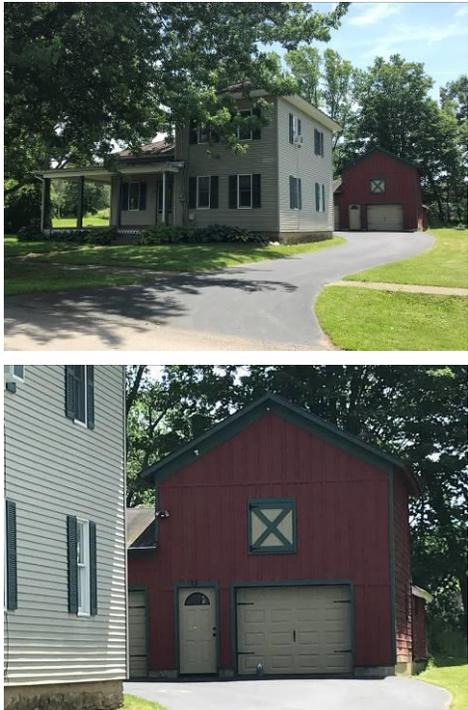
ADDRESS: 18 Academy Street	TAX ID: 99.12-2-22	DATE OF CONSTRUCTION: Ca. 1880	SIGNIFICANCE: D (local) - Contributing
CONDITION: Excellent		NAME: August A. Cook House

<p>DESCRIPTION:</p> <p>2-story gable-front-&-wing National Folk single-family frame house; stone and parged foundation, vinyl siding, roll asphalt roofing, and wide overhanging eaves. 1/1 double-hung replacement vinyl windows with shutters. L-shaped open front porch; simple square columns, and low-hipped roof.</p> <p>2-story front-gabled frame garage with 1-story side-gabled roof side wing; board and batten siding and hayloft door.</p>	
ADDRESS: 20 Academy Street	TAX ID: 99.12-2-21	DATE OF CONSTRUCTION: Ca. 1870	SIGNIFICANCE: D (local) - Contributing
CONDITION: Good		NAME:

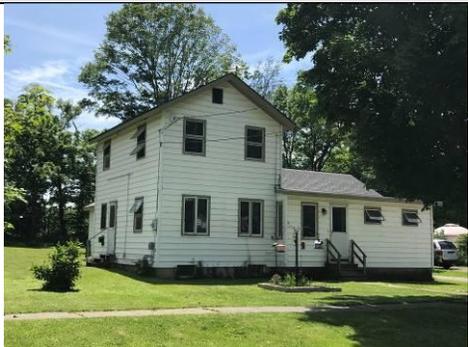
<p>DESCRIPTION:</p> <p>2-story gable-front-&-wing National Folk single-family frame house; parged and concrete block foundation, aluminum siding, and asphalt roofing. 1/1 double-hung, casement, fixed and awning replacement wood windows.</p>

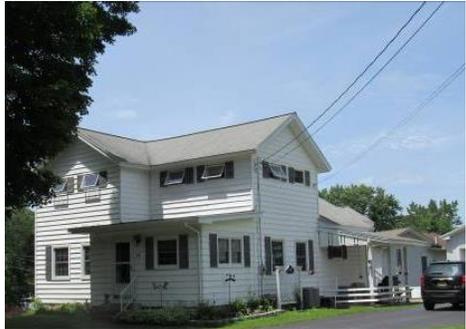
ADDRESS: 21 Academy Street	TAX ID: 99.12-2-14	DATE OF CONSTRUCTION: Ca. 1880	SIGNIFICANCE: D (local) - Contributing
CONDITION: Excellent		NAME:

DESCRIPTION: 2-story gable-front-&-wing National Folk single-family frame house; concrete block and parged foundation, vinyl siding, and asphalt roofing. 6/6 double-hung and awning replacement wood windows with shutters. Partial-width enclosed front porch with shed roof.	
ADDRESS: 22 Academy Street	TAX ID: 99.12-2-20	DATE OF CONSTRUCTION: Ca. 1880	SIGNIFICANCE: D (local) - Contributing
CONDITION: Fair		NAME: Pierce/Turner House

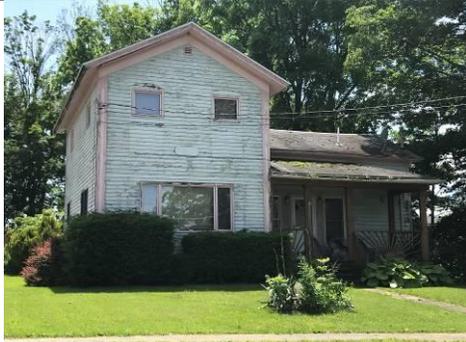
DESCRIPTION: 2-story gable-front-&-wing National Folk single-family frame house; stone foundation, clapboard siding, and asphalt roofing. 1/1 double-hung, casement and picture replacement wood windows. Partial-width open front porch; ornate balusters, chamfered columns, and hipped roof.

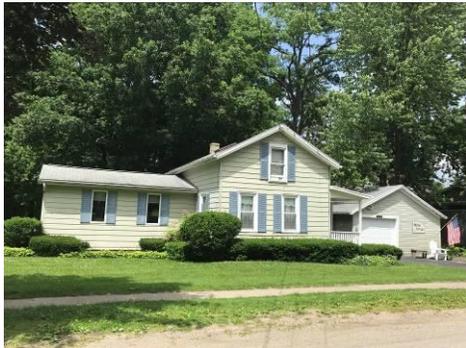
ADDRESS: 1 Cedar Street	TAX ID: 100.05-1-51	DATE OF CONSTRUCTION: Ca.1900	SIGNIFICANCE: D (local) - Contributing
CONDITION: Good		NAME:

DESCRIPTION: 1½-story gable-front-&-wing National Folk single-family frame house; stone foundation, aluminum siding, asphalt roofing with 1-story west wing. Fixed and 1/1 double-hung wood and vinyl windows with shutters. Partial-width open east side porch; spindlework porch detailing, plain balusters, simple square columns, and shed roof.

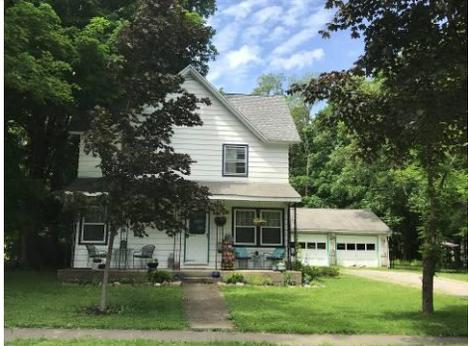
ADDRESS: 5 Cedar Street	TAX ID: 100.05-1-53	DATE OF CONSTRUCTION: 1900	SIGNIFICANCE: D (local) - Contributing
CONDITION: Good		NAME:

DESCRIPTION: 2½-story cross-gabled National Folk single-family frame house; parged foundation, aluminum siding, and asphalt roofing. Single and paired 1/1, 8/1 double-hung vinyl windows. Full-width open front porch; decorative metal supports, and hipped roof. 30	
ADDRESS: 6 Cedar Street	TAX ID: 100.05-2-37	DATE OF CONSTRUCTION: 1928	SIGNIFICANCE: I/D (local)- Contributing
CONDITION: Good		NAME: American Legion Hall, Post 953

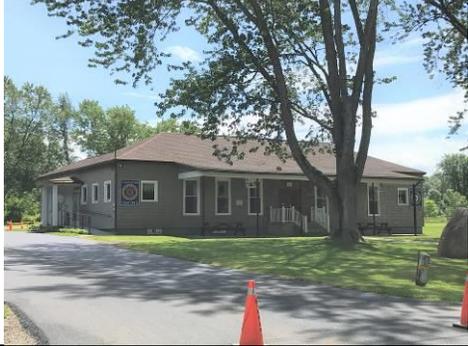
DESCRIPTION: 1-story hipped roof Ranch style frame social building; parged foundation, shingle and vinyl siding, and asphalt roofing. 1/1 double-hung and awning vinyl windows. Partial-width open front porch with a smaller centered entry porch; plain balusters, simple square columns, and principal roof.	
ADDRESS: 10 Cedar Street	TAX ID: 99.12-1-35	DATE OF CONSTRUCTION: 1920	SIGNIFICANCE: D (local) - Contributing

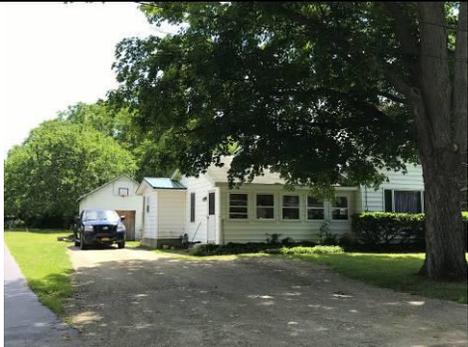
CONDITION: Good		NAME:

DESCRIPTION: 1½-story gable-front-&-wing National Folk single-family frame house; parged foundation, vinyl siding, asphalt and metal roofing. Single and ribbon 1/1 double-hung and picture vinyl windows. Indirect entrance.

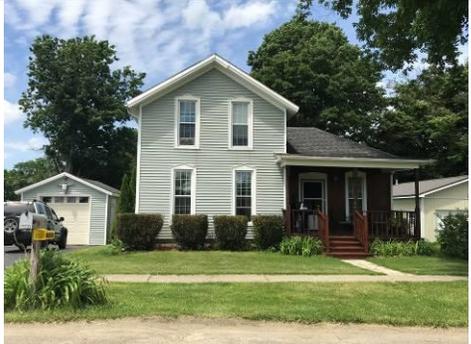
ADDRESS: 13 Cedar Street	TAX ID: 100.05-1-56	DATE OF CONSTRUCTION: Ca. 1870	SIGNIFICANCE: D (local) - Contributing
CONDITION: Good		NAME:

DESCRIPTION: 1½-story gable-front-&-wing National Folk single-family frame house; stone foundation, vinyl siding, and asphalt roofing. 6/6 double-hung vinyl windows. Partial-width open front porch; turned balusters and supports, and low-hipped roof.	
ADDRESS: 17 Cedar Street	TAX ID: 100.05-1-58	DATE OF CONSTRUCTION: Ca. 1870	SIGNIFICANCE: D (local) - Contributing
CONDITION: Good		NAME:

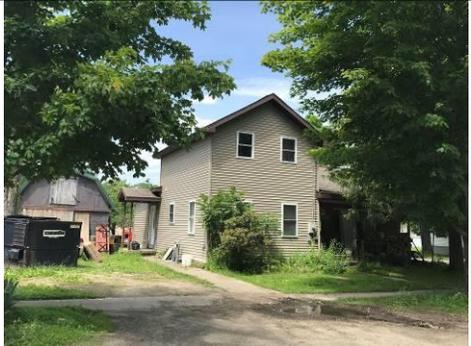
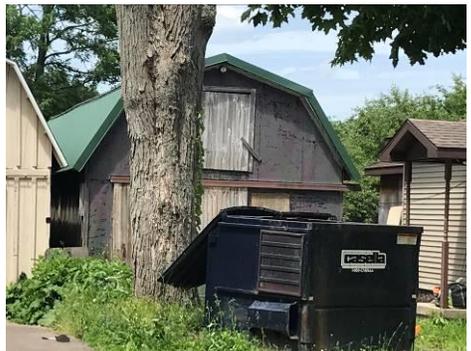
DESCRIPTION: 2-story gable-front-&-wing National Folk single-family frame house; parged foundation, vinyl siding, and asphalt roofing. 1/1 double-hung vinyl window. Partial-width open front porch; turned supports, and principal roof. 1½-story gambrel roof frame barn; wood siding, metal roofing and hayloft door.

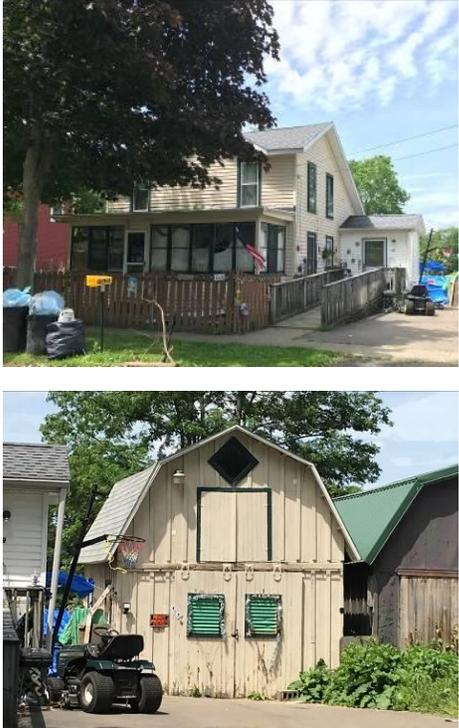
ADDRESS: 19 Cedar Street	TAX ID: 100.05-1-59	DATE OF CONSTRUCTION: Ca. 1870	SIGNIFICANCE: D (local) - Contributing
CONDITION: Good		NAME:

<p>DESCRIPTION:</p> <p>1½-story side-gabled roof National Folk single-family frame house; clapboard siding, and asphalt roofing. 1/1 double-hung wood and vinyl windows. Full-width enclosed front porch; plain balusters, ribbon windows, and shed roof. Indirect entrance with ramp and porch with plain balusters.</p> <p>1½-story gambrel roof frame barn; board and batten siding, asphalt roofing, hayloft door and a triangular shaped window in top of gable.</p>	
ADDRESS: 21 Cedar Street	TAX ID: 100.05-1-60	DATE OF CONSTRUCTION: Ca. 1870	SIGNIFICANCE: D (local) – Non-Contributing
CONDITION: Excellent		NAME:

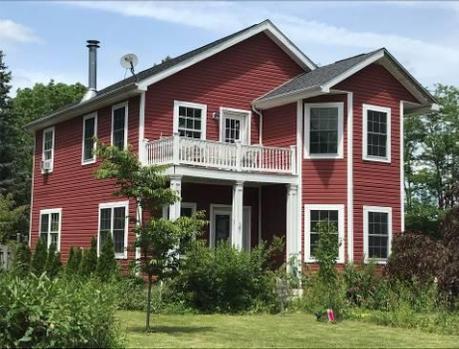
<p>DESCRIPTION:</p> <p>2-story front-gabled roof single-family frame house; vinyl siding, and asphalt roofing. 6/6 double-hung vinyl windows 2-story projecting front bay with cutaway bay windows and front-gabled roof. Partial-width open front porch; decorative square columns, roof-line balustrade.</p>

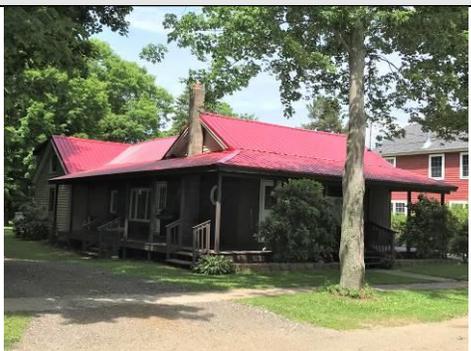
DESCRIPTION: 1½-story hall-and-parlor National Folk single-family frame house; parged foundation, clapboard siding, and metal roofing. 1/1 double-hung and fixed vinyl windows. Gable wall concrete block chimney. L-shaped open front porch; simple square columns, and hipped roof. 1-story gambrel roof frame barn; vinyl siding, and asphalt roofing.	
ADDRESS: 27 Cedar Street	TAX ID: 99.08-1-9	DATE OF CONSTRUCTION: Ca. 1870	SIGNIFICANCE: D (local) - Contributing
CONDITION: Excellent		NAME:

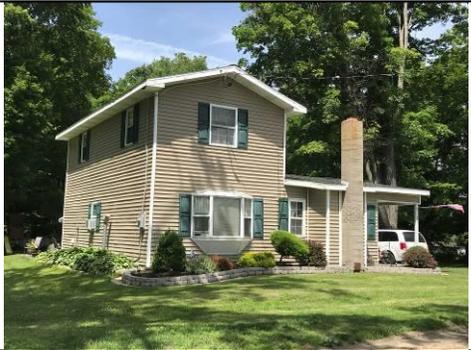
DESCRIPTION: 2-story gable-front-&-wing National Folk single-family frame house; parged foundation, vinyl siding, and asphalt roofing. 1/1,4/4,6/6 double-hung vinyl windows with vinyl shutters. Hipped roof bay window. Eave wall concrete block chimney. Entry open front porch; simple square columns, and principal roof.

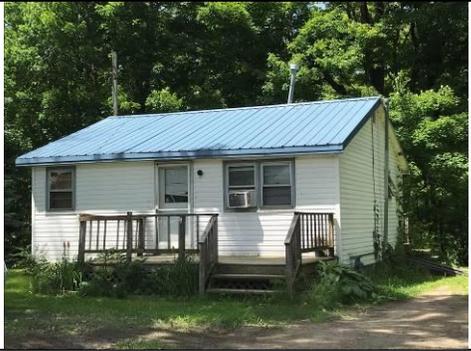
DESCRIPTION: 1-story side-gabled roof National Folk single-family frame house; stone foundation, vinyl siding, and metal roofing. Single and paired 1/1 double-hung wood windows. Partial-width open front porch; plain balusters.

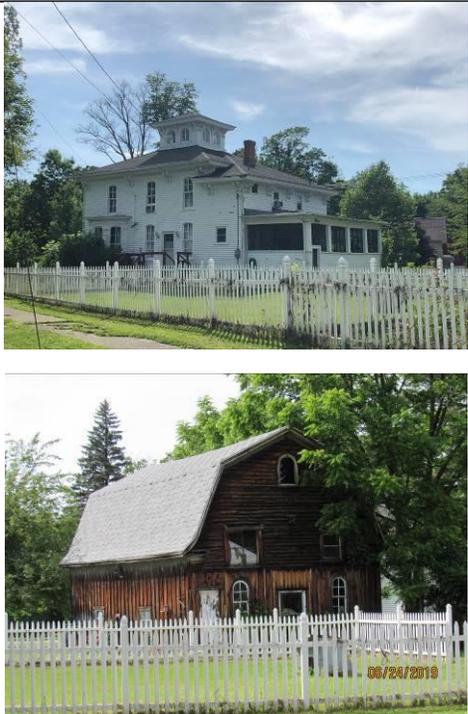
<p>DESCRIPTION:</p> <p>2½-story asymmetrical hipped roof Italianate style single-family frame house with the main entrance facing the 3-way intersection; parged foundation, clapboard siding, asphalt roofing, widely overhanging eaves supported by decorative bracket, and hipped roof square cupola. Tall and narrow 4/4 double-hung and multi-light fixed wood windows.</p> <p>2½-story gambrel roof frame barn; board and batten lower /clapboard siding upper, and asphalt roofing. Flat and round-arched top 1/1,4/4 double-hung and fixed wood windows.</p> <p>NR CRITERION: C</p>	
ADDRESS: 2 Center Street	TAX ID: 100.09-1-9	DATE OF CONSTRUCTION: 1890	SIGNIFICANCE: D (NR) - Contributing I/D (local) - Contributing
CONDITION: Good		NAME:

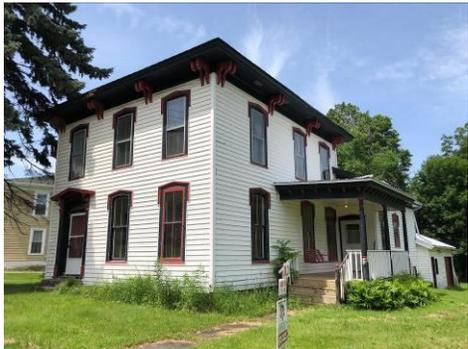
<p>DESCRIPTION:</p> <p>2-story hipped roof Italianate style single-family frame house; parged foundation, vinyl siding, asphalt roofing, and widely overhanging eaves supported by decorative brackets. 2/2 double-hung windows with hooded crows. Bracketed gable overhang main entrance. Partial-width open side porch; plain balusters, turned supports, low-hipped roof, and decorative brackets.</p> <p>NR CRITERION: C</p>

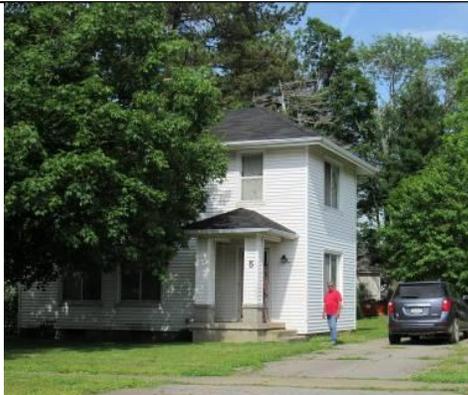
DESCRIPTION: 2-story hipped roof National Folk single-family frame house; parged foundation, vinyl siding, and asphalt roofing. 1/1 double-hung and sliding vinyl windows. Roof slope brick chimney. Entry open front porch; simple square columns, and hipped roof.	
ADDRESS: 6 Center Street	TAX ID: 100.09-1-5	DATE OF CONSTRUCTION: Ca. 1870	SIGNIFICANCE: D (NR) - Contributing I/D (local) - Contributing

CONDITION: Excellent		NAME:

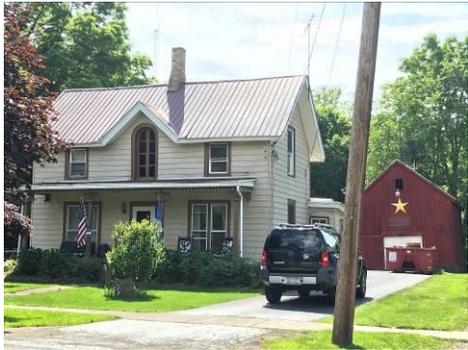
DESCRIPTION: 1½-story centered gable roof vernacular Gothic Revival single-family frame house; aluminum siding, and metal roofing. Single and paired 1/1 double-hung vinyl windows and centered round-arched top multi-light through-the-cornice wood window. Roof ridge brick chimney. Full-width open front porch; square columns with side brackets, and shed roof. 2½-story front-gabled frame barn; board and batten siding and metal roofing. 4-pane fixed window and hayloft door. NR CRITERION: C

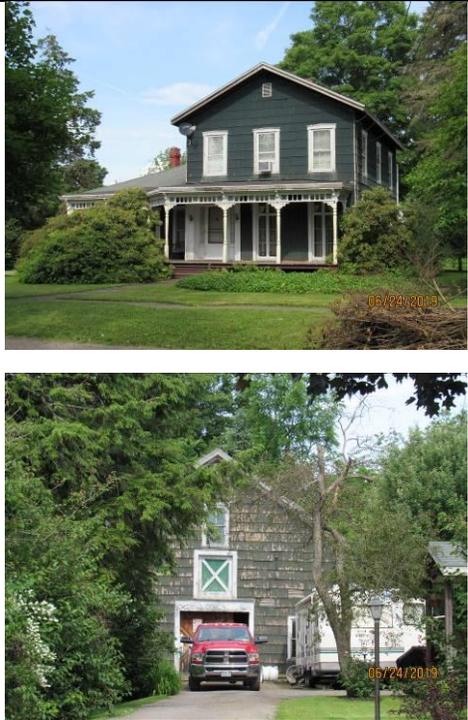
DESCRIPTION: 2-story gable-front-&-wing National Folk single-family frame house; stone foundation, composition siding, and asphalt roofing. 1/1,6/6 double-hung windows with triangular pediment. Roof slope brick chimney. Full-width open front porch; spindlework detailing, turned supports with side brackets, and low-hipped roof. 2½-story front-gabled frame barn; shingle siding, and asphalt roofing. Double-hung wood windows and hayloft door. NR CRITERION: C	
ADDRESS: 8 Center Street	TAX ID: 100.09-1-4	DATE OF CONSTRUCTION: Ca. 1880	SIGNIFICANCE: D (NR) - Contributing D (local) - Contributing
CONDITION: Good		NAME:

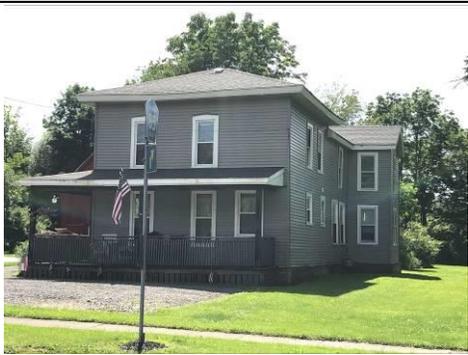
DESCRIPTION: 2-story pyramidal National Folk single-family frame house; parged foundation, vinyl siding, asphalt roofing, and wide overhanging eaves. 1/1 double-hung vinyl windows with triangular top molding. L-shaped open front porch; plain balusters, simple square columns, and hipped roof. NR CRITERION: C

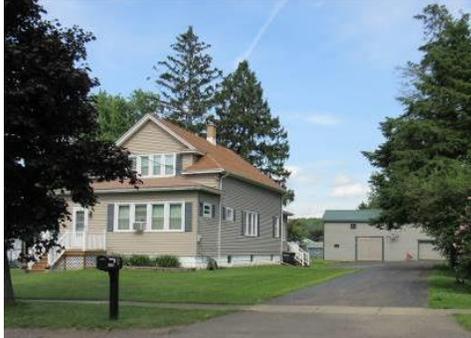
ADDRESS: 9 Center Street	TAX ID: 100.05-2-42.2	DATE OF CONSTRUCTION: 1920	SIGNIFICANCE: D (NR) - Contributing D (local) - Contributing
CONDITION: Excellent		NAME:

DESCRIPTION: 1½-story hipped roof Bungalow style single-family frame house; rough-faced concrete block foundation, vinyl siding, and asphalt roofing. Ribbon 1/1 double-hung windows with shutters. Prominent front-gabled through-cornice dormer. Roof slope brick chimney. Full-width enclosed front porch with hipped roof. NR CRITERION: C	
ADDRESS: 10 Center Street	TAX ID: 100.05-2-36	DATE OF CONSTRUCTION: 1840	SIGNIFICANCE: D (NR) - Contributing I/D (local) - Contributing
CONDITION: Good		NAME: Daniel Sherman House / Levi J. Pierce Homestead

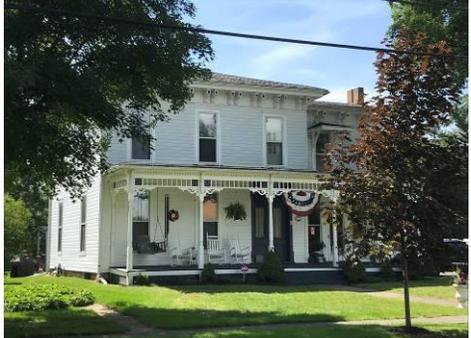
DESCRIPTION: 2-story low-hipped roof Italianate single-family frame house; stone foundation, clapboard siding, asphalt roofing, and widely overhanging eaves supported by decorative brackets. 1/1 double-hung wood windows. Roof slope brick chimney. Full-width open front porch with Victorian-era detailing; spindlework porch detailing, turned supports with decorative side brackets, and low-hipped roof. NR CRITERION: C

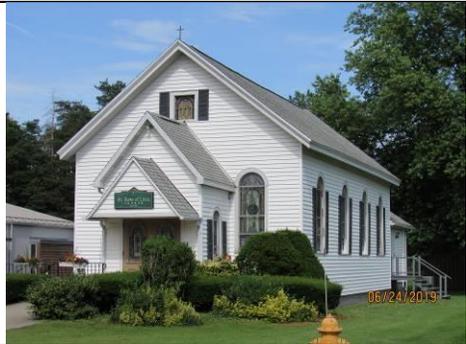
ADDRESS: 11 Center Street	TAX ID: 100.05-2-42.1	DATE OF CONSTRUCTION: 1939	SIGNIFICANCE: D (NR) - Contributing I/D (local) - Contributing
CONDITION: Excellent		NAME: St. Rose of Lima Church

DESCRIPTION: 1½-story front-gabled roof National Folk frame church; parged foundation, vinyl siding, asphalt roofing, and cascading gables. Flat and round top stained glass windows with shutters. Pediment roof overhang entrance. NR CRITERION: C	
ADDRESS: 12 Center Street	TAX ID: 100.05-2-40	DATE OF CONSTRUCTION: 1860	SIGNIFICANCE: D (NR) - Contributing I/D (local) - Contributing
CONDITION: Good		NAME:

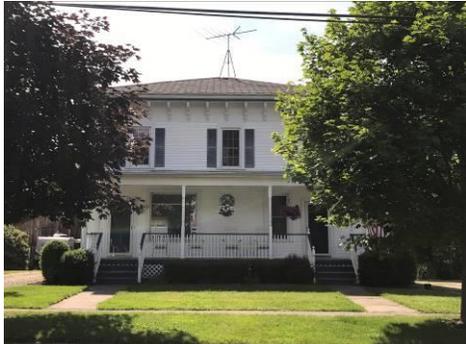
DESCRIPTION: 2-story hipped roof modest Italianate style duplex frame house; stone foundation, vinyl siding, asphalt roofing, and moderate overhanging eaves supported by decorative brackets. 6/6 double-hung, octagonal-shaped multi-light, and fixed wood and vinyl windows; shutters. Full-width open front porch; turned balusters and supports, separate entrances, and low-hipped roof. NR CRITERION: C

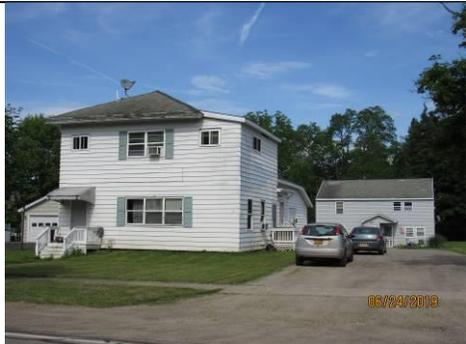
ADDRESS: 15 Center Street	TAX ID: 100.05-2-43	DATE OF CONSTRUCTION: Ca. 1900	SIGNIFICANCE: D (local) – Non-Contributing
CONDITION: Fair		NAME:

DESCRIPTION: 2-story hipped roof single-family frame house with 2-story shed roof side addition; cobblestone foundation, aluminum siding, asphalt roofing, and wide overhanging eaves. Paired and ribbon 1/1 double-hung and sliding windows; shutters. Entry open front porch with plain balusters.

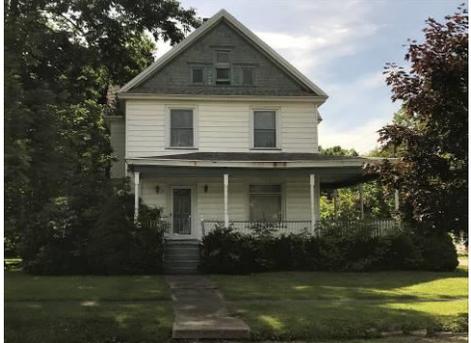
ADDRESS: 16 Center Street	TAX ID: 100.05-2-41	DATE OF CONSTRUCTION: Ca. 1900	SIGNIFICANCE: D (NR) - Contributing D (local) - Contributing
CONDITION: Fair		NAME:

DESCRIPTION: 2½-story cross-gabled roof modest Queen Anne single-family frame house; stone foundation, vinyl lower/shingle siding in gable, asphalt roofing, and pent roof enclosing gable. 1/1 double-hung, fixed and shaped wood and vinyl windows. L-shaped open front porch; turned balusters and supports, and low-hipped roof. NR CRITERION: C	
ADDRESS: 17 Center Street	TAX ID: 100.05-2-44	DATE OF CONSTRUCTION: Ca. 1900	SIGNIFICANCE: D (local) - Contributing
CONDITION: Excellent		NAME:

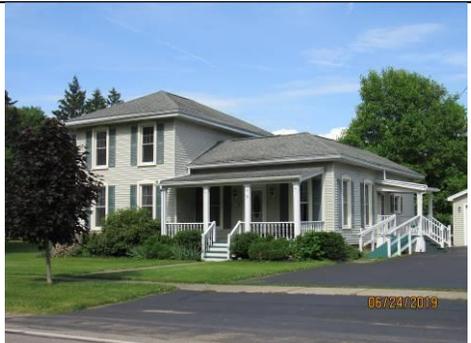
DESCRIPTION: 2-story hipped roof National Folk single-family frame house with 1-story hipped roof wing; cobblestone foundation, vinyl siding, asphalt roofing, and wide overhanging eaves. 6/1 double-hung windows with shutters. Partial-width open front porch; turned balusters, simple square columns, and shed roof.

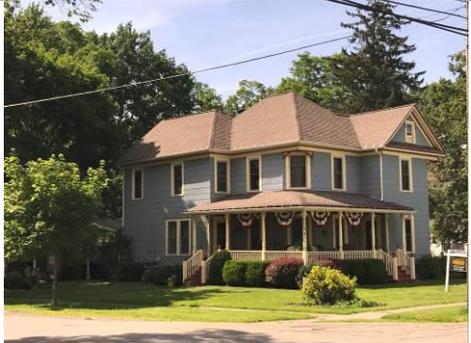
ADDRESS: 18 Center Street	TAX ID: 100.05-1-50	DATE OF CONSTRUCTION: 1887	SIGNIFICANCE: D (NR) - Contributing I/D (local) - Contributing
CONDITION: Excellent		NAME:

DESCRIPTION: 2½-story hipped roof Queen Anne single-family frame house with prominent front-facing gable; stone foundation, composition siding, asphalt roofing, and cutaway bay windows. 1/1 double-hung wood windows. L-shaped open front porch; turned supports and balusters, and hipped roof. NR CRITERION: C

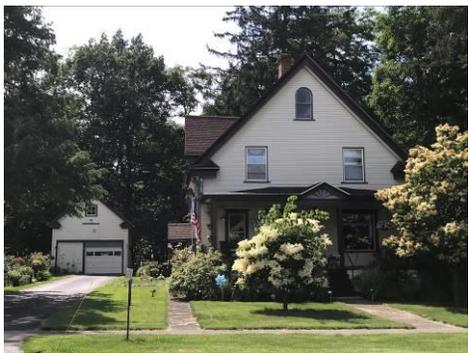
DESCRIPTION: 2½-story cross-gabled roof National Folk single-family frame house; stone foundation, vinyl siding, asphalt roofing, cornice on pediment, and decorative brackets at eaves. 1/1 double-hung vinyl windows; round-arched top in gable. Roof ridge brick chimney. Full-width open front porch; simple square columns, and pedimented roof. 1½-story front-gabled roof frame garage; vinyl siding, and asphalt roofing. 4-pane window in gable. NR CRITERION: C	
ADDRESS: 21 Center Street	TAX ID: 100.05-2-46	DATE OF CONSTRUCTION: Ca. 1930	SIGNIFICANCE: D (local) - Contributing
CONDITION: Good		NAME:

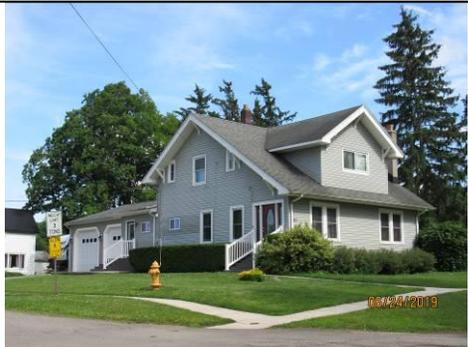
DESCRIPTION: 1½-story saltbox roof modest Craftsman Bungalow style single-family frame house with a prominent front-facing gabled dormer; rough-faced stone foundation, vinyl siding, asphalt roofing, and side brackets. Single and paired 1/1 double-hung and sliding vinyl windows. Brick and concrete block chimneys. 1-story 2 bay attached garage. Indirect entrance facing Eagle Street.

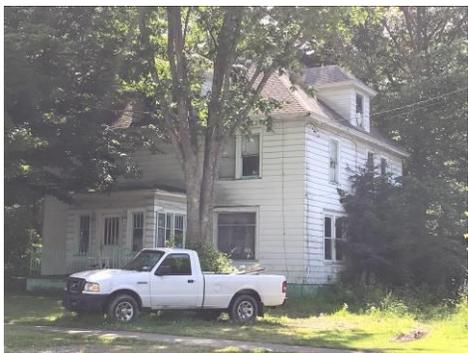
DESCRIPTION: 2½-story hipped roof single-family frame American Foursquare house with modest Colonial Revival detailing; concrete block foundation, aluminum siding, and asphalt roofing. Single and paired 1/1 double-hung and fixed wood windows. Hipped roof dormers. Partial-width enclosed front porch with low-hipped roof. 1-story front-gabled roof frame outbuilding. Clapboard siding lower/board and batten upper, and asphalt roofing.

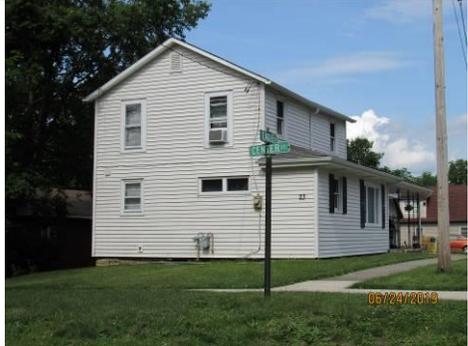
ADDRESS: 23 Center Street	TAX ID: 100.05-1-41	DATE OF CONSTRUCTION: Ca. 1860	SIGNIFICANCE: D (local) – Non-Contributing
CONDITION: Good		NAME:

DESCRIPTION: 2-story side-gabled National Folk single-family frame house; stone foundation, vinyl siding, and asphalt roofing. 1/1 double-hung vinyl windows; shutters. Partial-width open front porch facing Eagle Street; metal columns, and principal roof.	
ADDRESS: 24 Center Street	TAX ID: 100.05-1-47	DATE OF CONSTRUCTION: 1938	SIGNIFICANCE: D (local) - Contributing
CONDITION: Good		NAME:

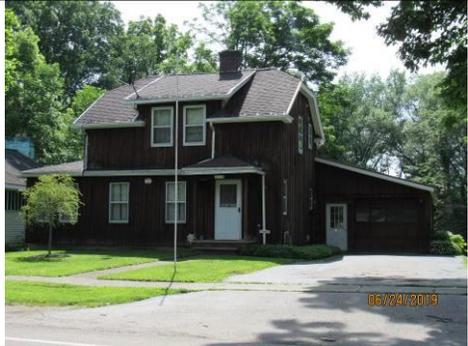
DESCRIPTION: 1½-story hip-on-gable roof Craftsman Bungalow style single-family frame house; parged foundation, board and batten siding, and asphalt roofing. 1/1,6/6 double-hung wood and vinyl windows. Prominent shed roof through-the-cornice dormer. Roof ridge brick chimney. Entry open front porch; simple square columns, and hipped roof.	
ADDRESS: 25 Center Street	TAX ID: 100.05-1-40	DATE OF CONSTRUCTION: Ca. 1850	SIGNIFICANCE: D (local) - Contributing

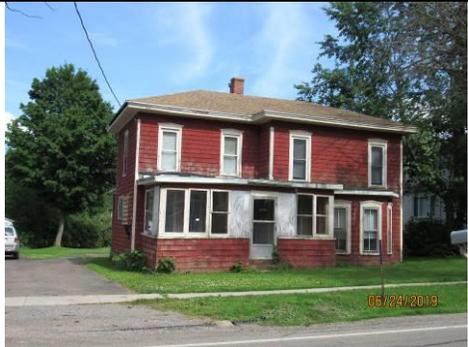
DESCRIPTION: 2-story hipped roof National Folk single-family frame house; parged foundation, shingle siding, asphalt roofing, and wide overhanging eaves. 1/1 double-hung window. 1-story hipped roof bay window. Roof ridge brick chimney. Partial-width enclosed front porch with low-hipped roof.

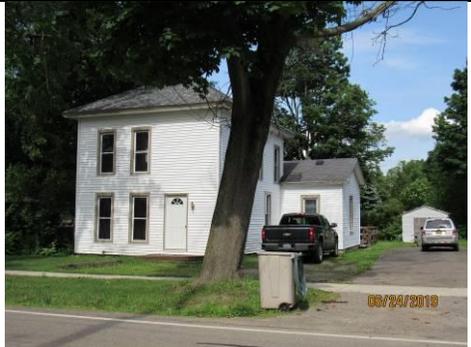
ADDRESS: 27 Center Street	TAX ID: 100.05-1-39	DATE OF CONSTRUCTION: Ca. 1860	SIGNIFICANCE: D (local) – Non-Contributing
CONDITION: Good		NAME:

DESCRIPTION: 2-story pyramidal roof National Folk single-family frame house; stone foundation, vinyl siding, asphalt roofing, and wide overhanging eaves. 1/1 double-hung vinyl windows. 1-story side-gabled rear wing.	
ADDRESS: 28 Center Street	TAX ID: 100.05-1-45	DATE OF CONSTRUCTION: 1820	SIGNIFICANCE: I (NR) – Individually Eligible I/D (local) - Contributing
CONDITION: Excellent		NAME:

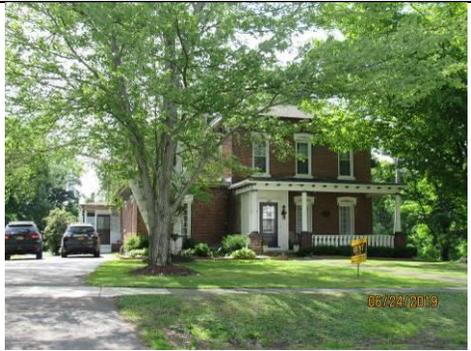
DESCRIPTION: 2-story pyramidal hipped roof Italianate single-family brick masonry house; stone foundation, asphalt roofing, and wide overhanging eaves. 6/1 double-hung and multi-light vinyl and wood windows with ornate pediment. Partial-width open front porch; turned balusters, Doric columns above piers, and low-hipped roof with decorative brackets at eaves. 1-story flat roof side wing with decorative brackets at eaves.

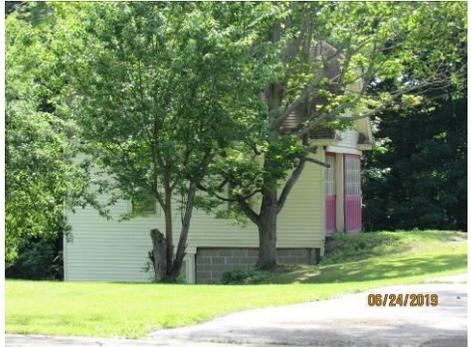
1½-story hip-on-gable roof frame garage; concrete block foundation, vinyl siding, and asphalt roofing. NR CRITERION: C

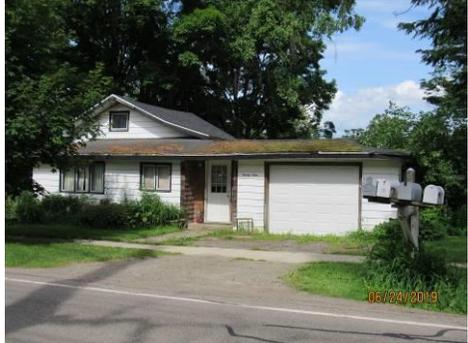
ADDRESS: 29 Center Street	TAX ID: 100.05-1-38	DATE OF CONSTRUCTION: Ca. 1860	SIGNIFICANCE: D (local) – Non-Contributing
CONDITION: Fair/Deteriorated		NAME:

DESCRIPTION: 1½-story front-gabled and hipped roof single-family frame house with attached 1-bay garage; wood shingle and aluminum siding, and asphalt roofing. Single-pane wood windows.	
ADDRESS: 30 Center Street	TAX ID: 100.05-1-44	DATE OF CONSTRUCTION: 1908	SIGNIFICANCE: D (local) - Contributing
CONDITION: Excellent		NAME:

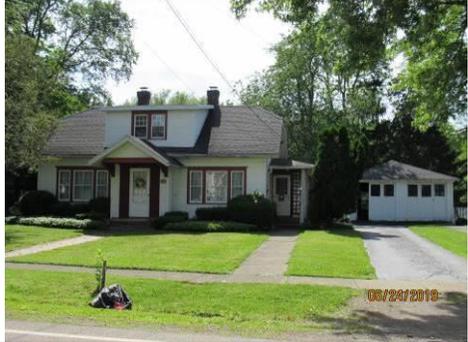
DESCRIPTION: 1½-story side-gabled roof Craftsman Bungalow style single-family frame house; vinyl siding, and asphalt roofing. Paired and grouped 6/1,8/1 double-hung wood windows. Prominent centered shed roof dormer. Roof ridge brick chimneys. Entry enclosed front porch with bracketed front-gabled roof. Entry open side porch; simple square columns, glass block wall, and hipped roof.	
ADDRESS: 31 Center Street	TAX ID: 100.05-1-37	DATE OF CONSTRUCTION: Ca. 1860	SIGNIFICANCE: D (local) - Contributing

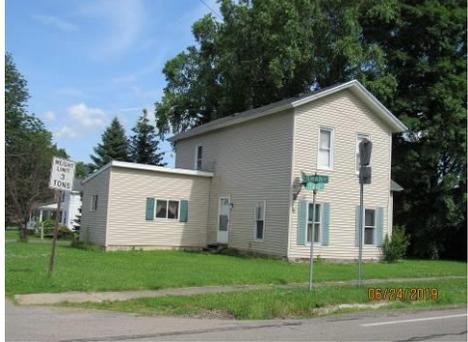
DESCRIPTION: 2-story gable-front-&-wing National Folk single-family frame house; parged foundation, vinyl siding, and asphalt roofing. 1/1 double-hung vinyl windows with shutters. 1-story shed front wing. Entrance facing Swan Street.
