Reconnaissance Level Historic Resources Survey of Forestville

Town of Hanover, Chautauqua County, NY
October 21, 2019

CBCA 19-013

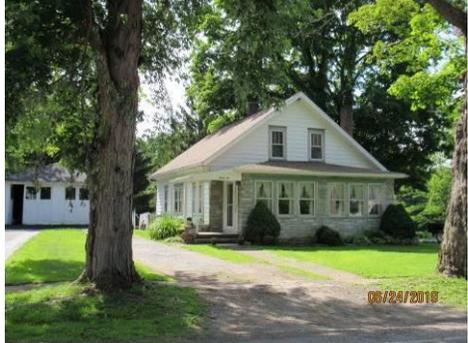
ADDRESS: 32 Center Street	TAX ID: 100.05-1-43	DATE OF CONSTRUCTION: Ca. 1860	SIGNIFICANCE: D (local) - Contributing
CONDITION: Excellent		NAME:

DESCRIPTION: 1½-story front-gabled roof National Folk single-family frame house; stone foundation, aluminum and stone veneer siding, and asphalt roofing. 3/1,4/1 double-hung windows. Roof slope and ridge brick chimneys. Entry open side front porch; simple square columns and shed roof.	
ADDRESS: 33 Center Street	TAX ID: 100.05-1-11	DATE OF CONSTRUCTION: Ca. 1940	SIGNIFICANCE: D (local) – Non-Contributing
CONDITION: Fair/Deteriorated		NAME:

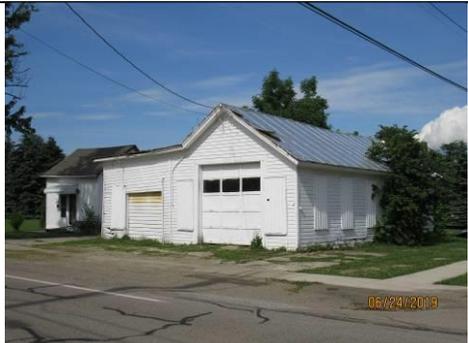
DESCRIPTION: 1-story front-gabled and shed roof frame structure; clapboard siding, metal roofing, garage doors and boarded up windows with vertical paneling.	
ADDRESS: 34 Center Street	TAX ID: 100.05-1-42	DATE OF CONSTRUCTION: Ca. 1880	SIGNIFICANCE: D (local) - Contributing
CONDITION: Excellent		NAME:

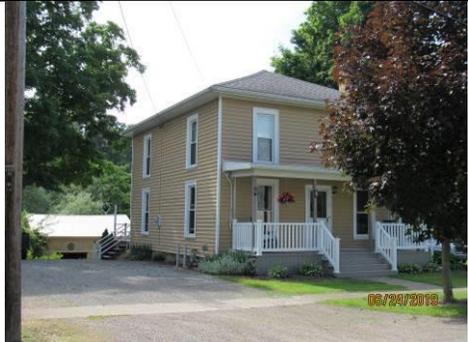
DESCRIPTION: 2-story pyramidal hipped National Folk single-family frame house; stone foundation, vinyl siding, asphalt roofing, and wide overhanging eaves. 1/1 double-hung vinyl windows. Eave wall concrete block chimney. Full-width open front porch; plain balusters, simple square columns, and shed roof.

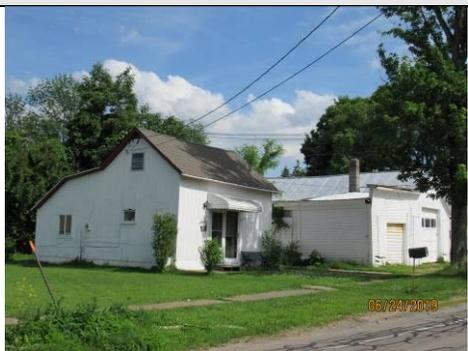
DESCRIPTION: 1½-story side-gabled roof frame house; aluminum siding, and asphalt roofing.	
ADDRESS: 37 Center Street	TAX ID: 100.05-1-9	DATE OF CONSTRUCTION: 1826	SIGNIFICANCE: I/D (local) - Contributing
CONDITION: Fair/Deteriorated		NAME: Forestville Meeting House/Forest House

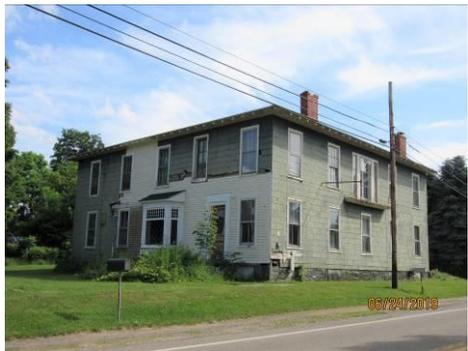
DESCRIPTION: 2-story hipped roof frame former meeting house; stone foundation, clapboard and composition siding, asphalt and metal roofing, and wide overhanging eaves with rafters exposed. 2/2, 6/6 double-hung wood windows. Shed roof bay window. Roof slope brick chimneys. This resource merits further research that may support a determination that this resource is I(NR) Eligible.	
ADDRESS: 38 Center Street	TAX ID: 100.05-1-7	DATE OF CONSTRUCTION: Ca.1860	SIGNIFICANCE: D (local) - Contributing

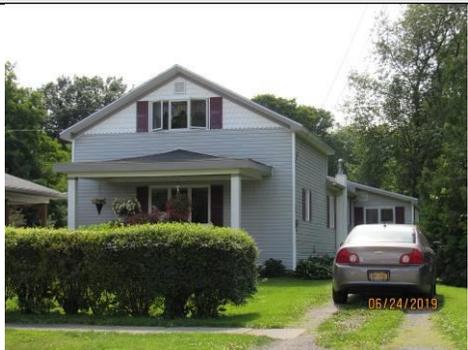
DESCRIPTION: 1½-story front-gabled roof single-family frame house; vinyl siding, asphalt roofing. Grouped casement windows with shutters. Full-width open front porch; simple square columns, and flared hipped roof.

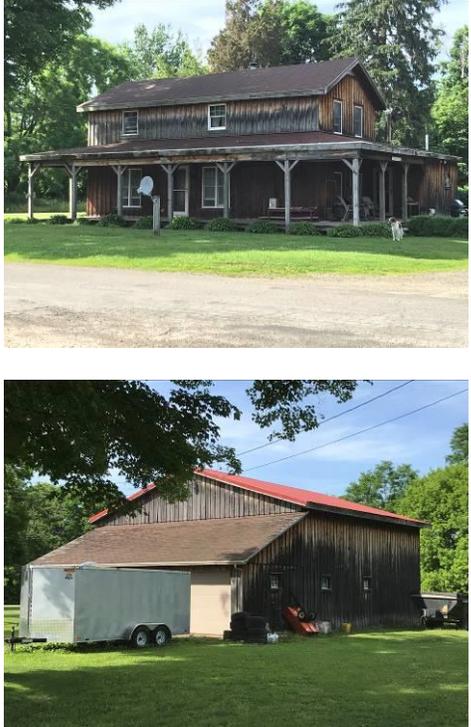
DESCRIPTION: 2-story side-gabled roof National Folk style single-family frame house; parged foundation, board and batten siding, and asphalt roofing. Single and paired 6/1 double-hung windows. L-shaped open front porch; simple square columns with side brackets, and hipped roof. 2-story front-gabled roof frame garage; board and batten siding, and metal roofing.	
ADDRESS: 40 Center Street	TAX ID: 100.05-1-5	DATE OF CONSTRUCTION: Ca. 1880	SIGNIFICANCE: D (local) – Non-Contributing
CONDITION: Fair		NAME:

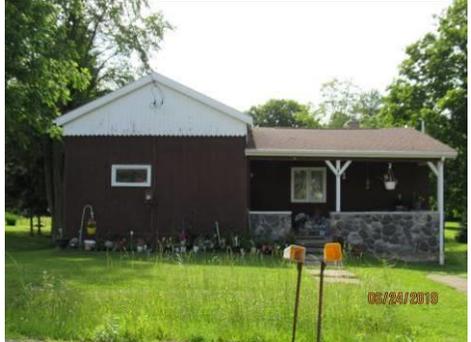
DESCRIPTION: 1-story gable-front-&-wing National Folk single-family frame house; stone foundation, horizontal clapboard siding, and asphalt roofing. Awning and casement vinyl windows. Partial-width open front porch; solid balustrade with stone veneer siding, simple square columns with side brackets, and principal roof.

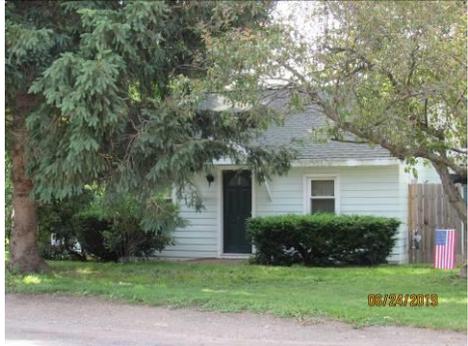
ADDRESS: 42 Center Street	TAX ID: 100.05-1-8	DATE OF CONSTRUCTION: Ca. 1950	SIGNIFICANCE: D (local) – Non-Contributing
CONDITION: Good		NAME:

DESCRIPTION: 1-story side-gabled roof single-family frame house; aluminum siding, and asphalt roofing. 1/1 double-hung vinyl windows. Centered bracketed front-gabled roof overhang front entrance.

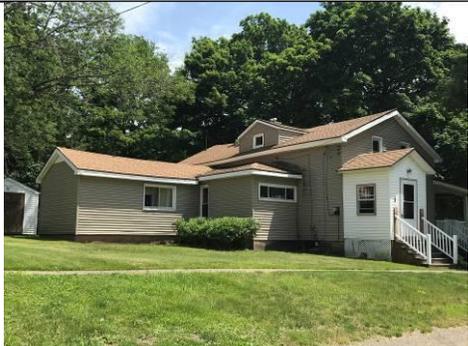
ADDRESS: 1 Chestnut Street	TAX ID: 99.12-1-43	DATE OF CONSTRUCTION: Ca. 1880	SIGNIFICANCE: D (local) - Contributing
CONDITION: Good		NAME:

DESCRIPTION: 1½-story gable-front-&-wing National Folk single-family frame house; parged foundation, vinyl siding, and asphalt roofing. 1/1 double-hung and sliding vinyl windows. Partial-width open side porch; plain balusters, simple square columns, and shed roof. Entry enclosed front porch with front-gabled roof.	
ADDRESS: 2 Chestnut Street	TAX ID: 99.12-1-20	DATE OF CONSTRUCTION: 1900	SIGNIFICANCE: D (local) - Contributing
CONDITION: Good		NAME:

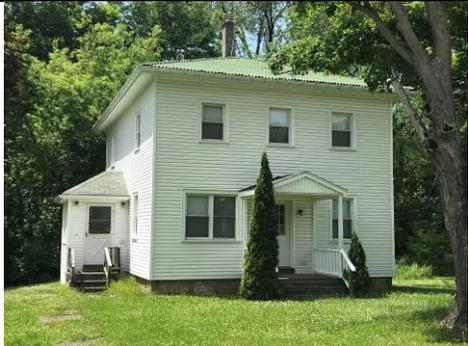
DESCRIPTION: 2-story pyramidal hipped roof National Folk single-family frame house; cobblestone foundation, vinyl siding, metal roofing, and wide overhanging eaves. Single and paired 1/1 double-hung vinyl windows. Roof ridge concrete block chimney. Entry open front porch; plain balusters, simple square columns, and front-gabled roof.

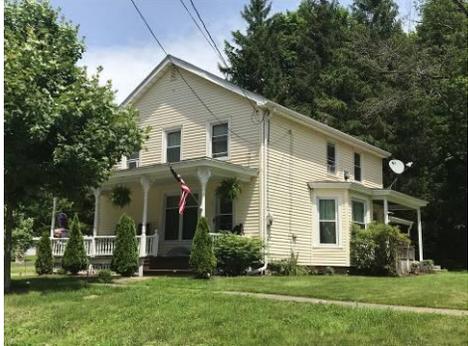
DESCRIPTION: 2-story front-gabled roof Folk Victorian single-family frame house; parged foundation, vinyl siding, and asphalt roofing. Single and paired 1/1 double-hung and fixed vinyl windows. Full-width open front porch; spindlework detailing, turned balusters and supports, and flat roof.	
ADDRESS: 4 Chestnut Street	TAX ID: 99.12-1-21	DATE OF CONSTRUCTION: 1925	SIGNIFICANCE: D (local) - Contributing
CONDITION: Good		NAME:

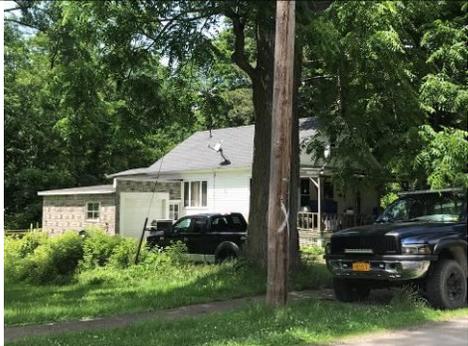
DESCRIPTION: 1½-story front-gabled roof National Folk single-family frame house; clapboard siding, and asphalt roofing. 1/1 double-hung wood and vinyl windows. Full-width open front porch; plain balusters, simple square columns, side brackets, and shed roof.	
ADDRESS: 6 Chestnut Street	TAX ID: 99.12-1-23	DATE OF CONSTRUCTION: 1900	SIGNIFICANCE: D (local) - Contributing

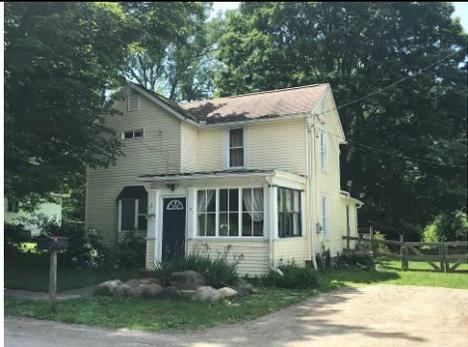
DESCRIPTION: 1½-story gable-front-&-wing National Folk single-family frame house; stone foundation, vinyl siding, and asphalt roofing. 1/1 double-hung, fixed and sliding wood and vinyl windows. Hipped roof bay window. Partial-width enclosed front porch with flat roof.

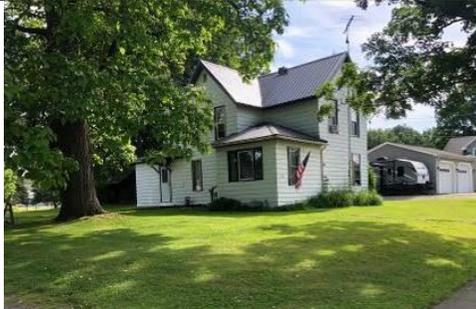
DESCRIPTION: 2-story gable-front-&-wing National Folk single-family frame house; parged foundation, vinyl siding, and metal roofing. 1/1 double-hung and fixed vinyl windows. Bracketed gable overhang entrance.	
ADDRESS: 2 Eagle Street	TAX ID: 100.05-1-34	DATE OF CONSTRUCTION: Ca. 1880	SIGNIFICANCE: D (local) - Contributing
CONDITION: Excellent		NAME:

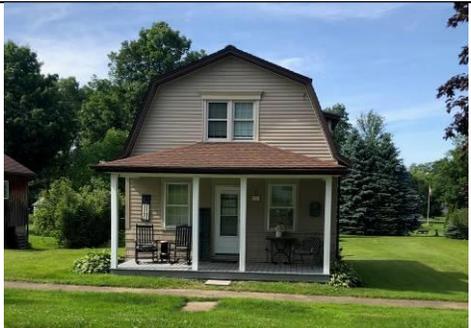
DESCRIPTION: 1½-story front gambrel roof vernacular single-family frame house; foundation not visible, vinyl siding, and asphalt roofing. Single and paired 6/6 double-hung vinyl windows. Full-width open front porch with concrete foundation added on later; simple square columns, and hipped roof.	
ADDRESS: 4 Eagle Street	TAX ID: 100.05-1-26	DATE OF CONSTRUCTION: 1906	SIGNIFICANCE: D (local) - Contributing

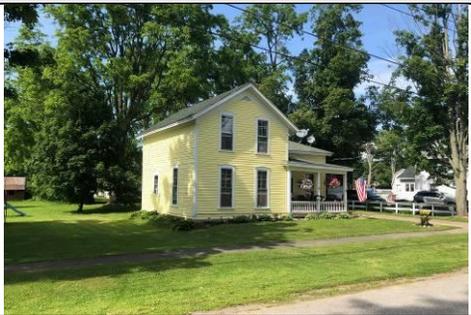
DESCRIPTION: 1½-story gable-front-&-wing National Folk single-family frame house; stone foundation, clapboard siding, and asphalt roofing. 4/4 double-hung wood windows. Partial-width open front porch; turned balusters, simple square columns, and hipped roof.

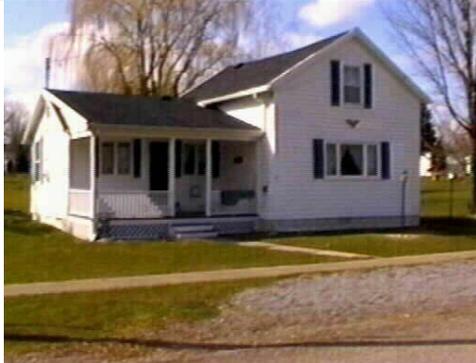
DESCRIPTION: 1½-story gable-front-&-wing National Folk single-family frame house; parged foundation, vinyl siding, and asphalt roofing. 1/1 double-hung and picture vinyl windows with shutters. Partial-width open front porch; plain balusters, simple square columns, and hipped roof.	
ADDRESS: 6 Eagle Street	TAX ID: 100.05-1-25	DATE OF CONSTRUCTION: Ca. 1880	SIGNIFICANCE: D (local) - Contributing
CONDITION: Good		NAME:

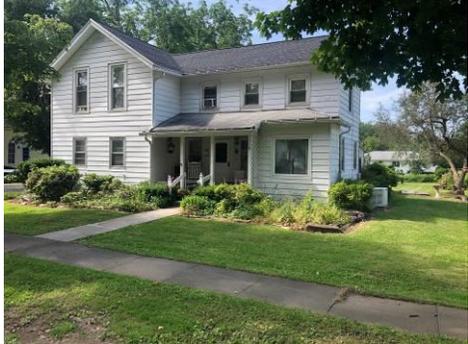
DESCRIPTION: 1½-story gable-front-&-wing National Folk single-family frame house; stone foundation, vinyl siding, and asphalt roofing. 1/1 double-hung and fixed vinyl windows. Partial-width partially open front porch; simple square columns, and hipped roof.

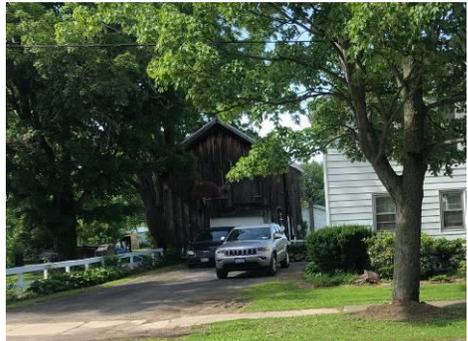
2-story front-gabled roof frame barn; board and batten siding.

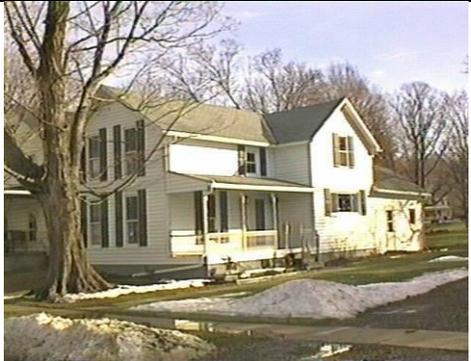
DESCRIPTION: 1½-story gable-front-&-wing National Folk single-family frame house; parged foundation, vinyl siding, and asphalt roofing. 1/1 double-hung vinyl windows with shutters. Partial-width open front porch; plain balusters, simple square columns, and shed roof.	
ADDRESS: 8 Eagle Street	TAX ID: 100.05-1-24	DATE OF CONSTRUCTION: 1849	SIGNIFICANCE: D (local) - Contributing
CONDITION: Excellent		NAME:

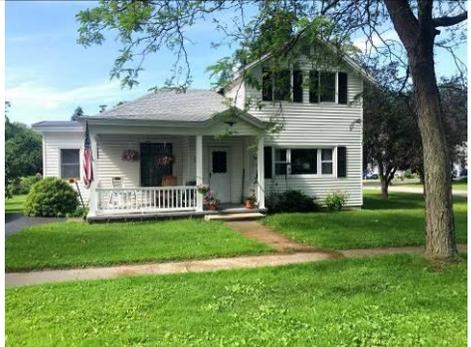
DESCRIPTION: 1½-story gable-front-&-wing National Folk single-family frame house; vinyl siding, and asphalt roofing. 1/1 double-hung and fixed windows with shutters. Partial-width open front porch; plain balusters, simple square columns, and pedimented roof.	
ADDRESS: 9 Eagle Street	TAX ID: 100.05-2-51	DATE OF CONSTRUCTION: 1914	SIGNIFICANCE: D (local) - Contributing

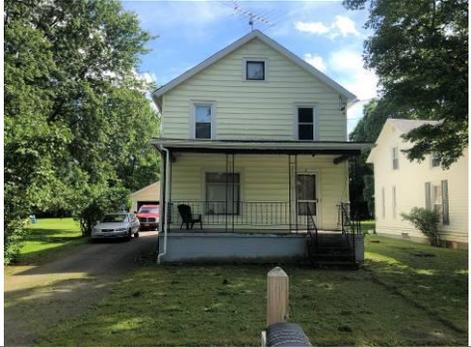
DESCRIPTION: 2½-story front-gabled National Folk single-family frame house; stone foundation, vinyl siding, and asphalt roofing. 1/1 double-hung and fixed windows. Full-width open front porch; metal balusters and columns, and flat roof.

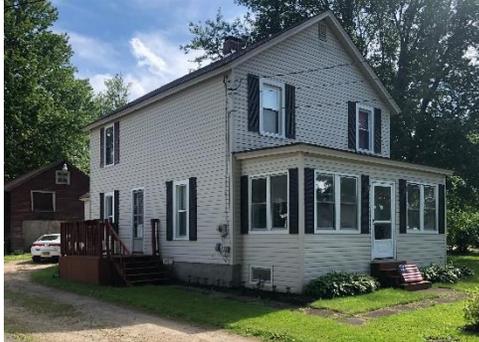
DESCRIPTION: 2-story front-gable roof National Folk single-family frame house; parged foundation, vinyl siding, and asphalt roofing. 1/1 double-hung vinyl windows with shutters. Full-width enclosed front porch. 2 ½-story front gable frame barn.	
ADDRESS: 13 Eagle Street	TAX ID: 100.05-2-59	DATE OF CONSTRUCTION: 1850	SIGNIFICANCE: I/D (local) - Contributing
CONDITION: Excellent		NAME:

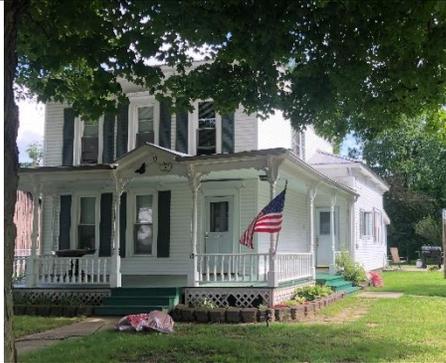
DESCRIPTION: 2-story pyramidal hipped roof Folk Victorian single-family frame house; parged foundation, vinyl siding, and asphalt roofing. 1/1 double-hung vinyl windows with shutters. L-shaped open front porch with Victorian-era detailing; turned balusters and supports with side brackets, and pedimented roof.	
ADDRESS: 15 Eagle Street	TAX ID: 100.05-2-60	DATE OF CONSTRUCTION: 1867	SIGNIFICANCE: I/D (local) - Contributing

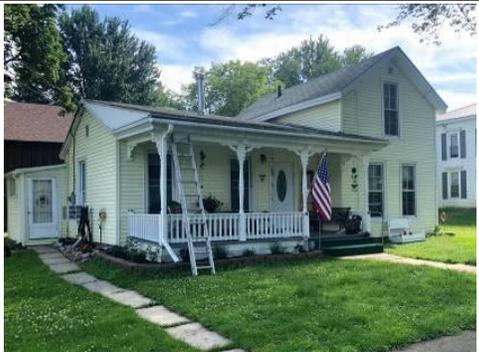
DESCRIPTION: 1½-story gable-front-&-wing Folk Victorian single-family frame house; parged foundation, vinyl siding, and asphalt roofing. 4/4 double-hung windows. Partial-width open front porch; plain balusters, turned supports with side brackets, and principal roof.

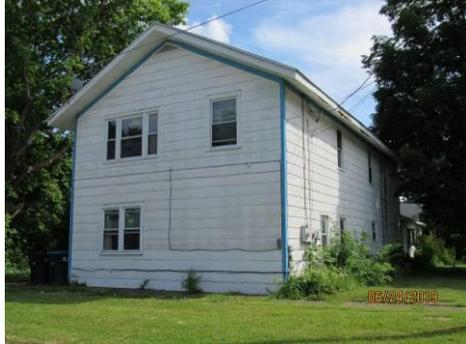
DESCRIPTION: 2-story front-gabled National Folk single-family frame house; composition siding, and asphalt roofing. Single, paired, and grouped 1/1 double-hung vinyl window. Indirect entrance.	
ADDRESS: 3 Erie Street	TAX ID: 100.05-2-2	DATE OF CONSTRUCTION: 1893	SIGNIFICANCE: I/D (local) - Contributing
CONDITION: Fair/Deteriorated		NAME: RR Depot

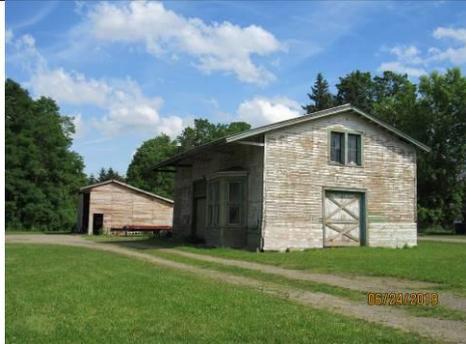
DESCRIPTION: 1½-story side-gabled roof frame railroad depot facing Hanover Street; stone foundation, clapboard siding, and metal roofing. Hipped roof bay window with 1/1 double-hung wood windows. Centered wide entrance.

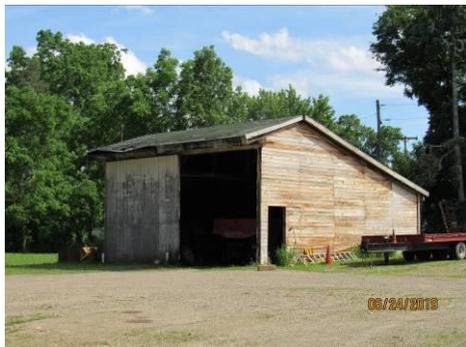
1½-story saltbox roof frame storage structure; clapboard siding, asphalt roofing, full-façade garage doors. This resource merits further research that may support a determination that this resource is I(NR) Eligible.

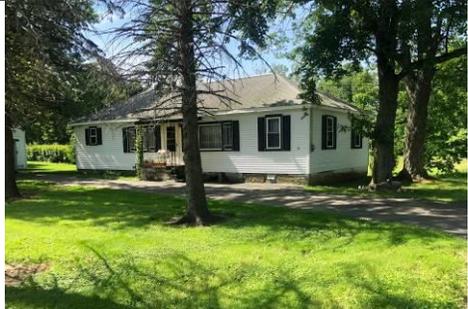
DESCRIPTION: 1-story hipped roof Ranch style single-family frame house; parged foundation, vinyl siding, and asphalt roofing. 1/1 double-hung and picture vinyl windows with shutters. Entry open front porch; metal columns and shed roof.	
ADDRESS: 10 Fourth Street	TAX ID: 100.05-2-14	DATE OF CONSTRUCTION: 1961	SIGNIFICANCE: D (local) – Non-Contributing
CONDITION: Good		NAME:

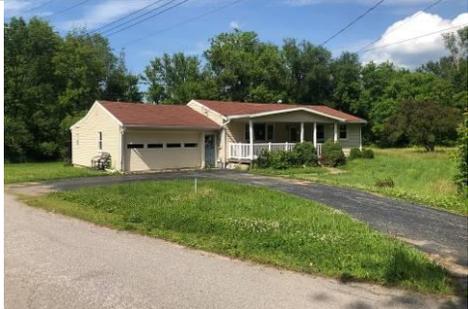
DESCRIPTION: 1-story side-gabled roof Ranch style single-family frame house; concrete block foundation, vinyl siding, and asphalt roofing. 1/1 double-hung and picture vinyl windows. Partial-width open front porch; plain balusters, simple square columns, and pedimented roof. Attached 1-story side-gabled roof 2-bay frame garage.

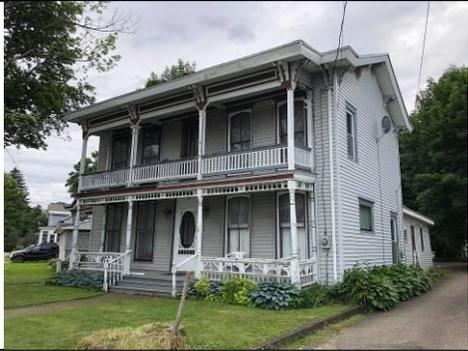
DESCRIPTION: 2-story side-gabled roof Folk Victorian single-family frame house; stone foundation, vinyl siding, asphalt roofing, and brackets at eaves. 2/2 double-hung windows. Full-width 2-story open front porch and 1-story side porch with Victorian-era detailing; elaborate balusters, turned supports, spindlework porch detailing, and principal roof. NR CRITERION: C

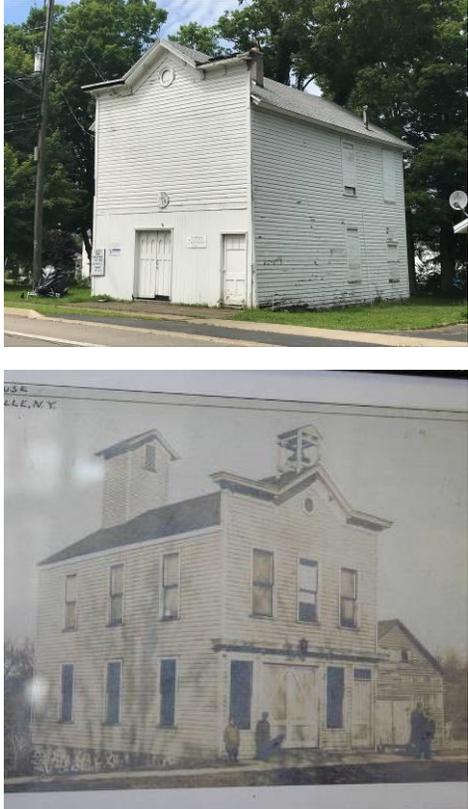
DESCRIPTION: 2-story parapet on gabled roof Italianate style 1 st Hose House; stone foundation, clapboard siding, asphalt roofing, and brackets at eaves. Original fenestrations with single and double doors. Covered up 2 nd -story windows. NR CRITERION: A, C Image Source: http://app.chautauquacounty.com/hist_struct/chsdb.html	
ADDRESS: 3 Lodi Street	TAX ID: 100.09-2-35	DATE OF CONSTRUCTION: Ca. 1870	SIGNIFICANCE: D (local) - Contributing
CONDITION: Good		NAME:

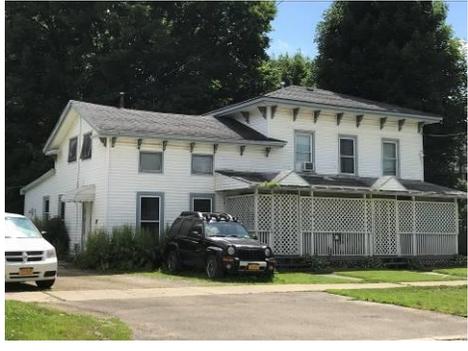
DESCRIPTION: 2-story hipped with side-gabled roof Italianate Style single-family frame house; parged foundation, vinyl siding, asphalt roofing, and brackets at eaves. 1/1 double-hung and single-pane wood and vinyl windows. Partial-width enclosed front porch; latticed screen, and pedimented roof. 1½-story saltbox roof frame garage; board and batten siding, and metal roofing.

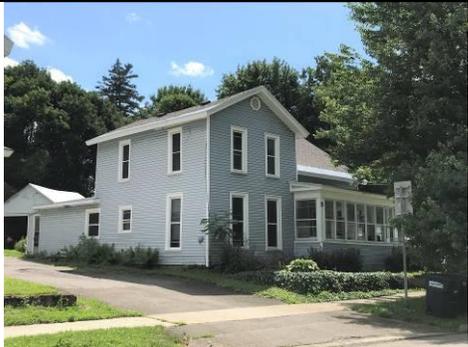
DESCRIPTION: 2-story gable-front-&-wing National Folk single-family frame house; stone foundation, vinyl siding, and asphalt roofing. 1/1 double-hung windows. Partial-width enclosed front porch with hipped roof.	
ADDRESS: 6 Lodi Street	TAX ID: 100.09-2-31	DATE OF CONSTRUCTION: 1862	SIGNIFICANCE: D (local) - Contributing
CONDITION: Fair/Deteriorated		NAME:

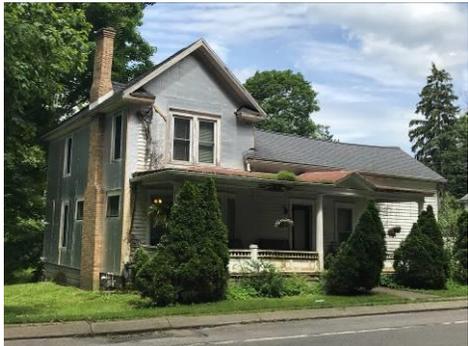
DESCRIPTION: 2-story gable-front-&-wing National Folk single-family frame house; rough-faced stone block foundation, clapboard siding, asphalt roofing, and cornice on pediment. 1/1 double-hung wood and vinyl windows. Eave wall brick chimney. Partial-width open front porch; decorative balustrade, Doric columns, and pedimented roof.

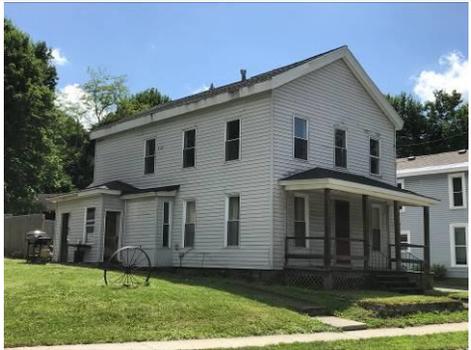
DESCRIPTION: 2-story front-gabled roof National Folk single-family frame house; stone foundation, vinyl siding, and asphalt roofing. 1/1 double-hung vinyl windows. Full-width open front porch; plain balusters, simple square columns, and hipped roof.	
ADDRESS: 8 Lodi Street	TAX ID: 100.09-2-30	DATE OF CONSTRUCTION: Ca. 1860	SIGNIFICANCE: D (local) - Contributing
CONDITION: Fair		NAME:

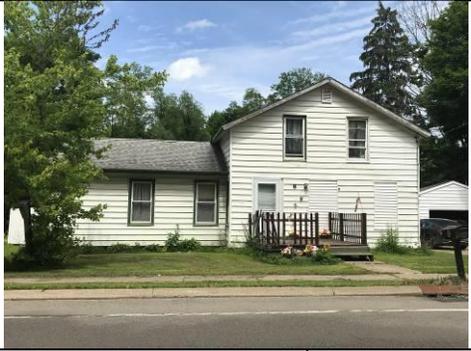
DESCRIPTION: 2-story gable-front-&-wing National Folk / Greek Revival single-family frame house; vinyl siding, and asphalt roofing. 1/1 double-hung vinyl windows. Entry open front porch with plain balusters.	
ADDRESS: 9 Lodi Street	TAX ID: 100.09-2-33	DATE OF CONSTRUCTION: Ca. 1860	SIGNIFICANCE: D (local) - Contributing
CONDITION: Good		NAME:

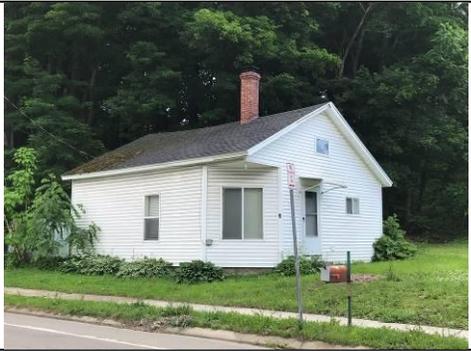
DESCRIPTION: 1½-story front-gabled roof National Folk single-family frame house; parged foundation, vinyl siding, asphalt roofing, and cutaway window. 1/1 double-hung, sliding and fixed vinyl windows. Roof ridge brick chimney.

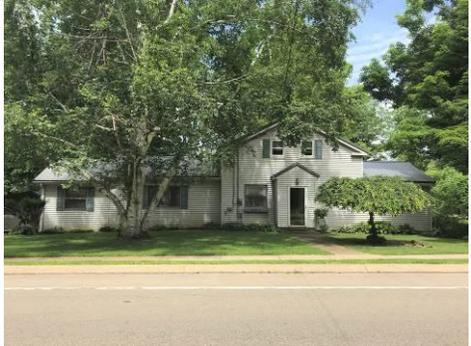
DESCRIPTION: 1½-story gable-front-&-wing National Folk single-family frame house; stone and concrete block foundation, vinyl siding, metal roofing, and cornice on pediment. 1/1 double-hung and casement vinyl windows with shutters. Entry enclosed front porch with front-gabled roof.	
ADDRESS: 11 Lodi Street	TAX ID: 100.09-2-43	DATE OF CONSTRUCTION: 1900	SIGNIFICANCE: D (local) - Contributing
CONDITION: Good		NAME: Washburn House

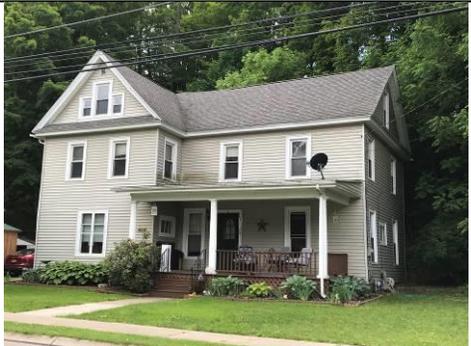
DESCRIPTION: 2½-story gable-front-&-wing National Folk single-family frame house with Queen Anne detailing; stone foundation, vinyl siding, asphalt roofing, and pent roof enclosing gable. Single and paired 1/1 double-hung vinyl windows; shaped in gable. Partial-width open front porch; plain balusters, Doric columns, and shed roof.

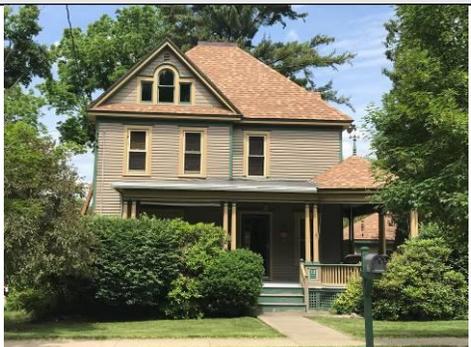
DESCRIPTION: 2½-story hipped roof with lower cross-gables Queen Anne single-family frame house; stone foundation, clapboard siding, asphalt roofing, and pent roof enclosing gable. 1/1 double-hung and Palladian, wood and vinyl windows. L-shaped open front porch; plain balusters, paired round columns above piers, hipped and round roof. NR CRITERION: C

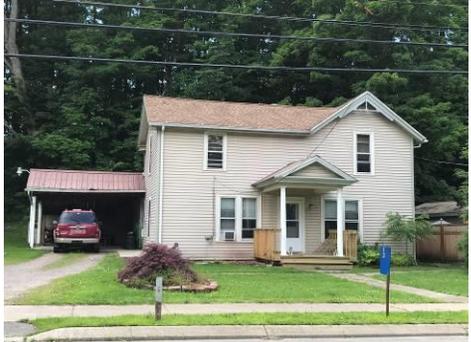
DESCRIPTION: 2-story gable-front-&-wing National Folk single-family frame house; parged foundation, vinyl siding, asphalt roofing, and trusses in gable. Single and paired 1/1 double-hung wood windows. Entry open front porch; plain balusters, Doric columns, and pedimented roof. Side-gabled roof attached carport.	
ADDRESS: 14 Lodi Street	TAX ID: 100.09-2-26	DATE OF CONSTRUCTION: Ca. 1900	SIGNIFICANCE: D (local) - Contributing
CONDITION: Excellent		NAME:

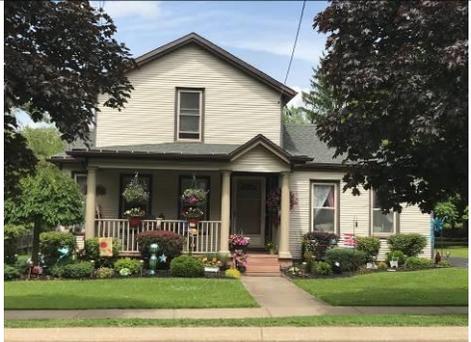
DESCRIPTION: 2-story gable-front-&-wing National Folk single-family frame house; vinyl siding, and asphalt roofing. 1/1 double-hung vinyl windows. Partial-width open front porch; plain balusters, Doric columns, and pedimented roof.	
ADDRESS: 16 Lodi Street	TAX ID: 100.09-2-25	DATE OF CONSTRUCTION: Ca. 1900	SIGNIFICANCE: D (local) - Contributing

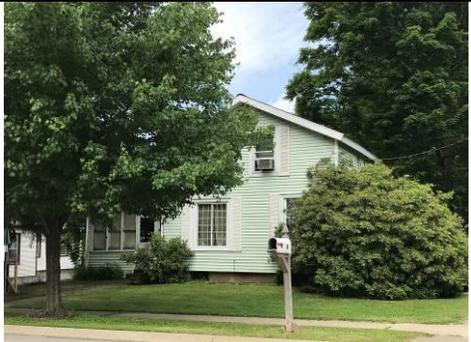
DESCRIPTION: 1½-story front-gabled roof National Folk single-family frame house; parged foundation, vinyl siding, and asphalt roofing. Single and ribbon 1/1 double-hung sliding vinyl and wood windows; shutters. Partial-width enclosed side porch with hipped roof.

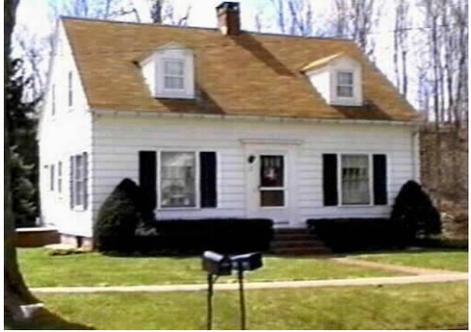
DESCRIPTION: 1½-story side-gabled roof Colonial Revival single-family frame house; brick foundation, vinyl siding, and asphalt roofing. 6/6,8/8 double-hung windows; shutters. Front-gabled roof dormers; cornice on pediment. Roof ridge brick chimney.	
ADDRESS: 18 Lodi Street	TAX ID: 100.09-2-24	DATE OF CONSTRUCTION: Ca. 1860	SIGNIFICANCE: D (local) - Contributing
CONDITION: Excellent		NAME:

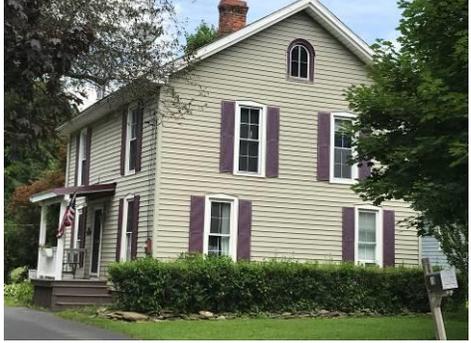
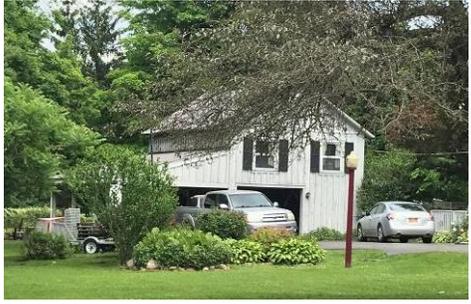
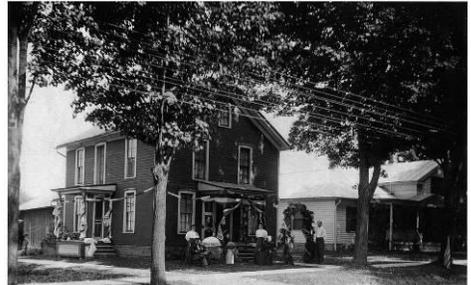
DESCRIPTION: 2½-story front-gabled National Folk single-family frame house facing northwest; parged foundation, vinyl siding, and asphalt roofing. 4/4 double-hung vinyl windows; shutters. Roof ridge brick chimney. Entry open front porch; plain balusters, simple square columns, and shed roof. 2-story front-gabled roof frame garage; board and batten siding. 1/1 double-hung vinyl windows with shutters. Image Source: http://app.chautauquacounty.com/hist_struct/chsdb.html

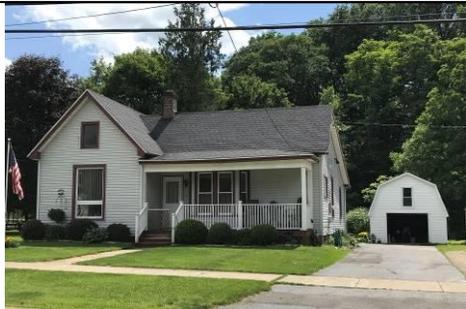
DESCRIPTION: 1½-story gable-front-&-wing National Folk single-family frame house; parged foundation, vinyl siding, and asphalt roofing. Grouped 1/1 double-hung and fixed vinyl windows. Partial-width open front porch; plain balusters, simple square columns, and hipped roof.	
ADDRESS: 20 Lodi Street	TAX ID: 100.09-2-23	DATE OF CONSTRUCTION: Ca. 1850	SIGNIFICANCE: D (local) - Contributing
CONDITION: Fair/Deteriorated		NAME:

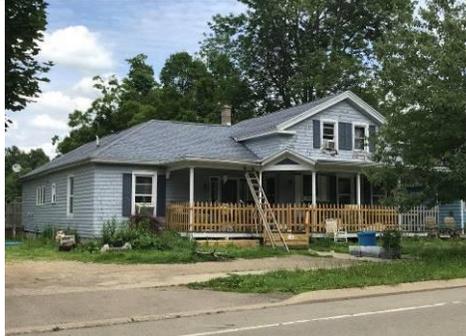
DESCRIPTION: 1½-story hipped roof with centered gable National Folk/Greek Revival single-family frame house; shingle siding, asphalt roofing, and cornice on pediment. Single and ribbon 1/1 double-hung vinyl windows. Full-width open front porch; plain balusters, simple square columns, and pedimented roof.	
ADDRESS: 21 Lodi Street	TAX ID: 100.09-2-48	DATE OF CONSTRUCTION: Ca. 1850	SIGNIFICANCE: D (local) - Contributing

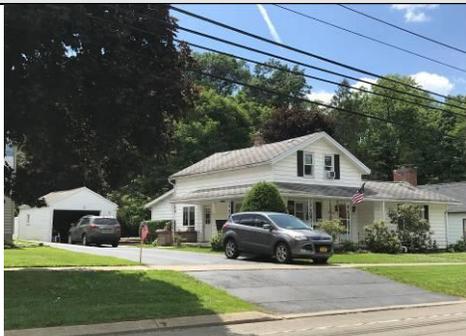
DESCRIPTION: 1½-story gable-front-&-wing National Folk single-family frame house; parged foundation, vinyl siding, and asphalt roofing. Single and paired 1/1 double-hung windows; shutters. Roof ridge brick chimney. L-shaped open front porch; metal columns, and hipped roof.

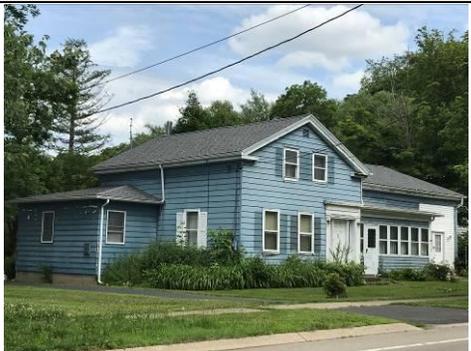
DESCRIPTION: 1½-story gable-front-&-wing Greek Revival single-family frame house; stone and concrete block foundation, aluminum siding, asphalt roofing, and cornice on pediment. Single and ribbon 1/1 double-hung vinyl windows; shutters. Partial-width enclosed front porch with hipped roof.	
ADDRESS: 23 Lodi Street	TAX ID: 100.13-1-33	DATE OF CONSTRUCTION: Ca. 1840	SIGNIFICANCE: D (local) - Contributing
CONDITION: Good		NAME:

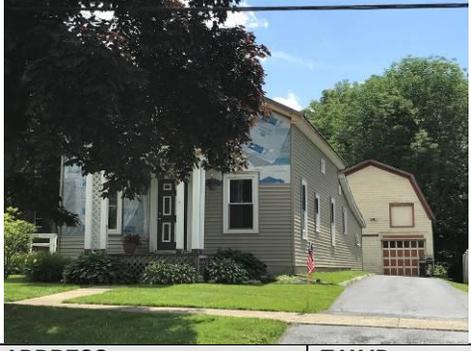
DESCRIPTION: 1½-story front-gabled roof National Folk single-family frame house; parged foundation, vinyl siding, and asphalt roofing. 1/1 double-hung vinyl windows. Entry open front porch; latticed detailing enclosed by square columns, and flat roof. 1½-story gambrel roof frame garage with clapboard siding.

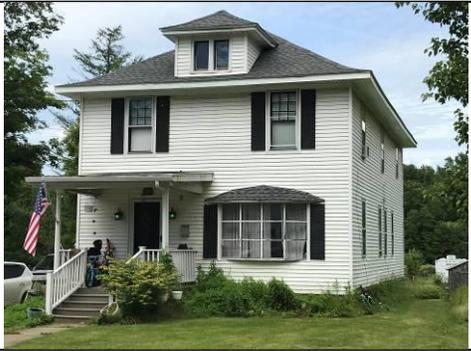
DESCRIPTION: 2½-story hipped roof Colonial Revival single-family frame house; stone foundation, vinyl siding, asphalt roofing, flared and wide overhanging eaves. 9/1 double-hung, sliding and multi-light wood windows; shutters. Hipped roof bay window. Hipped roof dormer. Partial-width open front porch; plain balusters, simple square columns, and shed roof.

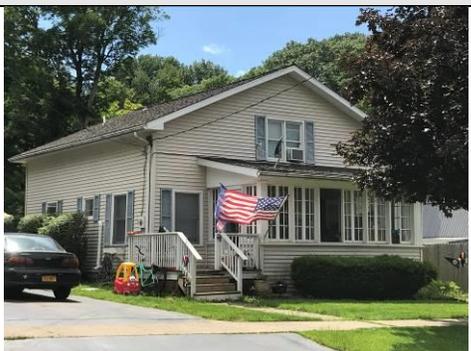
DESCRIPTION: 1½-story front-gabled roof National Folk single-family frame house; rough-faced stone foundation, vinyl siding, and asphalt roofing. Single, paired and ribbon 1/1 double-hung and casement vinyl windows; shutters. Full-width partially enclosed front porch; plain balusters and shed roof.	
ADDRESS: 26 Lodi Street	TAX ID: 100.13-1-36	DATE OF CONSTRUCTION: 1855	SIGNIFICANCE: D (local) - Contributing
CONDITION: Fair		NAME:

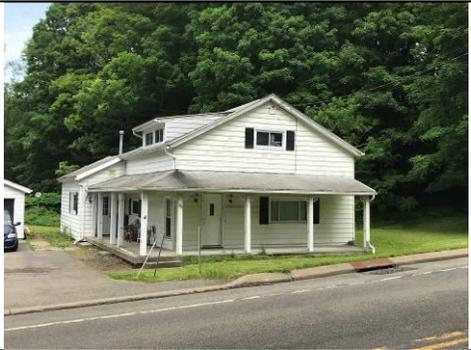
DESCRIPTION: 1½-story front-gabled roof National Folk single-family frame house; aluminum siding, and asphalt roofing. Sliding and picture vinyl windows. Shed roof side dormer. L-shaped open front porch; simple square columns with side brackets, and hipped roof.	
ADDRESS: 27 Lodi Street	TAX ID: 100.13-1-31	DATE OF CONSTRUCTION: Ca. 1860	SIGNIFICANCE: D (local) - Contributing

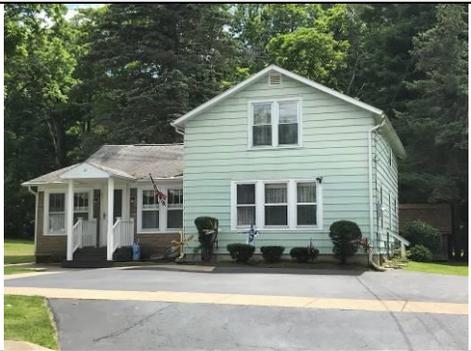
DESCRIPTION: 1½-story gable-front-&-wing National Folk single-family frame house; parged foundation, aluminum siding, and asphalt roofing. Paired and grouped 1/1, 3/1 double-hung vinyl windows. Entry open front porch; plain balusters, simple square columns, and pedimented roof.

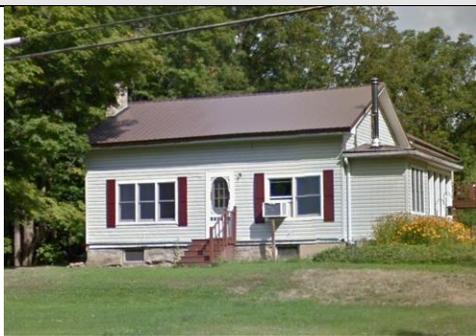
DESCRIPTION: 1-story side-gabled roof National Folk single-family frame house; stone foundation, vinyl siding, and metal roofing. Paired and ribbon 1/1 double-hung windows with shutters.	
ADDRESS: 29 Lodi Street	TAX ID: 100.13-1-28	DATE OF CONSTRUCTION: Ca. 1870	SIGNIFICANCE: I (NR) – Individually Eligible I/D (local) - Contributing
CONDITION: Good		NAME: McNeal House

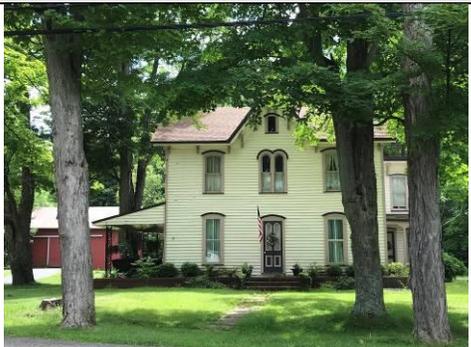
DESCRIPTION: 2½-story steeply pitched centered gable roof Gothic Revival single-family frame house; stone foundation, clapboard siding, asphalt roofing, and brackets at eaves. Single and paired 2/2 double-hung windows with round-arched top. Full-width open side porch; metal columns and shed roof. NR CRITERION: C	
ADDRESS: 30 Lodi Street	TAX ID: 100.09-2-20	DATE OF CONSTRUCTION: Ca. 1850	SIGNIFICANCE: D (local) - Contributing

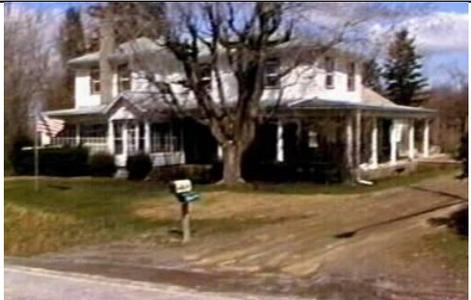
DESCRIPTION: 2½-story hipped roof National Folk single-family frame house; vinyl siding, and asphalt roofing. 1/1 double-hung and multi-light vinyl windows. L-shaped partially enclosed front porch; Doric columns, and hipped roof.

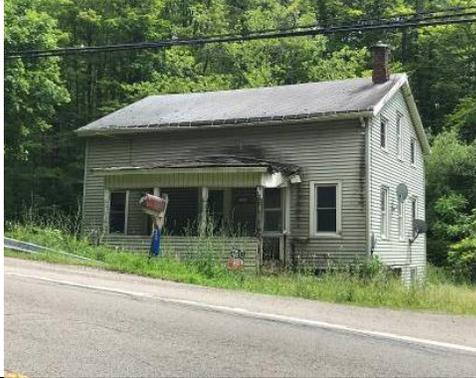
DESCRIPTION: 1½-story Pre-Railroad single-family frame house; vinyl siding, and asphalt roofing. 1/1 double-hung vinyl windows. Roof slope brick chimney. Partial-width open front porch; solid balustrade, turned supports, and hipped roof.	
ADDRESS: 35 Lodi Street	TAX ID: 100.13-1-23.3	DATE OF CONSTRUCTION: Ca. 1850	SIGNIFICANCE: D (local) - Contributing
CONDITION: Fair		NAME:

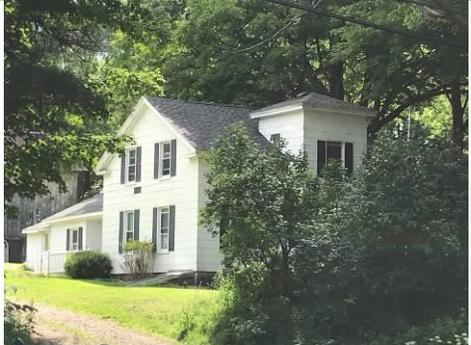
DESCRIPTION: 1½-story side-gabled roof single-family frame house with modest Italianate style; stone foundation, composite siding, and asphalt roofing. 1/1 double-hung wood windows; shutters. Centered hipped roof square tower. Entry open front porch with plain balusters.

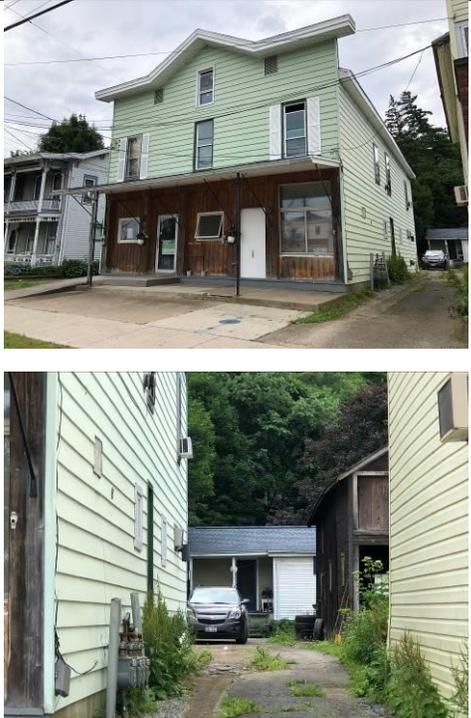
<p>DESCRIPTION:</p> <p>2½-story parapet on gable roof Italianate style mixed-use frame commercial block; parged foundation, clapboard lower/composition siding upper, asphalt roofing, and wide overhanging eaves. 1/1 double-hung, awning and sliding vinyl windows; shutters. 1st-story full-width bracketed roof.</p> <p>1-story side-gabled roof frame secondary structure; clapboard siding, and asphalt roofing. Partial-width open front porch; turned supports, and principal roof.</p>	
<p>ADDRESS: 3 Main Street</p>	<p>TAX ID: 100.09-1-24</p>	<p>DATE OF CONSTRUCTION: Ca. 1880</p>	<p>SIGNIFICANCE: D (local) – Non-Contributing</p>
<p>CONDITION: Good</p>		<p>NAME: Caves</p>

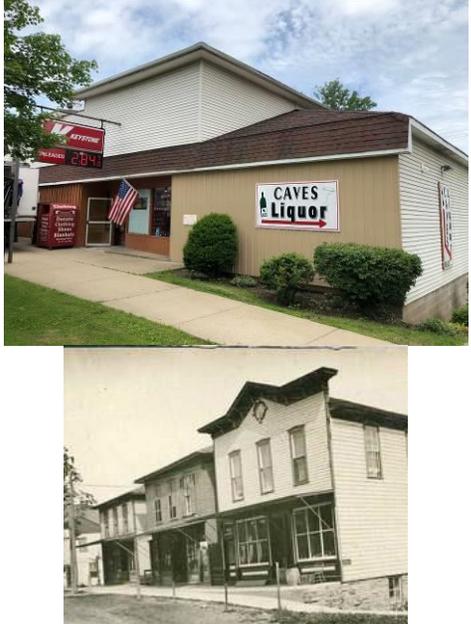
<p>DESCRIPTION:</p> <p>2-story hipped roof commercial frame building; concrete block foundation, board and batten lower/vinyl siding upper, and asphalt roofing. 1/1 double-hung wood and vinyl windows. Recessed entry.</p> <p>Image Source: http://app.chautauquacounty.com/hist_struct/chsdb.html</p>

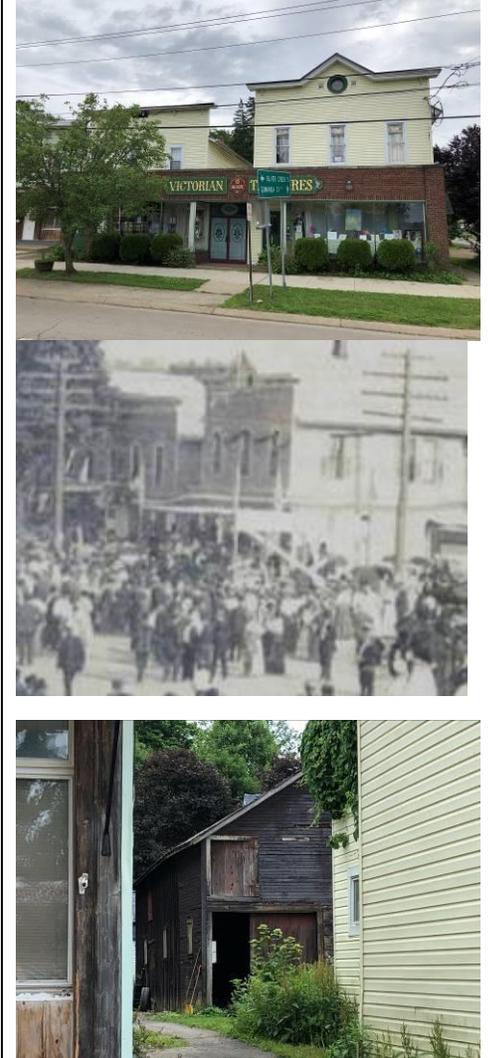
DESCRIPTION: Connected 2-story and 2½-story parapet on gable roof Italianate style commercial blocks; brick masonry lower/vinyl siding upper, and metal roofing. 1/1 double-hung wood windows and storefront wall; round window in gable. Recessed entry. 2-story front-gabled roof frame barn with clapboard siding. Image Source: http://app.chautauquacounty.com/hist_struct/chsdb.html

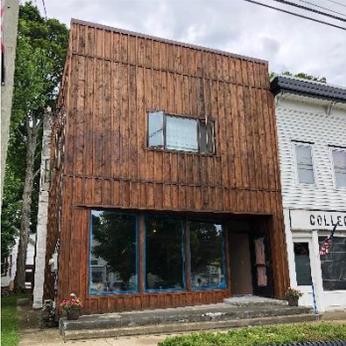
DESCRIPTION: 2-story parapet on flat roof frame mixed-use building; parged foundation, and board and batten siding. Casement vinyl windows and storefront wall.	
ADDRESS: 10 Main Street	TAX ID: 100.09-1-58	DATE OF CONSTRUCTION: Ca. 1860	SIGNIFICANCE: D (local) - Contributing
CONDITION: Good		NAME: Collector's Corner

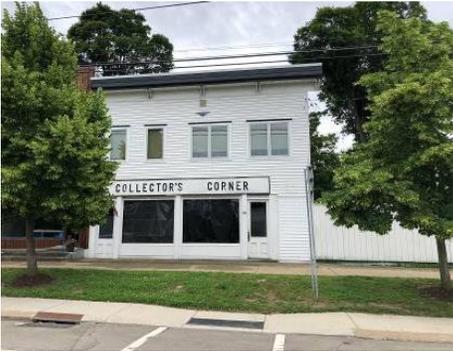
DESCRIPTION: 2-story parapet on flat roof frame mixed-use building; parged foundation, clapboard and vinyl siding, and decorative cornice brackets. Single and paired vinyl windows and wooden storefront wall. USN 01352.000046

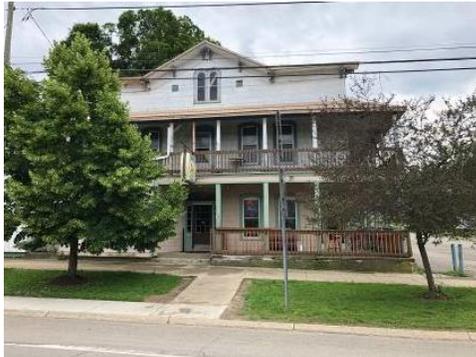
DESCRIPTION: 2½-story parapet on gable roof Italianate style mixed-use frame building; parged foundation, composition siding, metal roofing, and decorative cornice brackets. Single and paired 1/1 double-hung windows; round and segmental top. 2-story L-shaped open front porch; plain balusters, Doric columns, and principal roof. Former site of the Morrison House. USN 01352.000048 NR CRITERION: A, C	
ADDRESS: 16 Main Street	TAX ID: 100.09-1-40	DATE OF CONSTRUCTION: 1867	SIGNIFICANCE: D (local) - Contributing
CONDITION: Fair		NAME:

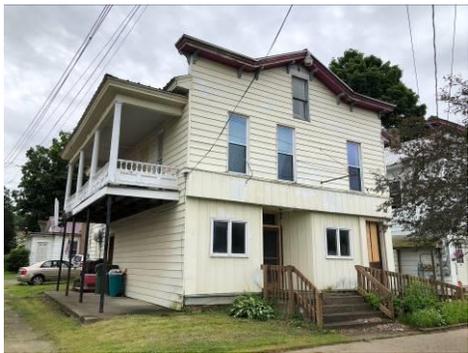
DESCRIPTION: 2½-story parapet on gable roof Italianate style frame mixed-use building commercial block; stone foundation, composition siding, and metal roofing. 1/1 double-hung and single-light vinyl and wood windows. Partial-width open side porch on 2 nd floor; decorative balustrade, Doric columns, and hipped roof. Recessed entry at enclosed former storefronts.

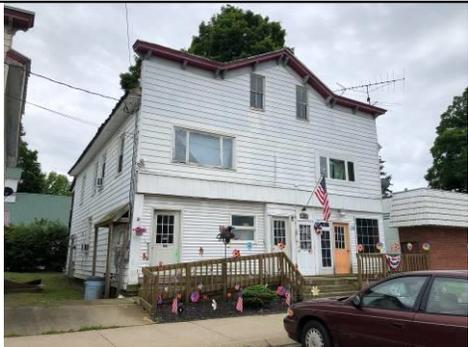
DESCRIPTION: 2½-story parapet on gable roof Italianate style frame mixed-use building commercial block; stone foundation, composition siding, metal roofing, and decorative cornice brackets. 2/2 double-hung, picture and multi-light vinyl and wood windows. Enclosed former storefronts.

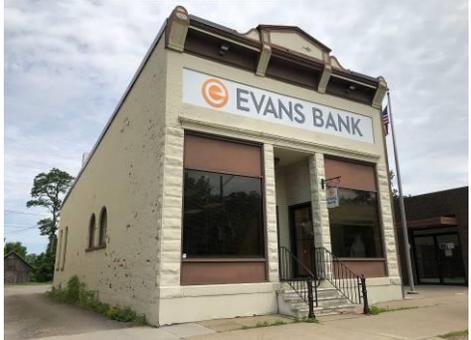
DESCRIPTION: 1-story, shaped parapet on flat roof, brick masonry commercial building; rock face stone pilasters on front facade, and decorative cornice. Storefront and recessed centered entry. NR CRITERION: A, C	
ADDRESS: 26 Main Street	TAX ID: 99.12-2-27	DATE OF CONSTRUCTION: 1862	SIGNIFICANCE: I (NR) – Individually Eligible I/D (local) - Contributing
CONDITION: Excellent		NAME:

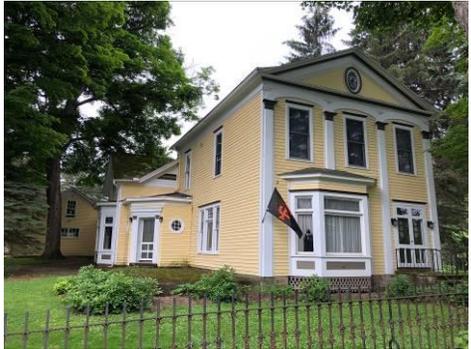
DESCRIPTION: 2½-story front-gabled roof Greek revival single-family frame house; stone foundation, clapboard siding, asphalt roofing, and decorative arcaded arches and pilasters. 1/1 double-hung and fixed wood and vinyl windows; oval shaped window in pediment. Hipped roof bay window. 1-story front-gabled outbuilding, clapboard siding and vinyl window. NR CRITERION: C

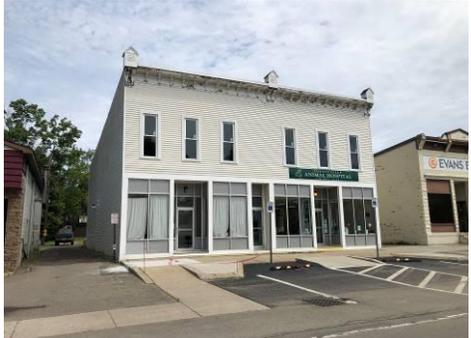
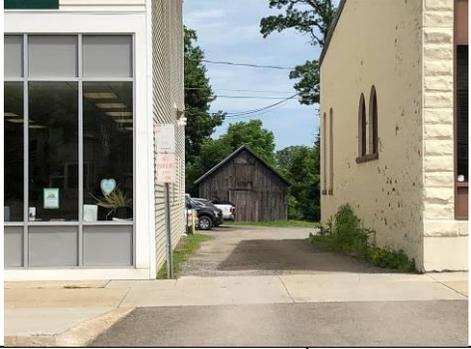
DESCRIPTION: 2-story parapet on flat roof mixed-use frame building; parged foundation, vinyl siding, and decorative metal cornice w/ brackets. 1/1 double-hung windows and storefront wall. 1½-story front-gabled roof frame barn with board and batten siding.

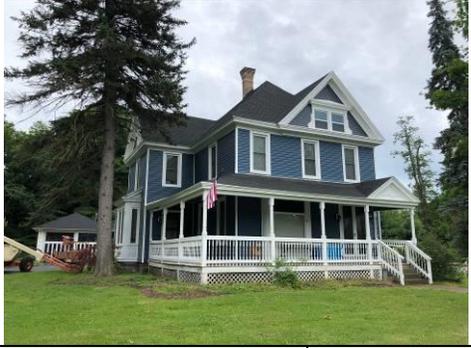
DESCRIPTION: 2½-story cross-gabled roof Queen Anne single-family frame house; rough-faced stone foundation, vinyl siding, and asphalt roofing. Single and paired 1/1 double-hung windows; pedimented in gable. L-shaped open front porch; turned balusters and supports, and pedimented roof. NR CRITERION: C	
ADDRESS: 34 Main Street	TAX ID: 99.12-2-8	DATE OF CONSTRUCTION: Ca. 1860	SIGNIFICANCE: D (local) - Contributing
CONDITION: Fair/Deteriorated		NAME:

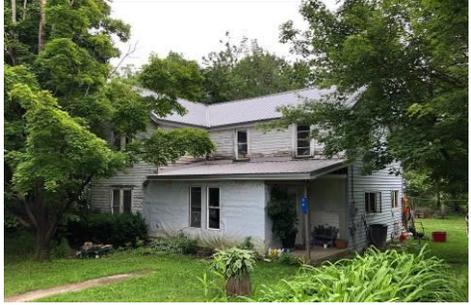
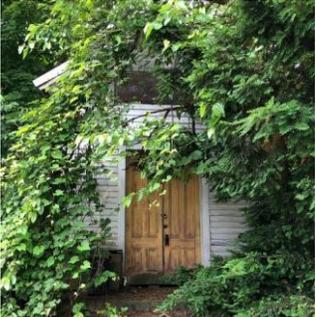
DESCRIPTION: 2-story gable-front-&-wing National Folk single-family frame house; stone block foundation, clapboard siding, and metal roofing. Single and paired 1/1 double-hung windows. Partial-width partially open front porch with shed roof. 1-story front-gabled roof former Free Methodist church; clapboard siding, and metal roofing.

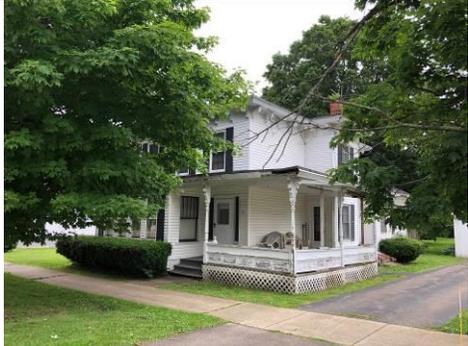
DESCRIPTION: 2-story hipped roof National Folk single-family frame house; stone foundation, vinyl siding, asphalt roofing, and brackets at eaves. 6/6 double-hung windows; shutters. L-shaped open front porch with Victorian era detailing; solid balustrade, turned supports, and flat roof.	
ADDRESS: 36 Main Street	TAX ID: 99.12-2-7	DATE OF CONSTRUCTION: 1850	SIGNIFICANCE: I/D (local) - Contributing
CONDITION: Fair/Deteriorated		NAME:

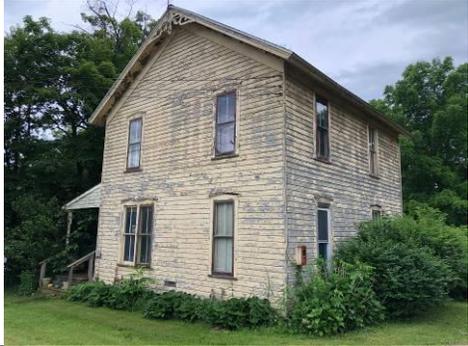
DESCRIPTION: 2-story front-gabled roof National Folk single-family frame house; stone foundation, clapboard siding, asphalt roofing, ornament in gable. 2/2 double-hung windows. Partial-width open side porch; plain balusters, turned supports, and shed roof.	
ADDRESS: 39 Main Street	TAX ID: 99.12-1-40	DATE OF CONSTRUCTION: Ca. 1880	SIGNIFICANCE: D (local) – Contributing

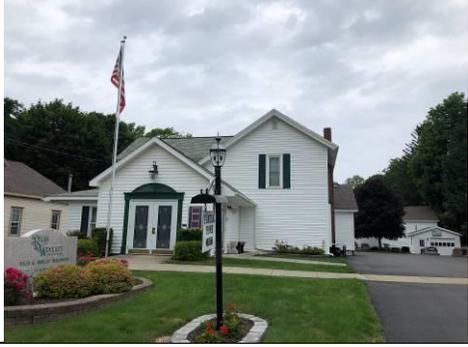
DESCRIPTION: 2-story asymmetrical roof Funeral Home; parged foundation, vinyl siding, and asphalt roofing. 1/1 double-hung vinyl windows with shutters. Centered projecting entry bay.

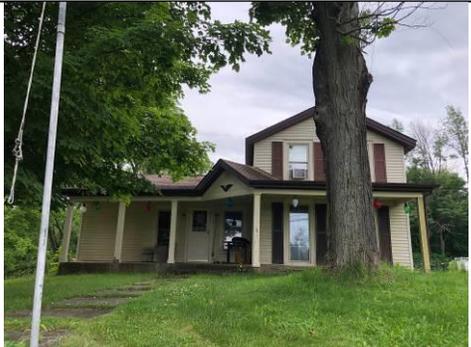
DESCRIPTION: 2-story front-gabled roof National Folk single-family frame house with later addition; parged foundation, vinyl siding, and asphalt roofing. 1/1 double-hung windows; shutters. Full-width open front porch; simple square columns, and pedimented roof.	
ADDRESS: 41 Main Street	TAX ID: 99.12-1-41	DATE OF CONSTRUCTION: Ca. 1870	SIGNIFICANCE: I/D (local) - Contributing
CONDITION: Excellent		NAME:

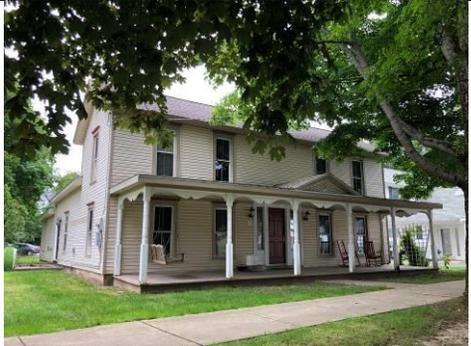
DESCRIPTION: 2-story side-gabled roof American Folk single-family frame house; parged foundation, vinyl siding, and asphalt roofing. 1/1 double-hung vinyl windows. Full-width open front porch; turned supports, decorative porch frieze, and pedimented roof.	
ADDRESS: 42 Main Street	TAX ID: 99.12-2-5	DATE OF CONSTRUCTION: Ca. 1900	SIGNIFICANCE: D (local) - Contributing

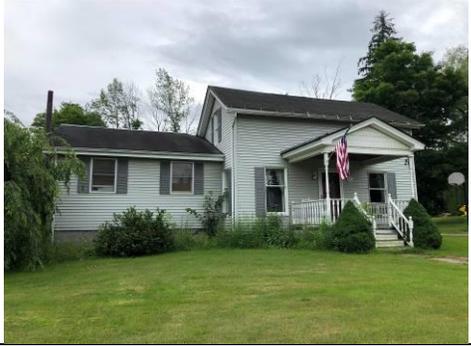
DESCRIPTION: 1½-story side-gabled roof single-family frame house; concrete block foundation, vinyl siding, and asphalt roofing. 1/1 double-hung windows; shutters. Open entry front porch; turned supports and balusters, and pedimented roof.
