Reconnaissance Level Historic Resources Survey of Forestville

Town of Hanover, Chautauqua County, NY
October 21, 2019

CBCA 19-013

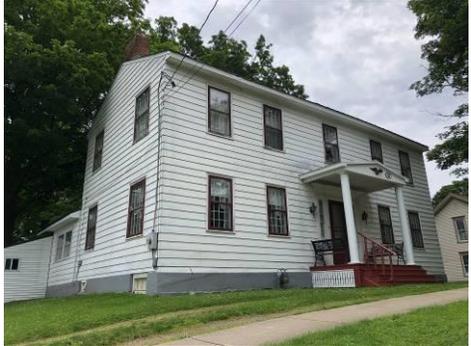
DESCRIPTION: 2-story side-gabled roof Pre-railroad Folk single-family frame house; parged foundation, composition siding. 12/12 double-hung wood windows. Open entry front porch; Doric columns, and pedimented roof.	
ADDRESS: 46 Main Street	TAX ID: 99.12-2-4	DATE OF CONSTRUCTION: Ca. 1900	SIGNIFICANCE: D (local) - Contributing
CONDITION: Fair		NAME:

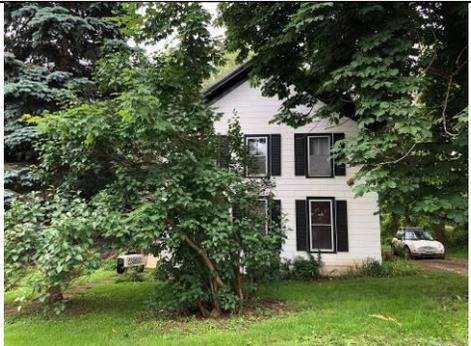
DESCRIPTION: 2-story front-gabled roof National Folk single-family frame house; parged foundation, aluminum siding, and metal roofing. 2/2 double-hung wood windows; shutters. Indirect entrance.	
ADDRESS: 49 Main Street	TAX ID: 99.12-1-16	DATE OF CONSTRUCTION: 1841	SIGNIFICANCE: D (local) - Contributing
CONDITION: Fair/Deteriorated		NAME:

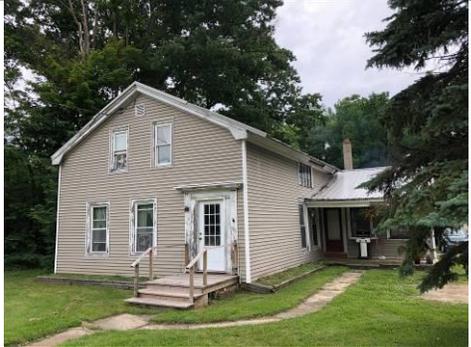
DESCRIPTION: 1½-story front-gabled roof Pre-railroad Folk single-family frame house; vinyl siding, and metal roofing. 1/1 double-hung vinyl windows. 1-story side-gabled roof wing.

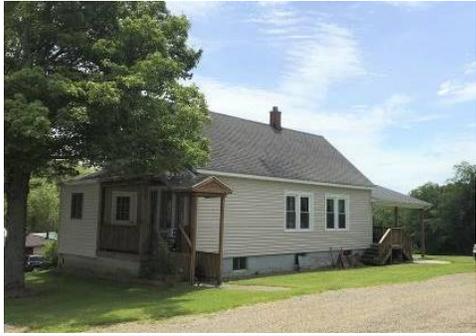
DESCRIPTION: 1½-story front-gabled roof single-family frame house; concrete block foundation, vinyl siding, and asphalt roofing. Paired 1/1 double-hung vinyl windows. Full-width partially open front porch; plain balusters, simple square columns, and hipped roof.	
ADDRESS: 51 Main Street	TAX ID: 99.12-1-15	DATE OF CONSTRUCTION: Ca. 1900	SIGNIFICANCE: D (local) - Contributing
CONDITION: Good		NAME:

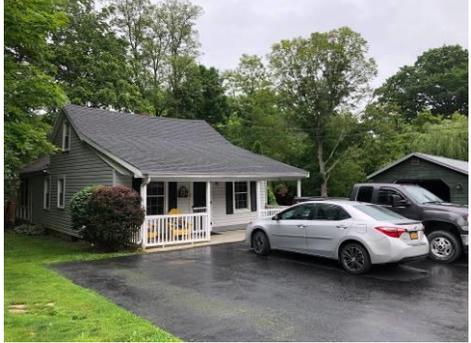
DESCRIPTION: 1-story side-gabled single-family frame house; stone foundation, vinyl siding, and asphalt roofing. 6/6 double-hung vinyl windows; shutters. Full-width open front porch; plain balusters, simple square columns, and principal roof.

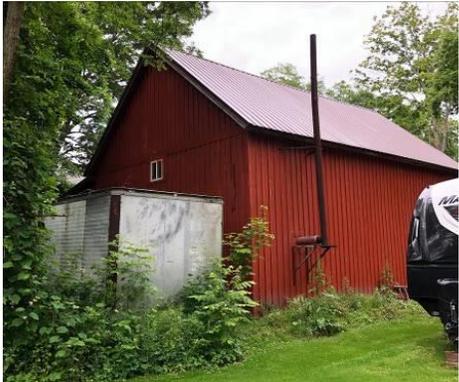
2-story front-gabled roof frame barn; board and batten siding, and metal roofing.

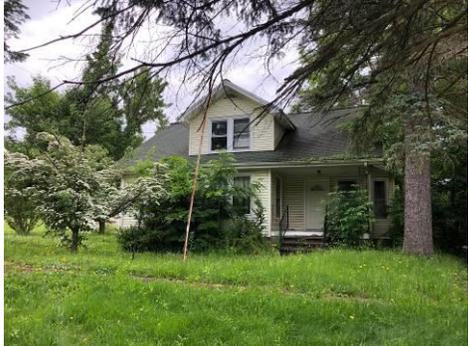
DESCRIPTION: 1½-story side-gabled roof single-family frame house; concrete block foundation, vinyl siding, and asphalt roofing. Single and paired 1/1 double-hung vinyl windows. Prominent front-gable dormer. Partial-width open front porch; metal balusters and columns, and principal roof.	
ADDRESS: 57 Main Street	TAX ID: 99.12-1-10	DATE OF CONSTRUCTION: 1867	SIGNIFICANCE: D (local) - Contributing
CONDITION: Fair		NAME:

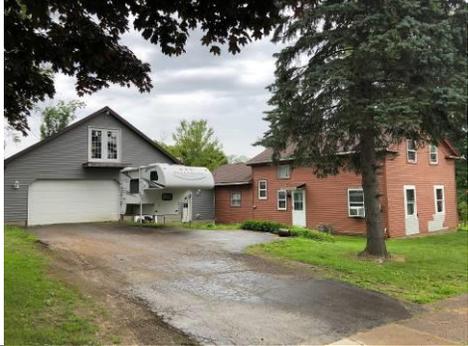
DESCRIPTION: 1½-story front-gabled roof National Folk single-family frame house; concrete block foundation, clapboard siding, asphalt roofing, and cornice on pediment. 1/1 double-hung vinyl window. 1½-story attached garage. Indirect entrance.	
ADDRESS: 59 Main Street	TAX ID: 99.12-1-9	DATE OF CONSTRUCTION: 1872	SIGNIFICANCE: D (local) - Contributing

CONDITION: Good		NAME:

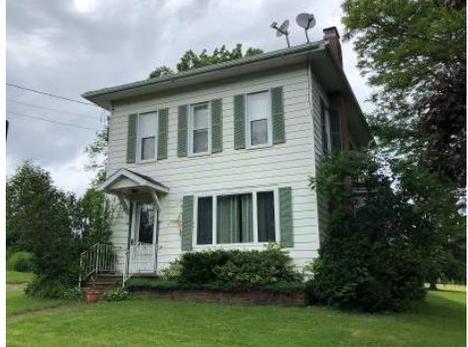
DESCRIPTION: 2-story hipped roof National Folk single-family frame house; parged foundation, composition siding, asphalt roofing, and wide overhanging eaves. 1/1 double-hung vinyl windows; shutters. Eave wall brick chimney.

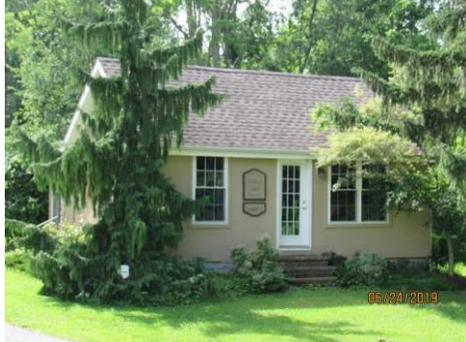
DESCRIPTION: 1-story side-gabled roof single-family frame house; rough-faced concrete block foundation, stucco finish, and asphalt roofing. Single and paired 6/6 double-hung vinyl windows.	
ADDRESS: 3 Mixer Road	TAX ID: 100.05-1-3	DATE OF CONSTRUCTION: Ca. 1900	SIGNIFICANCE: D (local) - Contributing
CONDITION: Good		NAME:

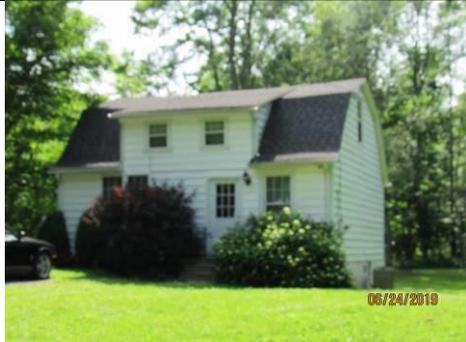
DESCRIPTION: 1½-story side-gambrel roof Dutch Colonial Revival single-family frame house; parged foundation, aluminum siding, and asphalt roofing. Single and paired 6/6 double-hung vinyl windows. Prominent continuous dormer.

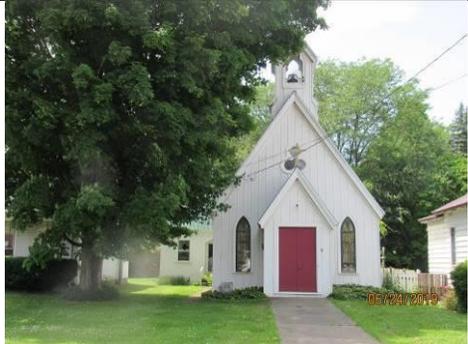
DESCRIPTION: 1½-story front-gabled roof Carpenter Gothic inspired frame church; stone foundation, aluminum siding, and metal roofing. Pointed arched stained glass and trefoil windows. Enclosed front entrance bay. Front-gabled roof bell tower. NR CRITERION: A, C	
ADDRESS: 2 Park Street	TAX ID: 100.09-1-53	DATE OF CONSTRUCTION: Ca. 1870	SIGNIFICANCE: D (local) – Non-Contributing

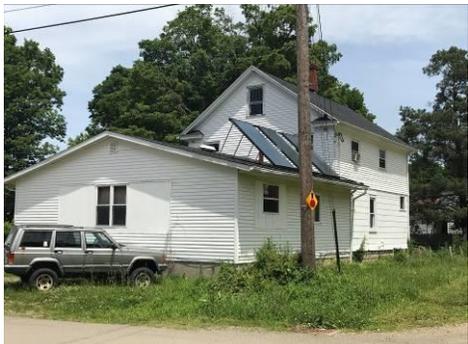
DESCRIPTION: 2½-story front-gabled roof National Folk single-family frame house; rough-faced stone and concrete block foundation, vinyl siding, and asphalt roofing. Single and paired 1/1 double-hung windows. 1-story front-gabled roof projecting front bay. Indirect entrance. Large 1-story front-gabled addition.

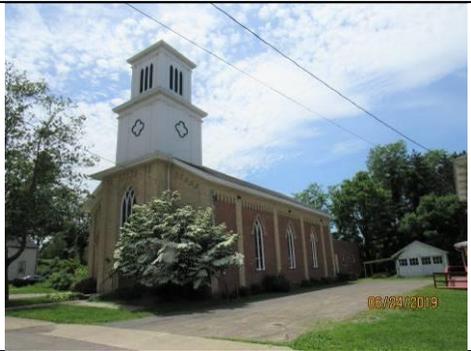
DESCRIPTION: 1-story front-gabled roof Gothic Revival Inspired brick masonry church; stone foundation, asphalt roofing, brick frieze detailing, pilasters. Lancet wood windows. Projecting entry bay. 2½-story centered square tower.	
ADDRESS: 4 Park Street	TAX ID: 100.09-1-50	DATE OF CONSTRUCTION: Ca. 1860	SIGNIFICANCE: D (local) – Non-Contributing
CONDITION: Good		NAME:

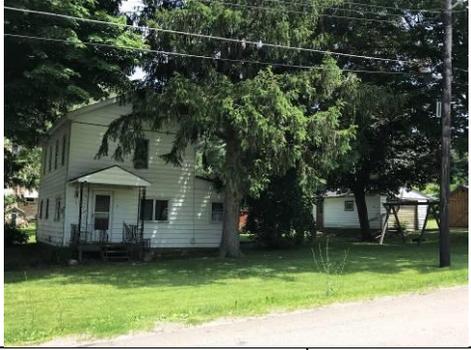
DESCRIPTION: 2-story front-gabled roof National Folk single-family frame house; parged foundation, vinyl siding, and asphalt roofing. Open entry front porch; metal columns, and pedimented roof. 1-story shed roof wing.	
ADDRESS: 5 Park Street	TAX ID: 100.09-1-46	DATE OF CONSTRUCTION: 1867	SIGNIFICANCE: D (local) – Non-Contributing
CONDITION: Good		NAME:

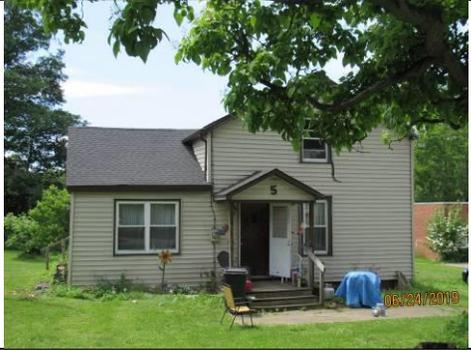
DESCRIPTION: 1½-story gable-front-&-wing National Folk single-family frame house; brick foundation, vinyl siding, and asphalt roofing. Single and paired 1/1 double-hung windows. Open entry front porch; simple square columns, and pedimented roof.

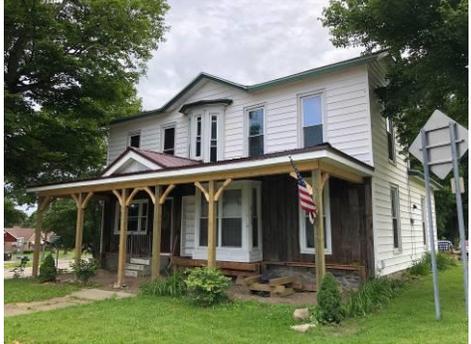
DESCRIPTION: 2-story side-gabled roof Gothic Revival single-family frame house; stone foundation, vinyl siding, and asphalt roofing. Single and paired 1/1 double-hung vinyl windows. 2 nd -story flat roof bay window. Full-width open front porch; simple square with side brackets, and pedimented roof. NR CRITERION: C	
ADDRESS: 2 Pearl Street	TAX ID: 100.09-1-21	DATE OF CONSTRUCTION: Ca. 1880	SIGNIFICANCE: D (NR) - Contributing D (local) - Contributing
CONDITION: Fair/Deteriorated		NAME:

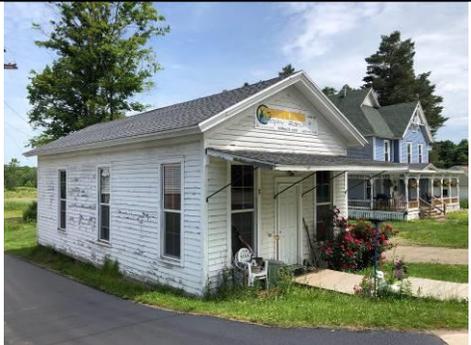
DESCRIPTION: 1-story front-gabled roof National Folk single-family frame house; stone foundation, clapboard siding, and asphalt roofing. 4/4 double-hung vinyl windows. Full-width bracketed shed roof overhang entry. NR CRITERION: C	
ADDRESS: 4 Pearl Street	TAX ID: 100.09-1-18.1	DATE OF CONSTRUCTION: Ca. 1865	SIGNIFICANCE: D (NR) - Contributing I/D (local) - Contributing

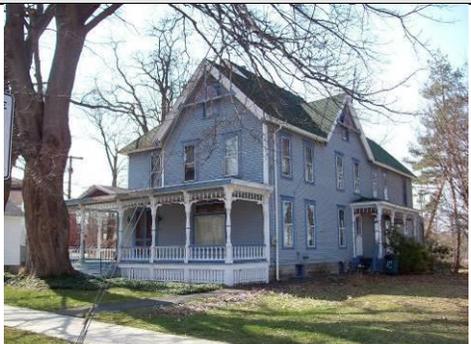
DESCRIPTION: 2½-story hipped roof with cross gables Folk Victorian multiple-family frame house; stone foundation, clapboard siding, asphalt roofing, and decorative trusses in gable. 1/1 double-hung wood and vinyl windows. L-shaped open front porch; plain balusters, turned supports, spindlework detailing, and pedimented roof. NR CRITERION: C

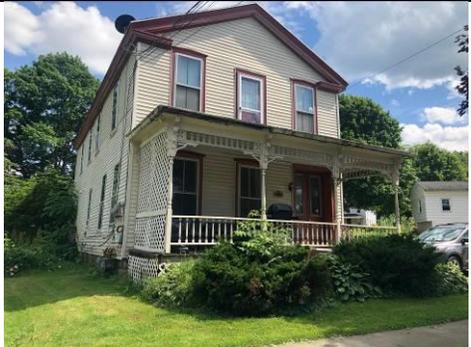
DESCRIPTION: 2-story front-gabled roof Folk Victorian single-family frame house; stone foundation, vinyl siding, asphalt roofing, and cornice on pediment. 2/2 double-hung vinyl windows. Full-width partially open front porch; spindlework detailing, turned balusters and supports, and flat roof. NR CRITERION: C	
ADDRESS: 7 Pearl Street	TAX ID: 100.09-2-6	DATE OF CONSTRUCTION: Ca. 1880	SIGNIFICANCE: D (NR) - Contributing D (local) - Contributing
CONDITION: Good		NAME:

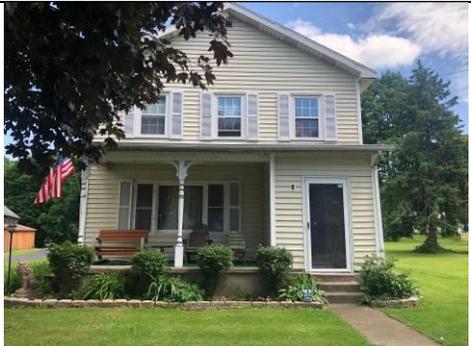
DESCRIPTION: 2-story front-gabled roof National Folk single-family frame house; parged foundation, vinyl siding, and asphalt roofing. 6/6 double-hung and fixed windows; shutters. Full-width partially open front porch; turned supports, and flat roof. NR CRITERION: C

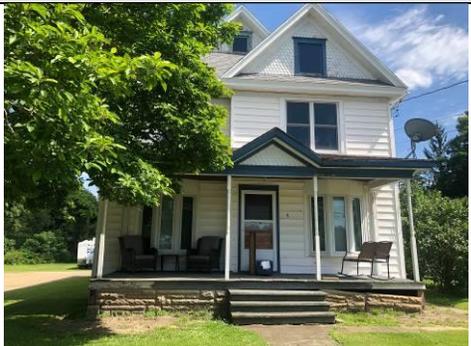
DESCRIPTION: 2½-story hipped roof with cross gables Queen Anne single-family frame house; stone foundation, vinyl siding, shingled gable, asphalt roofing, pent roof enclosing gable. Single and paired 1/1 double-hung and vinyl windows. Full-width open front porch; turned supports, and pedimented roof. NR CRITERION: C

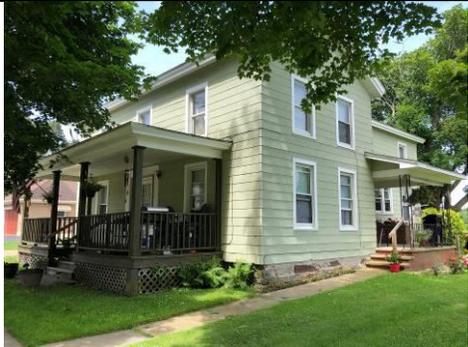
DESCRIPTION: 2-story side-gabled roof National Folk single-family frame house; stone foundation, composition siding, and asphalt roofing. 1/1 double-hung windows. Full-width open front porch; plain balusters, simple square columns, and flat roof. NR CRITERION: C	
ADDRESS: 11 Pearl Street	TAX ID: 100.09-2-8	DATE OF CONSTRUCTION: Ca. 1860	SIGNIFICANCE: D (NR) - Contributing I/D (local) - Contributing
CONDITION: Good		NAME:

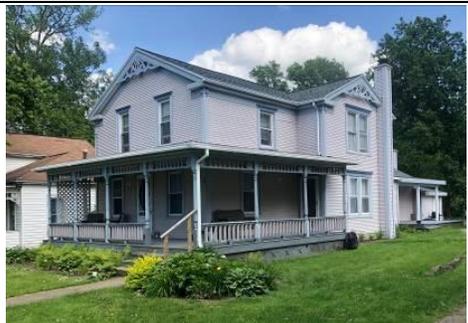
DESCRIPTION: 2-story cross-gabled roof Folk Victorian single-family frame house; parged foundation, aluminum siding, metal roofing, cornice on pediment, and decorative trusses in gable. 1/1 double-hung vinyl windows. L-shaped open front porch; spindlework detailing, plain balusters, turned supports, and flat roof. NR CRITERION: C

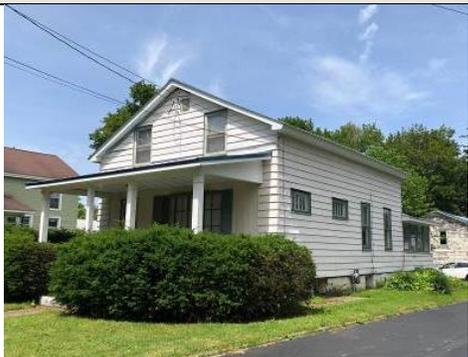
DESCRIPTION: 1½-story front-gabled roof National Folk single-family frame house; parged foundation, aluminum siding, and metal roofing. 1/1 double-hung wood and vinyl windows. Full-width open front porch; simple square columns, and shed roof. NR CRITERION: C

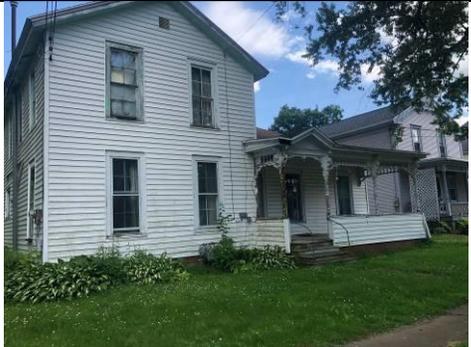
DESCRIPTION: 2-story gable-front-&-wing National Folk single-family frame house; brick foundation, clapboard siding, and asphalt roofing. 4/4 double-hung wood windows. Partial-width open front porch; spindlework detailing, solid balustrade, turned supports, and pedimented roof. NR CRITERION: C	
ADDRESS: 14 Pearl Street	TAX ID: 100.09-1-11	DATE OF CONSTRUCTION: Ca. 1900	SIGNIFICANCE: D (NR) - Contributing D (local) - Contributing
CONDITION: Good		NAME:

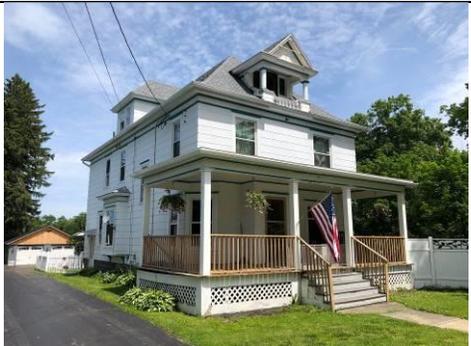
DESCRIPTION: 2½-story hipped Colonial Revival single-family frame house; concrete block foundation, composition siding, and asphalt roofing. 1/1 double-hung wood and vinyl windows. Pedimented roof dormer; recessed window. Full-width open front porch; plain balusters, and low-hipped roof. NR CRITERION: C

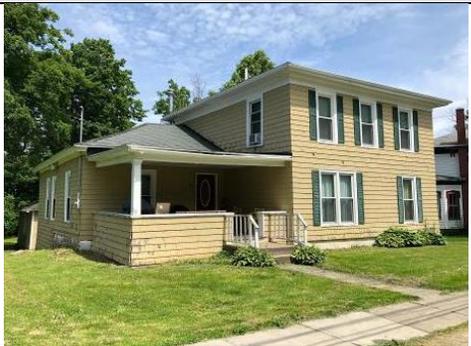
DESCRIPTION: 2-story low-hipped roof modest Italianate style single-family frame house; stone foundation, clapboard siding, asphalt roofing, and wide overhanging eaves. Single and paired 1/1 double-hung windows; shutters; solid balustrade, and flat roof. 1-story hipped roof wing and partial-width open porch. NR CRITERION: C

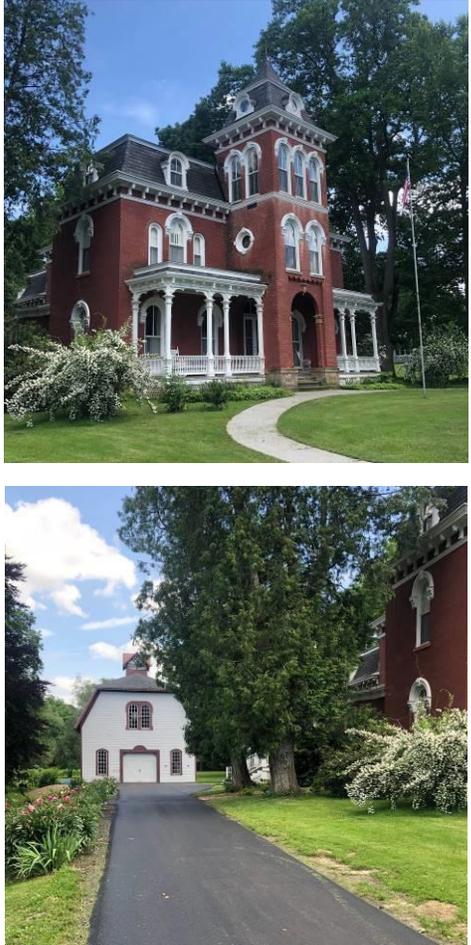
DESCRIPTION: 2½-story mansard roof Second Empire style single-family brick masonry house; stone foundation, asphalt roofing, decorative brackets. Single, paired and grouped 2/2 double-hung and round wood windows; round arched top and elaborated crowns. Arched top and round dormers. Centered square tower, round arched entryway, and flared and pointed roof. Full-width open front porch; turned balusters, elaborate square columns, and flat roof. 1½-story hip-on-gable roof frame carriage house; clapboard siding, shingle roofing. Single and paired 9/9 double-hung windows; round arched top. Rooftop cupola. NR CRITERION: C

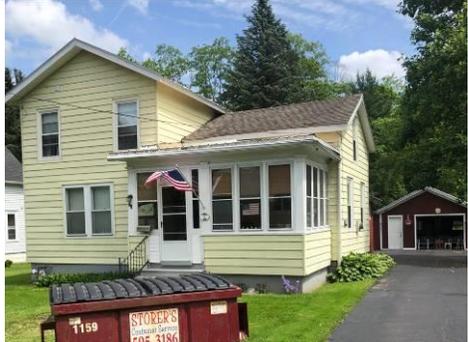
DESCRIPTION: 2-story gable-front-&-wing National Folk single-family frame house; composition siding, and asphalt roofing. Single and paired 1/1 double-hung windows. Partial-width enclosed front porch; flat roof.	
ADDRESS: 26 Pearl Street	TAX ID: 100.05-2-34	DATE OF CONSTRUCTION: Ca. 1900	SIGNIFICANCE: D (local) - Contributing
CONDITION: Fair/Deteriorated		NAME:

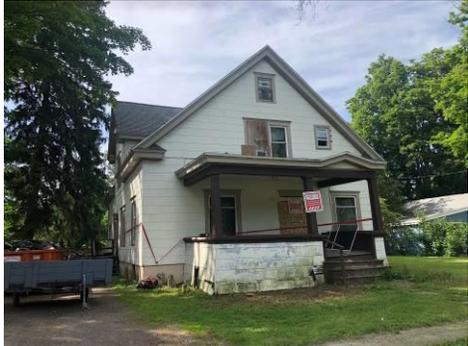
DESCRIPTION: 1½-story cross-gabled roof National Folk single-family frame house; parged foundation, composition siding, asphalt roofing, and cornice on pediment. Single and paired 1/1 double-hung vinyl windows. Partial-width open front porch; solid balustrade, simple square columns, and pedimented roof.	
ADDRESS: 27 Pearl Street	TAX ID: 100.09-2-14	DATE OF CONSTRUCTION: Ca. 1900	SIGNIFICANCE: D (local) - Contributing

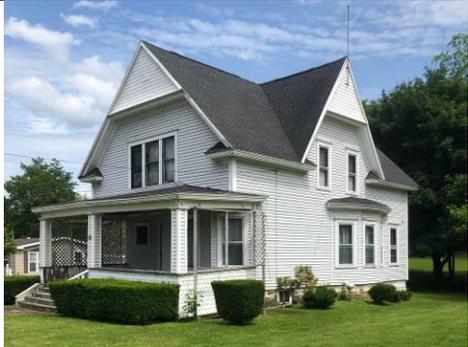
DESCRIPTION: 1½-story cross-gabled roof modest Queen Anne single-family frame house; stone foundation, vinyl siding, asphalt roofing, and cornice on pediment. Single and grouped 1/1 double-hung vinyl and wood windows. 1 st -story bay window. Full-width open front porch; solid balustrade, simple square columns, and low-hipped roof.

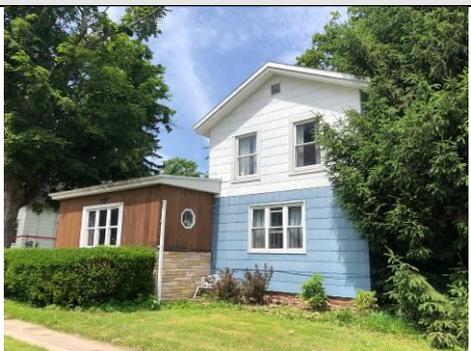
DESCRIPTION: 2-story cross-gabled roof National Folk single-family frame house; stone foundation, composition siding, and asphalt roofing. Single and grouped 1/1 double-hung vinyl windows. 1-story shed roof wing. Indirect entrance. Attached garage.	
ADDRESS: 30 Pearl Street	TAX ID: 100.05-2-32	DATE OF CONSTRUCTION: Ca. 1860	SIGNIFICANCE: D (local) - Contributing
CONDITION: Good		NAME:

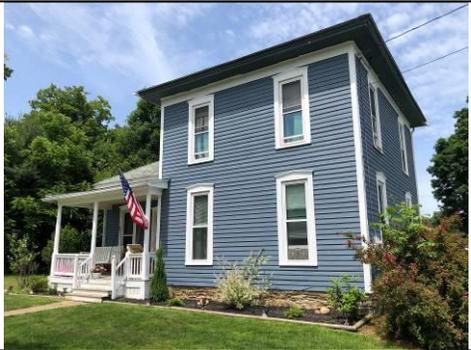
DESCRIPTION: 2-story hipped roof National Folk single-family frame house; stone foundation, clapboard siding, asphalt roofing, and wide overhanging eaves. 1/1 double-hung vinyl windows. 1-story hipped roof wing. Partial-width open front porch; plain balusters, and hipped roof.	
ADDRESS: 35 Pearl Street	TAX ID: 100.09-2-16	DATE OF CONSTRUCTION: Ca. 1870	SIGNIFICANCE: D (local) - Contributing

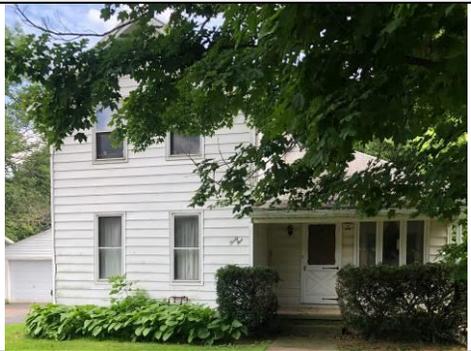
DESCRIPTION: 2-story gable-front-&-wing National Folk single-family frame house; parged foundation, composition siding, and asphalt roofing. 1/1 double-hung vinyl windows. Partial-width open front porch; simple square columns, and principal roof.

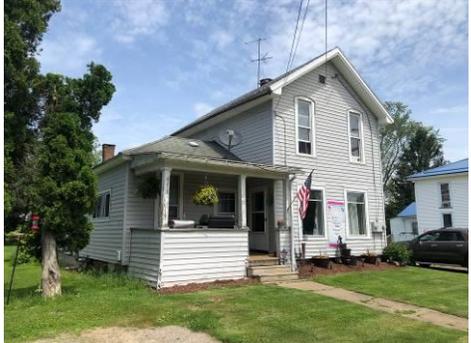
DESCRIPTION: 2-story gable-front-&-wing National Folk single-family frame house; stone foundation, vinyl siding, and asphalt roofing. 1/1 double-hung and fixed wood and vinyl windows. Partial-width open front porch; solid balustrade, and shed roof.	
ADDRESS: 37 Pearl Street	TAX ID: 100.09-2-17	DATE OF CONSTRUCTION: Ca. 1870	SIGNIFICANCE: D (local) - Contributing
CONDITION: Good		NAME:

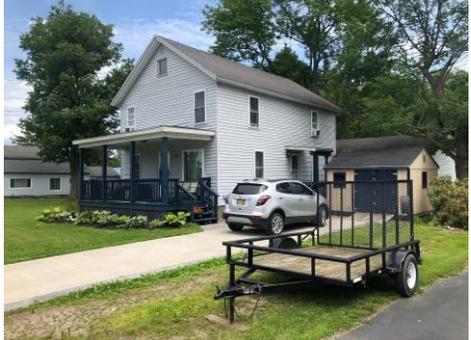
DESCRIPTION: 2½-story front-gabled roof National Folk single-family frame house; stone foundation, vinyl siding, and asphalt roofing. 1/1 double-hung and single-pane vinyl windows. Full-width open front porch; plain balusters, simple square columns, and hipped roof.

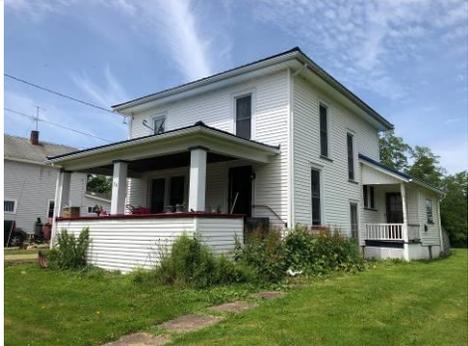
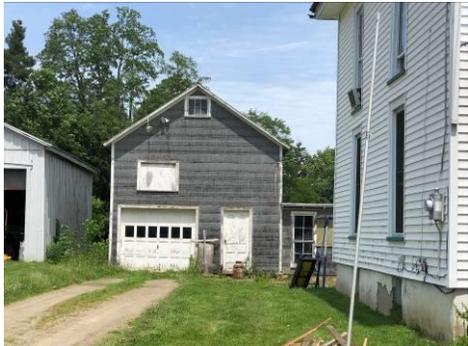
<p>DESCRIPTION:</p> <p>2-story hipped roof National Folk single-family frame house; parged foundation, vinyl siding, metal roofing, and wide overhanging eaves. 1/1 double-hung vinyl windows. Full-width open front porch; solid balustrade, simple square columns, and hipped roof.</p> <p>2½-story front-gabled roof frame garage. 6-light wood window and hayloft door.</p>

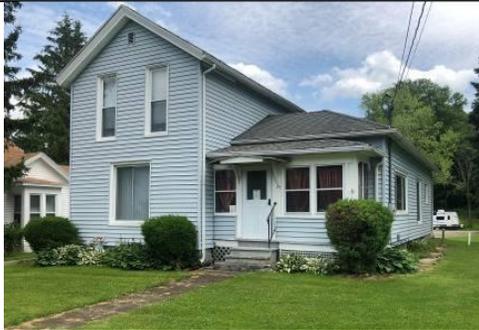
<p>DESCRIPTION:</p> <p>2-story gable-front-&-wing National Folk single-family frame house; parged foundation, vinyl siding, and asphalt roofing. 1/1 double-hung and sliding vinyl windows. Partial-width enclosed front porch with hipped roof.</p>

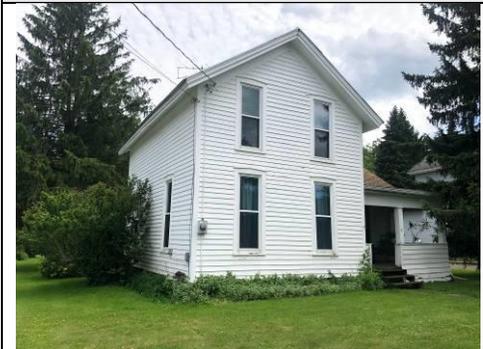
DESCRIPTION: 1½-story gable-front-&-wing National Folk single-family frame house; stone foundation, clapboard siding, and asphalt roofing. 1/1 double-hung vinyl windows. Partial-width open front porch with flat roof.	
ADDRESS: 43 Pearl Street	TAX ID: 100.05-2-28	DATE OF CONSTRUCTION: Ca. 1870	SIGNIFICANCE: D (local) - Contributing
CONDITION: Good		NAME:

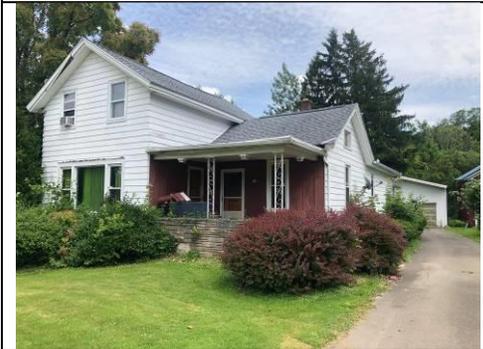
DESCRIPTION: 1½-story gable-front-&-wing National Folk single-family frame house; aluminum siding, and asphalt roofing. 1/1 double-hung and picture vinyl windows. Partial-width open front porch; solid balustrade with stone veneer, metal columns, and flat roof.	
ADDRESS: 44 Pearl Street	TAX ID: 100.05-2-55	DATE OF CONSTRUCTION: Ca. 1880	SIGNIFICANCE: D (local) - Contributing
CONDITION: Good		NAME:

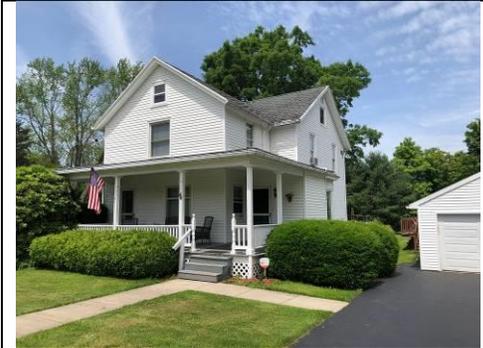
DESCRIPTION: 2½-story cross-gabled roof National Folk single-family frame house; stone foundation, vinyl siding, and asphalt roofing. 1/1 double-hung vinyl windows. L-shaped open front porch; plain balusters, simple square columns, and flat roof.

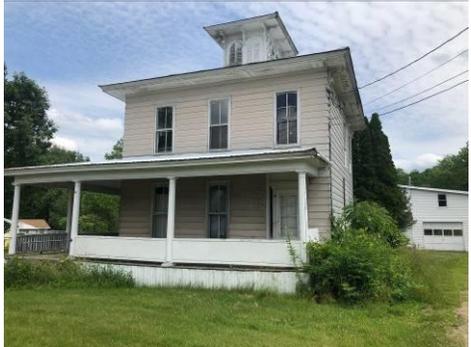
DESCRIPTION: 2½-story hipped roof single-family frame house; parged foundation, aluminum siding, and asphalt roofing. 1/1 double-hung windows. Prominent front facing gable with pent roof enclosing gable. Partial-width open front porch; metal columns, and shed roof.	
ADDRESS: 49 Pearl Street	TAX ID: 100.05-2-24	DATE OF CONSTRUCTION: Ca. 1870	SIGNIFICANCE: D (local) - Contributing
CONDITION: Good		NAME:

DESCRIPTION: 2½-story hipped roof Italianate style single-family frame house; aluminum siding, asphalt roofing, and widely overhanging eaves supported by decorative brackets. 2/2 double-hung wood windows. L-shaped open front porch; solid balustrade, Doric columns, and hipped roof with cupola.	
ADDRESS: 50 Pearl Street	TAX ID: 100.05-2-61	DATE OF CONSTRUCTION: 1895	SIGNIFICANCE: D (local) - Contributing

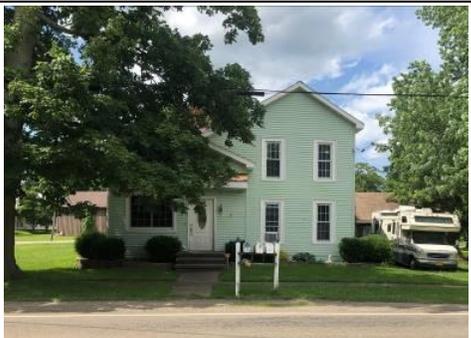
CONDITION: Good		NAME:

DESCRIPTION: 2-story cross-gabled roof National Folk single-family frame house; parged foundation, vinyl siding, and asphalt roofing. 6/6 double-hung vinyl windows. 1-story front-gabled roof entry wing.

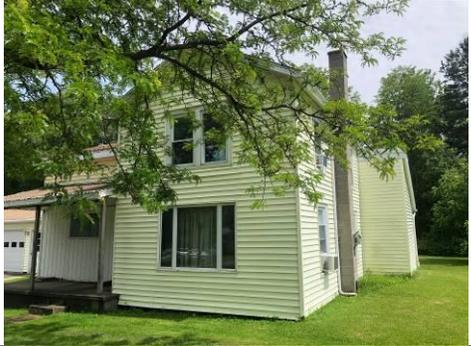
DESCRIPTION: 1½-story front-gabled roof National Folk single-family frame house; parged foundation, shingle siding, and asphalt roofing. Single and paired 1/1 double-hung windows; shutters. Full-width enclosed front porch; hipped roof. Indirect entrance.	
ADDRESS: 53 Pearl Street	TAX ID: 100.05-2-21	DATE OF CONSTRUCTION: Ca. 1870	SIGNIFICANCE: D (local) - Contributing
CONDITION: Good		NAME:

DESCRIPTION: 2-story gable-front-&-wing National Folk single-family frame house; stone foundation, vinyl siding, and asphalt roofing. Paired 1/1 double-hung and picture vinyl windows. Partial-width open front porch; simple square columns, and shed roof. Attached garage.	
ADDRESS: 54 Pearl Street	TAX ID: 100.05-2-64	DATE OF CONSTRUCTION: Ca. 1900	SIGNIFICANCE: D (local) - Contributing

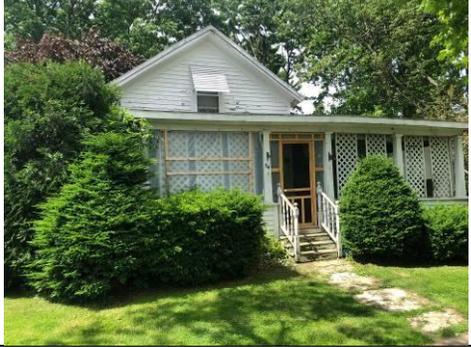
CONDITION: Good		NAME:

DESCRIPTION: 1½-story front-gabled roof National Folk single-family frame house; stone foundation, vinyl siding, and asphalt roofing. 1/1 double-hung vinyl windows. Full-width open front porch; solid balustrade, Doric columns, and flat roof.

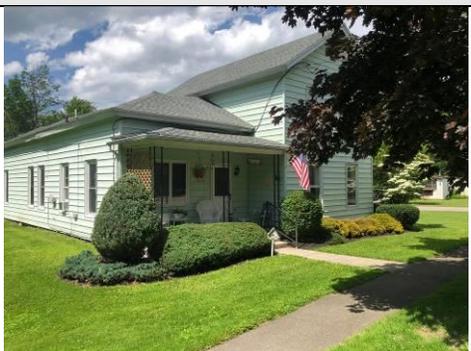
ADDRESS: 56 Pearl Street	TAX ID: 100.05-2-65	DATE OF CONSTRUCTION: Ca. 1850	SIGNIFICANCE: D (local) - Contributing
CONDITION: Good		NAME:

DESCRIPTION: 2-story gable-front-&-wing National Folk single-family frame house; stone foundation, vinyl siding, and asphalt roofing. 1/1 double-hung vinyl windows. Partial-width open front porch; metal columns, and hipped roof.	
ADDRESS: 57 Pearl Street	TAX ID: 100.05-2-19	DATE OF CONSTRUCTION: Ca. 1900	SIGNIFICANCE: D (local) - Contributing
CONDITION: Good		NAME:

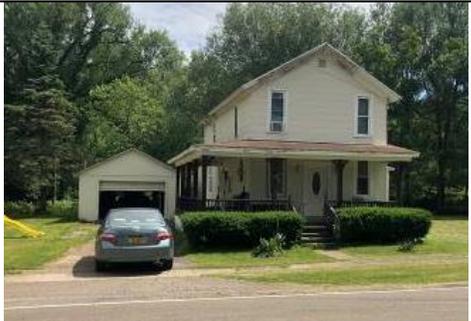
DESCRIPTION: 2-story front-gabled roof National Folk single-family frame house; parged foundation, composition siding, and asphalt roofing. 1/1 double-hung vinyl windows. L-shaped open front porch; plain balusters, simple square columns with side brackets, and hipped roof.	
ADDRESS: 59 Pearl Street	TAX ID: 100.05-2-18	DATE OF CONSTRUCTION: Ca. 1870	SIGNIFICANCE: D (local) - Contributing

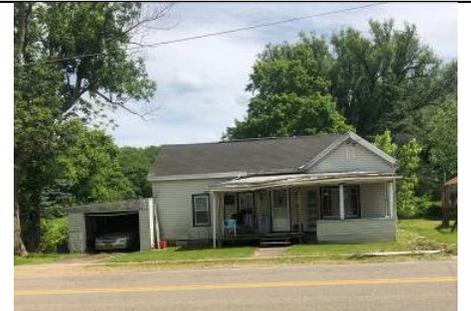
CONDITION: Fair/Deteriorated		NAME:

DESCRIPTION: 1-story gable-front-&-wing National Folk National Folk single-family frame house; parged foundation, vinyl siding, and asphalt roofing. 1/1 double-hung and fixed vinyl windows. Partial-width open front porch; solid balustrade, simple square columns, and hipped roof. Attached garage.

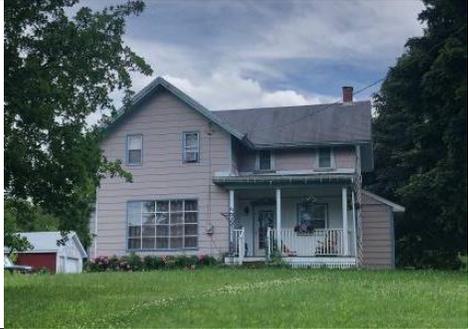
ADDRESS: 61 Pearl Street	TAX ID: 100.05-2-17	DATE OF CONSTRUCTION: Ca. 1850	SIGNIFICANCE: D (local) - Contributing
CONDITION: Good		NAME:

DESCRIPTION: 2-story gable-front-&-wing National Folk single-family frame house; stone foundation, composition siding, and asphalt roofing. 1/1 double-hung and multi-light vinyl windows. Partial-width open front porch; plain balusters, simple square columns, and shed roof.	
ADDRESS: 63 Pearl Street	TAX ID: 100.00-1-5	DATE OF CONSTRUCTION: Ca. 1870	SIGNIFICANCE: D (local) - Contributing
CONDITION: Good		NAME:

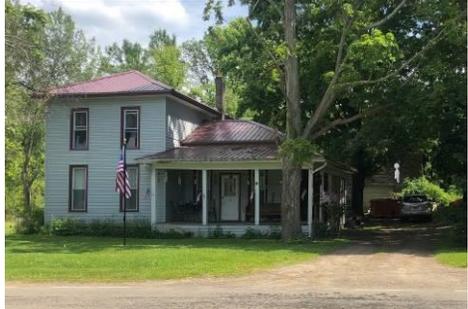
DESCRIPTION: 2-story National Folk single-family frame house; brick foundation, vinyl siding, and metal roofing. 1/1 double-hung vinyl windows. Partial-width open front porch; simple square columns, and hipped roof.

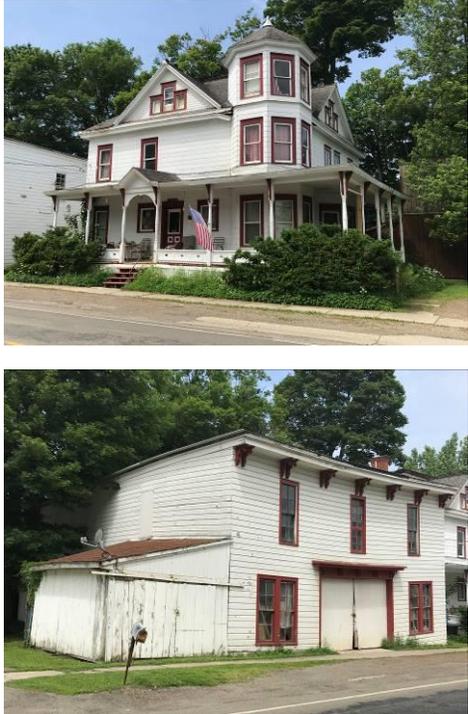
<p>ADDRESS: 1 Prospect Street</p>	<p>TAX ID: 100.09-1-60</p>	<p>DATE OF CONSTRUCTION: Ca. 1870</p>	<p>SIGNIFICANCE: I (NR) – Individually Eligible I/D (local) - Contributing</p>
<p>CONDITION: Good</p>		<p>NAME:</p>

<p>DESCRIPTION:</p> <p>2½-story hipped roof with cross gables Queen Anne single-family frame house; aluminum siding, and asphalt roofing. 1/1 double-hung and fixed wood windows; shaped in gable. 3-story polygonal roof tower. L-shaped open front porch; solid balustrade, turned supports, and pedimented roof.</p> <p>2-story flat roof frame secondary building; clapboard siding, brackets at cornice. Single and paired 4/4 double-hung windows. Centered wide double-leaf door. 1-story shed roof wing.</p> <p>NR CRITERION: C</p>	
<p>ADDRESS: 2 Prospect Street</p>	<p>TAX ID: 100.09-2-39</p>	<p>DATE OF CONSTRUCTION: 1887</p>	<p>SIGNIFICANCE: I (NR) – Individually Eligible I/D (local) - Contributing</p>

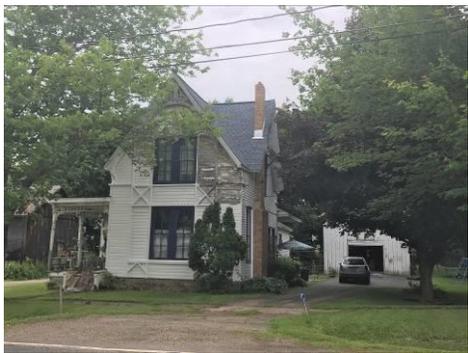
<p>CONDITION: Fair/Deteriorated</p>		<p>NAME:</p>

<p>DESCRIPTION:</p> <p>1½-story cross-gabled roof Victorian Stick style single-family frame house; stone foundation, clapboard siding, asphalt roofing, and half timbering. Paired tall 8-light wood windows. Partial-width open front porch with Victorian-era detailing; spindlework detailing, side brackets, solid balustrade, turned supports, and flat roof.</p> <p>1½-story front-gabled roof frame barn with clapboard siding.</p> <p>NR CRITERION: C</p>

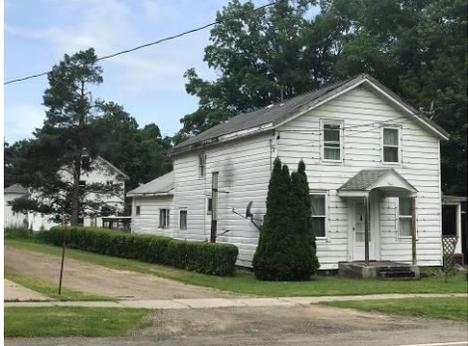
ADDRESS: 3 Prospect Street	TAX ID: 100.09-1-54	DATE OF CONSTRUCTION: Ca.1870	SIGNIFICANCE: D (local) - Contributing
CONDITION: Good		NAME:

DESCRIPTION: 1½-story front-gabled roof National Folk single-family frame house; stone foundation, aluminum siding, and asphalt roofing. 1/1 double-hung wood windows. Bracketed roof overhang entry.	
ADDRESS: 4 Prospect Street	TAX ID: 100.09-2-40	DATE OF CONSTRUCTION: Ca.1870	SIGNIFICANCE: I/D (local) - Contributing
CONDITION: Good		NAME:

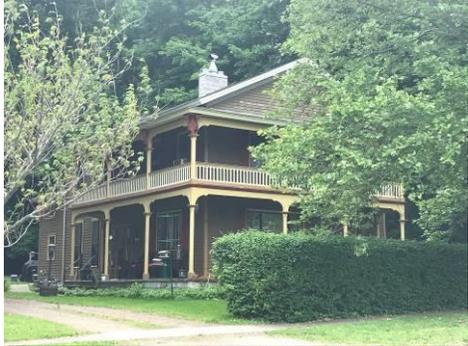
DESCRIPTION: 2-story front-gabled National Folk style single-family frame house; stone foundation, clapboard siding, and asphalt roofing. 1/1 double-hung and multi-light wood and vinyl windows. 2-story L-shaped open front porch with plain balusters, decorative columns, and principal roof.

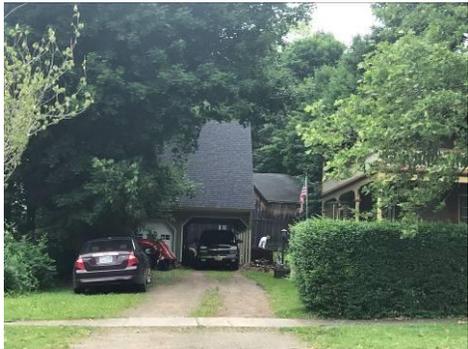
1½-story cross-gabled roof frame barn; board and batten siding, and asphalt roofing.

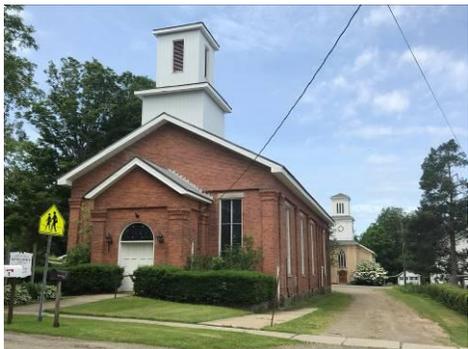
ADDRESS: 5 Prospect Street	TAX ID: 100.09-1-52	DATE OF CONSTRUCTION: 1834	SIGNIFICANCE: I/D (local) - Contributing
CONDITION: Excellent		NAME: Baptist Church

<p>DESCRIPTION:</p> <p>1-story front-gabled roof brick masonry Greek Revival church; stone foundation, metal roofing, pilasters with dentil molding. Tall 6-light wood windows. Centered square bell tower. Centered projecting entry bay; round arched transom above door. Church Associated with the Underground Railroad.</p> <p>NR CRITERION: A (more research needed to confirm story of role in Network to Freedom/Underground Railroad)</p>	
ADDRESS: 7 Prospect Street	TAX ID: 100.09-1-51	DATE OF CONSTRUCTION: Ca. 1870	SIGNIFICANCE: D (local) - Contributing
CONDITION: Excellent		NAME:

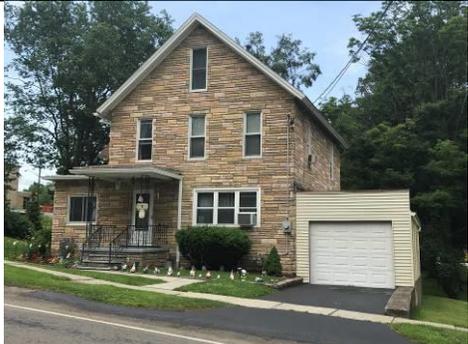
<p>DESCRIPTION:</p> <p>2½-story front-gabled roof National Folk single-family frame house; stone veneer siding, and asphalt roofing. Single and grouped 1/1 double-hung and sliding vinyl windows. Entry open front porch; metal balusters and columns, and flat roof.</p>

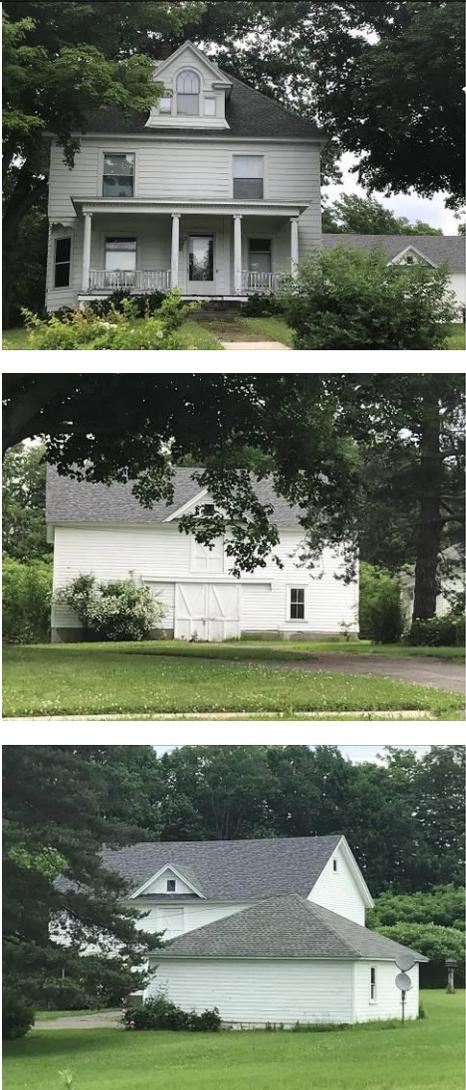
<p>ADDRESS: 8 Prospect Street</p>	<p>TAX ID: 100.09-2-49</p>	<p>DATE OF CONSTRUCTION: Ca. 1900</p>	<p>SIGNIFICANCE: I/D (local) - Contributing</p>
<p>CONDITION: Excellent</p>		<p>NAME:</p>

<p>DESCRIPTION:</p> <p>2½-story hipped roof Colonial Revival single-family frame house; stone foundation, aluminum siding, and asphalt roofing. 1/1 double-hung and Palladian wood and vinyl windows. Front-gabled roof dormer; cornice on pediment. Cutaway bay window. Full-width open front porch; plain balusters, Ionic columns, and flat roof.</p> <p>2½-story side-gabled roof frame barn; parged foundation, clapboard siding, and asphalt roofing. Front-gabled roof dormer. 2/2 double-hung windows. Double leaf and hayloft door.</p> <p>1-story hipped roof frame garage; parged foundation, clapboard siding, and asphalt roofing.</p>	
<p>ADDRESS: 11 Prospect Street</p>	<p>TAX ID: 100.09-1-47</p>	<p>DATE OF CONSTRUCTION: Ca. 1890</p>	<p>SIGNIFICANCE: D (local) - Contributing</p>

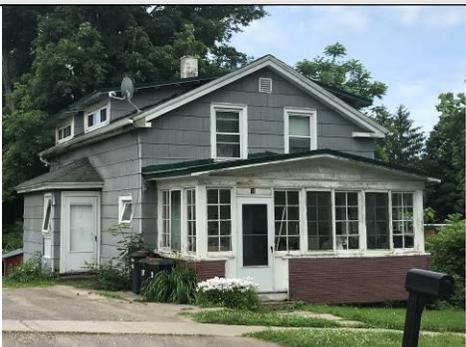
<p>CONDITION: Good</p>		<p>NAME:</p>

<p>DESCRIPTION:</p> <p>1½-story front-gabled roof National Folk single-family frame house; asphalt siding, asphalt roofing, and cornice on pediment. 1/1 double-hung and 8-light vinyl and wood windows. Full-width enclosed front porch with front-gabled roof.</p>

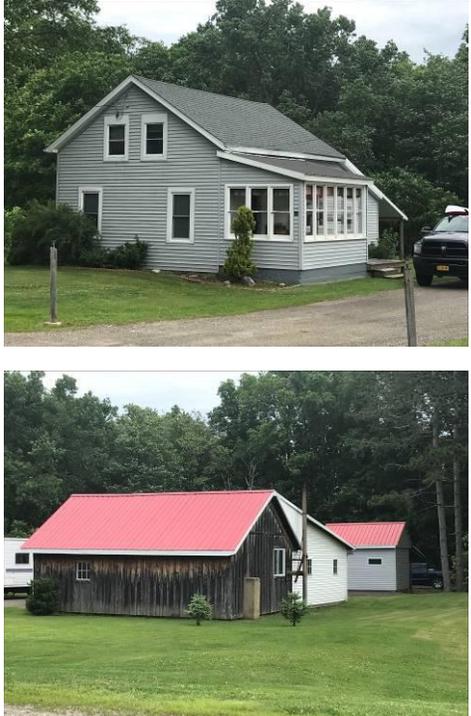
ADDRESS: 18 Prospect Street	TAX ID: 100.13-1-13	DATE OF CONSTRUCTION: Ca. 1900	SIGNIFICANCE: D (local) - Contributing
CONDITION: Good		NAME:

DESCRIPTION: 1½-story front-gabled roof vernacular National Folk single-family frame house; stone foundation, vinyl siding, and asphalt roofing. Single and grouped 1/1 double-hung vinyl windows. Partial-width enclosed side porch with shed roof. Indirect entrance. 1-story side-gabled roof frame garage; board and batten siding, and metal roofing.	
ADDRESS: 20 Prospect Street	TAX ID: 100.13-1-27	DATE OF CONSTRUCTION: 1845	SIGNIFICANCE: D (local) – Non-Contributing
CONDITION: Good		NAME:

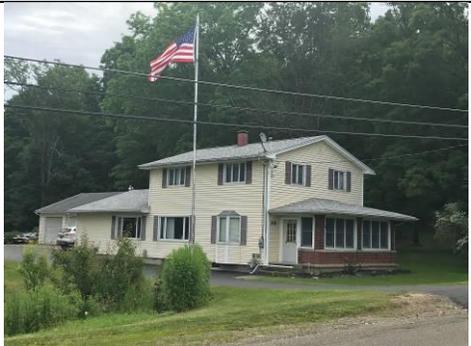
DESCRIPTION: 2-story front-gabled roof single-family frame house with significant alterations; parged foundation, vinyl siding, and asphalt roofing. 1/1 double-hung and single-pane wood windows; shutters. Full-width enclosed front porch; brick siding, and hipped roof.

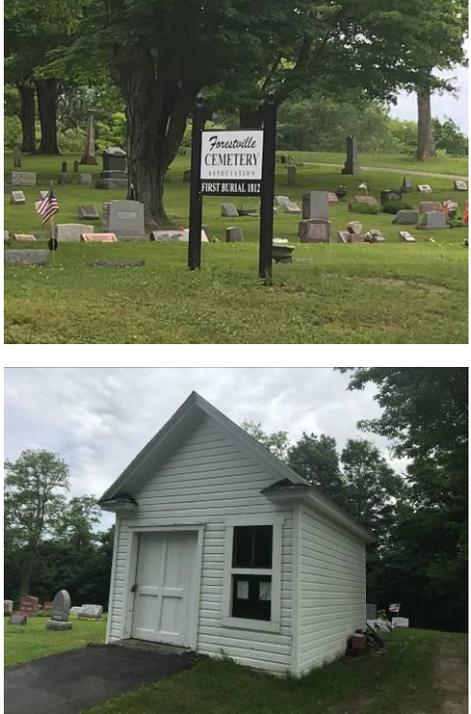
ADDRESS: 10507 Prospect Street	TAX ID: 100.13-1-18	DATE OF CONSTRUCTION: 1812 1 st Burial	SIGNIFICANCE: I/D (local) - Contributing
CONDITION: Good		NAME: Forestville Cemetery

DESCRIPTION: 7-acre cemetery with small storage building ca. 1965 1½-story front-gabled roof frame building; clapboard siding, asphalt roofing, and cornice on pediment. 2/1 double-hung windows. Wide sliding door.

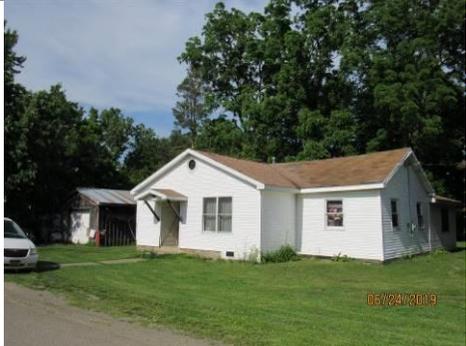
ADDRESS: 1 Second Street	TAX ID: 100.05-1-18	DATE OF CONSTRUCTION: Ca. 1880	SIGNIFICANCE: D (local) – Non-Contributing
CONDITION: Good		NAME:

DESCRIPTION: 1-story gable-front-&-wing National Folk single-family frame house; parged foundation, vinyl siding, and asphalt roofing. Bracketed gable overhang entrance.	
ADDRESS: 3 Second Street	TAX ID: 100.05-1-30	DATE OF CONSTRUCTION: Ca. 1950	SIGNIFICANCE: D (local) – Non-Contributing
CONDITION: Good		NAME:

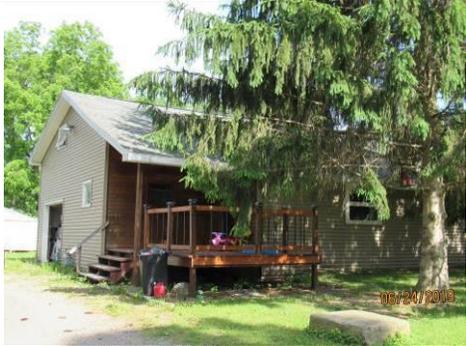
DESCRIPTION: 1½-story side-gabled roof National Folk single-family house; parged foundation, vinyl siding, and asphalt roofing. 1/1 double-hung vinyl windows. Partial-width open front porch; plain balusters, simple square columns, and principal roof.	
ADDRESS: 4 Second Street	TAX ID: 100.05-1-35	DATE OF CONSTRUCTION: Ca. 1890	SIGNIFICANCE: D (local) - Contributing
CONDITION: Fair/Deteriorated		NAME:

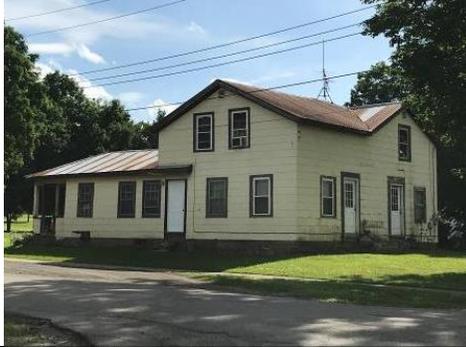
DESCRIPTION: 2-story National Folk single-family frame house; stone foundation, composition siding, and metal roofing. 1/1,6/6,8/8 double-hung wood and vinyl windows.

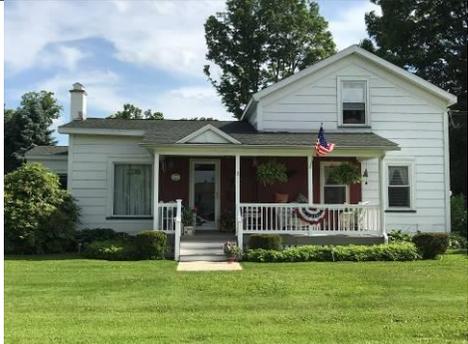
ADDRESS: 1 Swan Street	TAX ID: 100.05-1-36	DATE OF CONSTRUCTION: Ca. 1880	SIGNIFICANCE: D (local) - Contributing
CONDITION: Good		NAME:

DESCRIPTION: 1½-story gable-front-&-wing National Folk single-family frame house; aluminum siding, and asphalt roofing. 1/1 double-hung and fixed wood and vinyl windows. Partial-width open front porch; turned balusters, simple square columns, and pedimented roof.	
ADDRESS: 2 Swan Street	TAX ID: 100.05-1-12	DATE OF CONSTRUCTION: Ca. 1890	SIGNIFICANCE: D (local) - Contributing
CONDITION: Good		NAME:

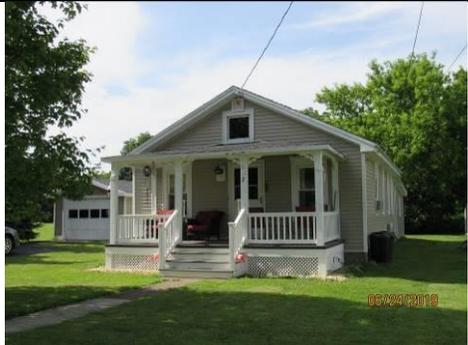
DESCRIPTION: 1½-story front-gabled National Folk single-family frame house; parged foundation, vinyl siding, and asphalt roofing. 1/1 double-hung and single-pane vinyl windows. Full-width open front porch; plain balusters, simple square columns with side brackets, and hipped roof.	
ADDRESS: 3 Swan Street	TAX ID: 100.05-1-29	DATE OF CONSTRUCTION: 1867	SIGNIFICANCE: I/D (local) - Contributing

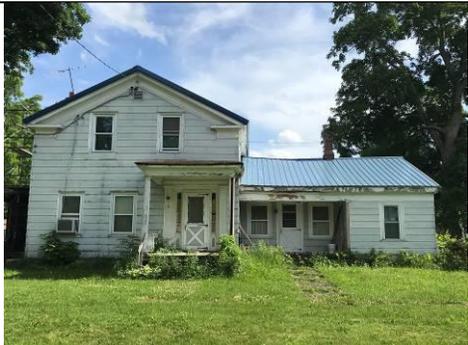
CONDITION: Fair/Deteriorated		NAME:

DESCRIPTION: 2-story gable-front-&-wing Greek Revival single-family frame house; parged foundation, aluminum siding, metal roofing, and cornice on pediment. 1/1 double-hung windows. Entry and partial-width open front porches; turned balusters, Doric columns, hipped and principal roof.

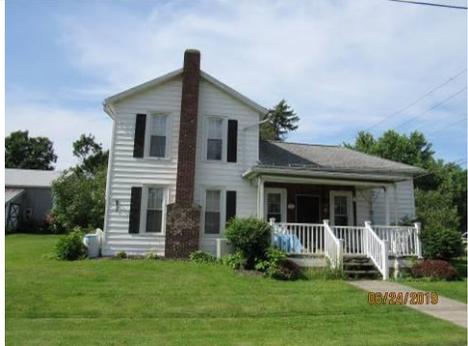
ADDRESS: 6 Swan Street	TAX ID: 100.05-1-14	DATE OF CONSTRUCTION: 1872	SIGNIFICANCE: D (local) - Contributing
CONDITION: Good		NAME:

DESCRIPTION: 2-story gable-front-&-wing National Folk single-family frame house; aluminum siding, and asphalt roofing. 4/4 double-hung vinyl windows; shutters. Eave wall brick chimney. Partial-width open front porch; plain balusters, simple square columns, and flat roof.	
ADDRESS: 7 Swan Street	TAX ID: 100.05-1-27	DATE OF CONSTRUCTION: 1963	SIGNIFICANCE: D (local) – Non-Contributing
CONDITION: Good		NAME:

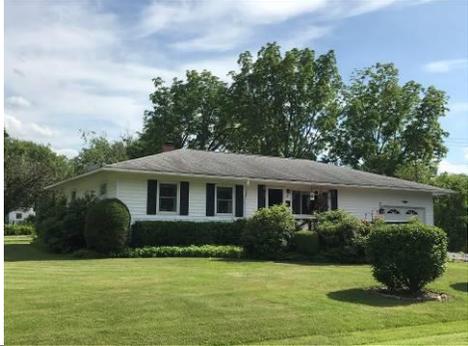
DESCRIPTION: 1-story hipped roof Ranch style single-family frame house; parged foundation, aluminum siding, and asphalt roofing. 1/1 double-hung windows; shutters. Attached garage.

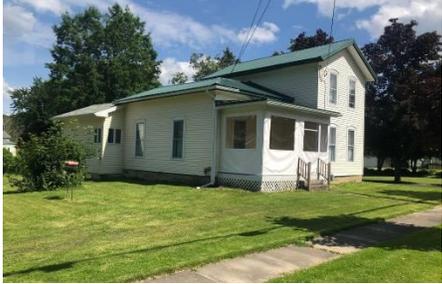
ADDRESS: 1 Third Street	TAX ID: 100.05-2-62	DATE OF CONSTRUCTION: Ca. 1875	SIGNIFICANCE: D (local) - Contributing
CONDITION: Good		NAME:

<p>DESCRIPTION:</p> <p>2-story gable-front-&-wing National Folk single-family frame house; parged foundation, vinyl siding, and metal roofing. 1/1 double-hung windows. Partial-width enclosed front porch; simple square columns, and low-hipped roof.</p> <p>Image Source: http://app.chautauquacounty.com/hist_struct/chsdb.html</p>

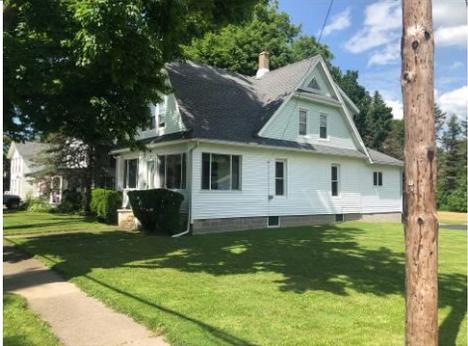
ADDRESS: 3 Third Street	TAX ID: 100.05-2-68	DATE OF CONSTRUCTION: Ca. 1930	SIGNIFICANCE: D (local) - Contributing
CONDITION: Good		NAME:

<p>DESCRIPTION:</p> <p>1½-story cross-gabled roof single-family frame house; concrete block foundation, vinyl siding, asphalt roofing, pent roof enclosing gable. 1/1,6/1 double-hung and sliding vinyl windows. Full-width enclosed side porch with principal roof.</p>

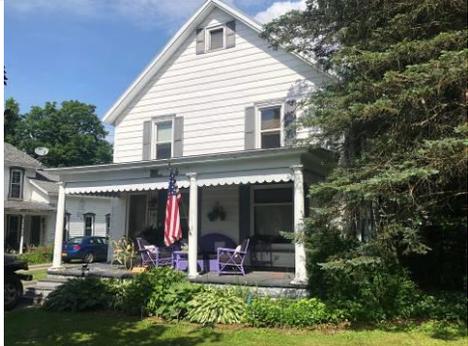
ADDRESS: 5 Third Street	TAX ID: 100.05-2-69	DATE OF CONSTRUCTION: ca. 1910	SIGNIFICANCE: D (local) - Contributing
CONDITION: Good		NAME:

DESCRIPTION: 2½-story front-gabled roof vernacular Colonial Revival single-family frame house; stone foundation, clapboard siding, and metal roofing. 1/1 double-hung and 4-light wood and vinyl windows; shutters. Full-width open front porch; Doric columns, and shed roof.	
ADDRESS: 7 Third Street	TAX ID: 100.05-2-70	DATE OF CONSTRUCTION: Ca. 1890	SIGNIFICANCE: I (NR) – Individually Eligible I/D (local) - Contributing
CONDITION: Good		NAME:

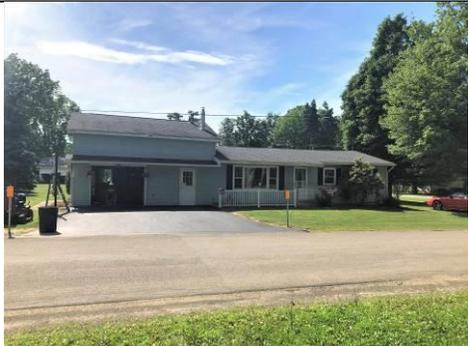
DESCRIPTION: 2-story front-gabled roof vernacular modest Italianate single-family frame house; stone foundation, clapboard siding, and asphalt roofing. 4/4 double-hung vinyl windows; segmental arch top. Partial-width open side porch; turned supports, and low-hipped roof. NR CRITERION: C	
ADDRESS: 8 Third Street	TAX ID: 100.05-1-23	DATE OF CONSTRUCTION: Ca. 1960	SIGNIFICANCE: D (local) – Non-Contributing

CONDITION: Good		NAME:

DESCRIPTION: 1½-story side-gabled roof Ranch style single-family frame house; parged foundation, vinyl siding, and asphalt roofing. 1/1 double-hung and picture vinyl windows; shutters. Attached garage.

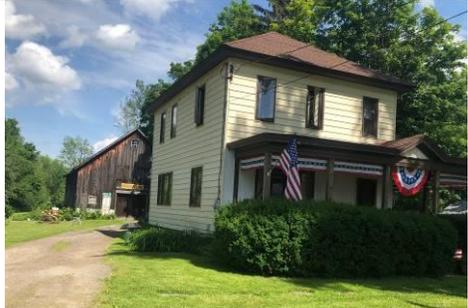
ADDRESS: 9 Third Street	TAX ID: 100.05-2-71	DATE OF CONSTRUCTION: Ca. 1900	SIGNIFICANCE: D (local) - Contributing
CONDITION: Good		NAME:

DESCRIPTION: 2-story hipped roof National Folk single-family frame house; parged foundation, vinyl siding, asphalt roofing, and wide overhanging eaves. Single and grouped casement vinyl windows. L-shaped open front porch; simple square columns, and pedimented roof.

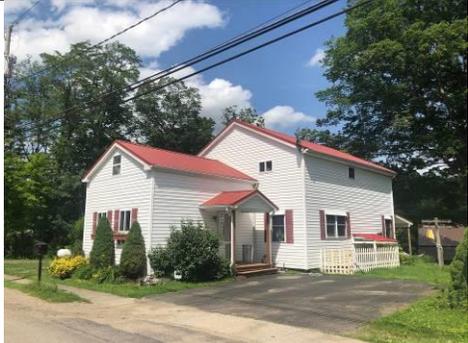
ADDRESS: 1 Walnut Street	TAX ID: 99.12-2-9	DATE OF CONSTRUCTION: Ca. 1900	SIGNIFICANCE: D (local) – Non-Contributing
CONDITION: Good		NAME:

DESCRIPTION: 1½-story front-gabled roof National Folk single-family frame house; vinyl siding, and metal roofing. 1/1 double-hung and sliding vinyl windows. Entry open side porch; simple square columns, and front-gabled roof.	
ADDRESS: 2 Walnut Street	TAX ID: 99.12-1-12	DATE OF CONSTRUCTION: 1881	SIGNIFICANCE: D (local) – Non-Contributing
CONDITION: Fair		NAME:
