Reconnaissance Level Historic Resources Survey of Forestville

Town of Hanover, Chautauqua County, NY
October 21, 2019

CBCA 19-013

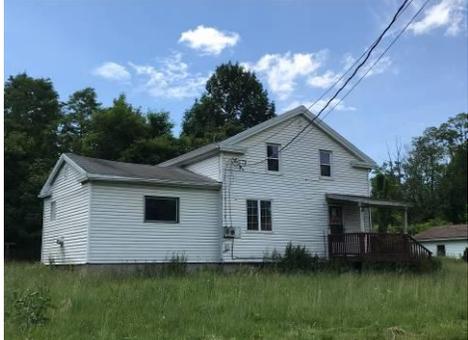
DESCRIPTION: 1½-story front-gabled roof National Folk single-family frame house; vinyl siding, and metal roofing. 1/1 double-hung and sliding vinyl windows. Entry open side porch; simple square columns, and front-gabled roof.	
ADDRESS: 2 Walnut Street	TAX ID: 99.12-1-12	DATE OF CONSTRUCTION: 1881	SIGNIFICANCE: D (local) – Non-Contributing
CONDITION: Fair		NAME:

DESCRIPTION: 1½-story gable-front-&-wing National Folk single-family frame house; parged foundation, vinyl siding, asphalt roofing, and cornice on pediment. Partial-width open front porch; plain balusters, simple square columns, and shed roof.

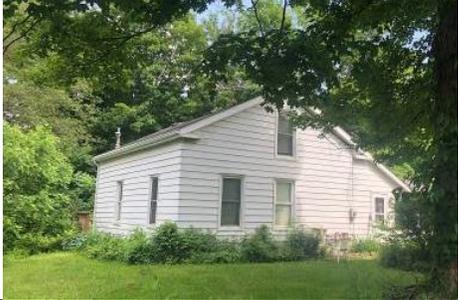
ADDRESS: 3 Walnut Street	TAX ID: 99.08-1-16	DATE OF CONSTRUCTION: Ca. 1920	SIGNIFICANCE: D (local) – Non-Contributing
CONDITION: Good		NAME:

DESCRIPTION: 1½-story front-gabled roof single-family frame house with 1-story hipped roof side addition; aluminum siding, asphalt roofing, and cornice on pediment. Single and ribbon 1/1 double-hung vinyl windows.	
ADDRESS: 8 Walnut Street	TAX ID: 99.12-1-7	DATE OF CONSTRUCTION: Ca. 1900	SIGNIFICANCE: D (local) – Non-Contributing
CONDITION: Good		NAME:

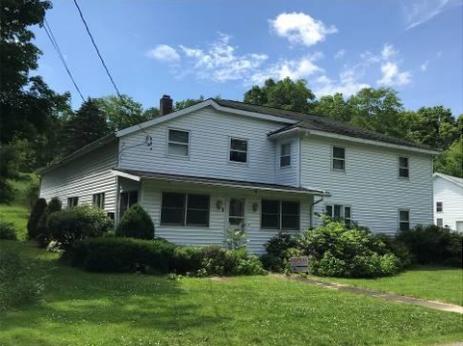
DESCRIPTION: 2-story hipped roof single-family frame house; vinyl siding, and asphalt roofing. Single and paired 1/1 double-hung vinyl windows. Partial-width enclosed front porch with shed roof.	
ADDRESS: 10 Walnut Street	TAX ID: 99.12-1-6	DATE OF CONSTRUCTION: Ca. 1900	SIGNIFICANCE: D (local) – Non-Contributing
CONDITION: Fair/Deteriorated		NAME:

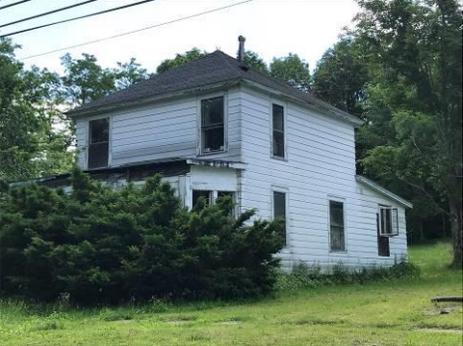
DESCRIPTION: 2-story hipped roof National Folk single-family frame house; parged foundation, aluminum siding, and asphalt roofing. 1/1 double-hung wood windows. Full-width enclosed front porch with low-hipped roof.

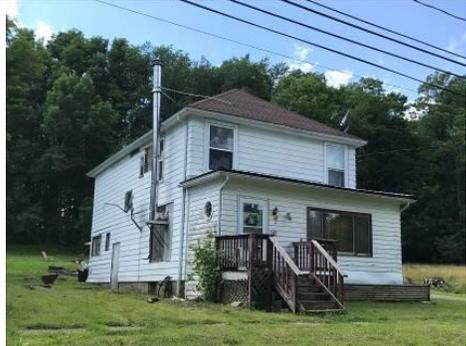
ADDRESS: 10B Walnut Street	TAX ID: 99.12-1-4	DATE OF CONSTRUCTION: 1900	SIGNIFICANCE: D (local) – Non-Contributing
CONDITION: Fair/Deteriorated		NAME:

DESCRIPTION: 2-story hipped roof National Folk single-family frame house; parged foundation, clapboard and aluminum siding, and asphalt roofing. 1/1 double-hung and picture wood and vinyl windows. Full-width enclosed front porch with shed roof.	
ADDRESS: 12A Walnut Street	TAX ID: 99.08-1-21	DATE OF CONSTRUCTION: Ca. 1900	SIGNIFICANCE: D (local) - Contributing
CONDITION: Good		NAME:

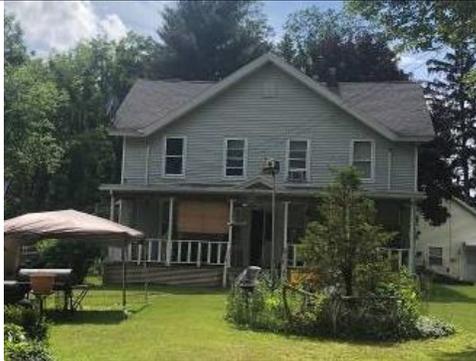
DESCRIPTION: 2-story cross-gabled roof Colonial Revival single-family frame house; clapboard siding, and asphalt roofing. 1/1 double-hung vinyl windows. Full-width open front porch; plain balusters, simple square columns, and pedimented roof.	
ADDRESS: 12D Walnut Street	TAX ID: 99.08-1-20	DATE OF CONSTRUCTION: Ca. 1900	SIGNIFICANCE: D (local) – Non-Contributing

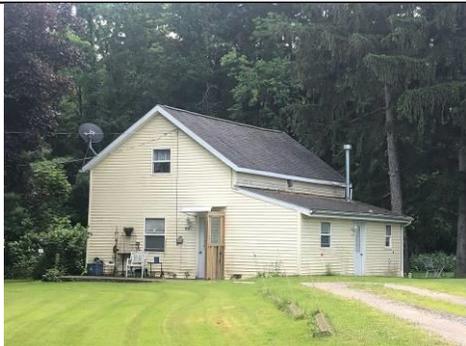
CONDITION: Good		NAME:

DESCRIPTION: 1½-story front-gabled roof National Folk single-family frame house; vinyl siding, and asphalt roofing. 1/1 double-hung vinyl windows. 1-story shed roof side wing.

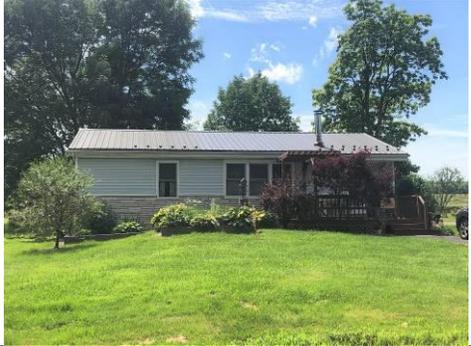
DESCRIPTION: 2-story front-gabled roof single-family frame house; aluminum siding, and asphalt roofing. 1/1 double-hung and fixed vinyl windows. Attached garage.	
ADDRESS: 14 Walnut Street	TAX ID: 99.08-1-6	DATE OF CONSTRUCTION: Ca. 1960	SIGNIFICANCE: D (local) – Non-Contributing
CONDITION: Good		NAME:

DESCRIPTION: 1-story side-gabled roof Ranch Style single-family frame house; stone veneer lower/vinyl siding upper, and metal roofing. Single and ribbon 1/1 double-hung vinyl windows. Partial-width open front porch; plain balusters.	
ADDRESS: 16 Walnut Street	TAX ID: 99.08-1-5	DATE OF CONSTRUCTION: Ca. 1960	SIGNIFICANCE: D (local) – Non-Contributing
CONDITION: Good		NAME:

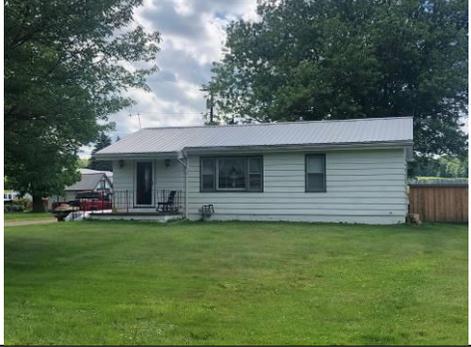
DESCRIPTION: 1-story side-gabled roof Ranch style single-family frame house; concrete block foundation, aluminum siding, and metal roofing. 1/1 double-hung and picture vinyl windows. Entry open front porch with plain balusters.

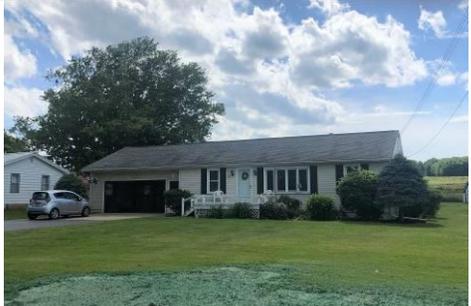
ADDRESS: 18 Walnut Street	TAX ID: 99.08-1-3	DATE OF CONSTRUCTION: Ca. 1960	SIGNIFICANCE: D (local) – Non-Contributing
CONDITION: Good		NAME:

DESCRIPTION: 1-story side-gabled roof Ranch style single-family frame house; parged foundation, vinyl siding, and asphalt roofing. 1/1 double-hung and casement vinyl windows; shutters. Entry open front porch with plain balusters. Attached garage.

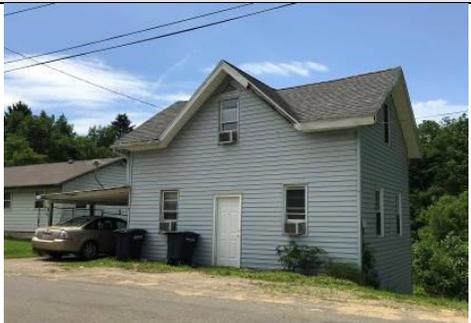
ADDRESS: 1 Water Street	TAX ID: 99.12-2-9	DATE OF CONSTRUCTION: 1867	SIGNIFICANCE: D (local) - Contributing
CONDITION: Good		NAME:

DESCRIPTION: 1½-story cross-gabled roof vernacular single-family frame house with modest Gothic Revival elements; vinyl siding, and asphalt roofing. 1/1 double-hung vinyl windows. Attached carport.	
ADDRESS: 2 Water Street	TAX ID: 99.12-2-11	DATE OF CONSTRUCTION: Ca. 1900	SIGNIFICANCE: I/D (local) - Contributing
CONDITION: Excellent		NAME:

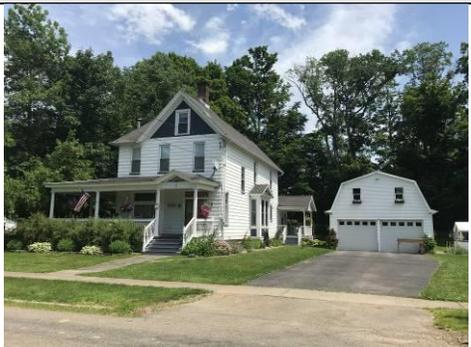
DESCRIPTION: 2½-story hipped roof with cross gables Queen Anne single-family frame house; stone foundation, aluminum siding, and asphalt roofing. 1/1 double-hung vinyl windows. Roof ridge brick chimney. L-shaped open front porch with turned supports, Doric columns, and pedimented roof. 2-Story Gambrel roof barn/garage.

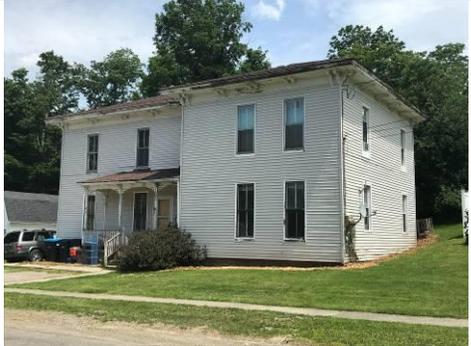
ADDRESS: 4 Water Street	TAX ID: 99.12-2-12	DATE OF CONSTRUCTION: 1881	SIGNIFICANCE: D (local) - Contributing
CONDITION: Good		NAME:

DESCRIPTION: 2-story low-hipped roof modest Italianate style single-family frame house; stone foundation, vinyl siding, asphalt roofing, wide overhanging eaves with decorative brackets. 2/2 double-hung wood windows. Partial-width open front porch with Victorian-era detailing; plain balusters, simple square columns with side brackets, and hipped roof.	
ADDRESS: 5 Water Street	TAX ID: 99.12-2-15	DATE OF CONSTRUCTION: Ca.1870	SIGNIFICANCE: D (local) - Contributing
CONDITION: Good		NAME:

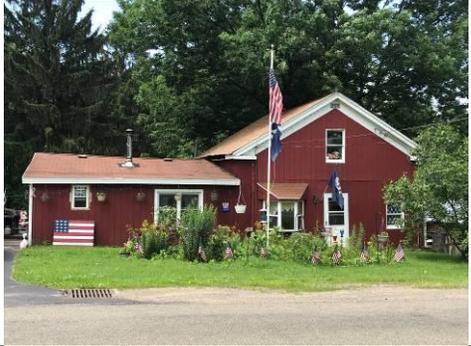
DESCRIPTION: 1½-story gable-front-&-wing National Folk single-family frame house; stone foundation, vertical paneling, asphalt roofing, and cornice on pediment. Single and paired 1/1 double-hung windows.	
ADDRESS: 7 Water Street	TAX ID: 99.12-2-16	DATE OF CONSTRUCTION: Ca. 1900	SIGNIFICANCE: D (local) - Contributing

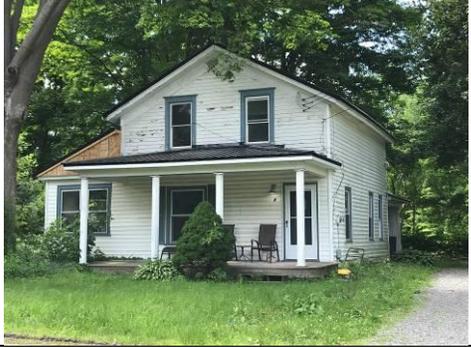
CONDITION: Good		NAME:

DESCRIPTION: 1½-story front-gabled roof National Folk single-family frame house; clapboard siding, and metal roofing. 1/1 double-hung windows. Full open front porch; Doric columns, and hipped roof. 1-story shed roof addition.

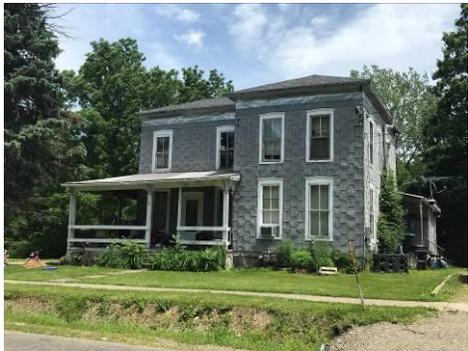
ADDRESS: 8 Water Street	TAX ID: 99.16-1-19.2	DATE OF CONSTRUCTION: Ca.1880	SIGNIFICANCE: D (local) - Contributing
CONDITION: Good		NAME:

DESCRIPTION: 2-story low-hipped roof modest Italianate style single-family frame house; parged foundation, asphalt siding, and asphalt roofing. 2/2 double-hung windows. L-shaped open front porch; plain balusters, simple square columns, and hipped roof.	
ADDRESS: 9 Water Street	TAX ID: 99.12-2-18	DATE OF CONSTRUCTION: Ca.1870	SIGNIFICANCE: I (NR) – Individually Eligible I/D (local) - Contributing
CONDITION: Excellent		NAME:

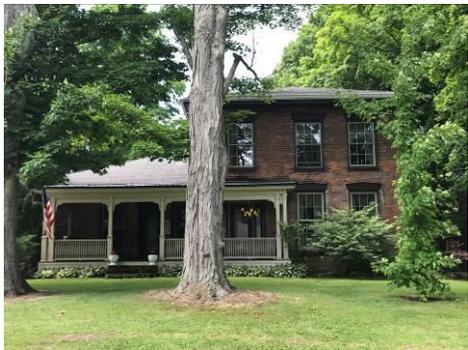
DESCRIPTION: 2-story hipped roof Folk Victorian brick masonry house; stone foundation, asphalt roofing, and wide overhanging eaves. 6/6 double-hung windows; pediments. Partial-width open front porch; turned balusters, simple square columns with side brackets, dentil molding, and principal roof. NR CRITERION: C	
ADDRESS: 10 Water Street	TAX ID: 99.16-1-18	DATE OF CONSTRUCTION: Ca. 1880	SIGNIFICANCE: D (local) - Contributing

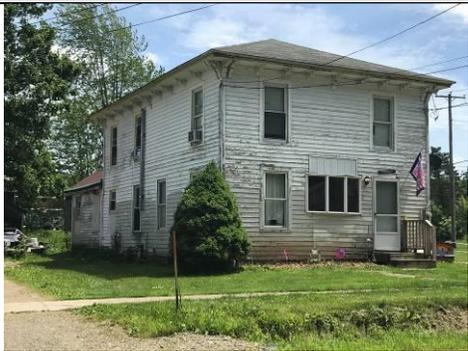
CONDITION: Fair/Deteriorated		NAME:

DESCRIPTION: 2-story low-hipped roof modest Italianate style single-family frame house; stone foundation, clapboard siding, asphalt roofing, and brackets at eaves. 1/1 double-hung windows. 1½-story front-gabled roof frame barn; board and batten siding, hayloft door.

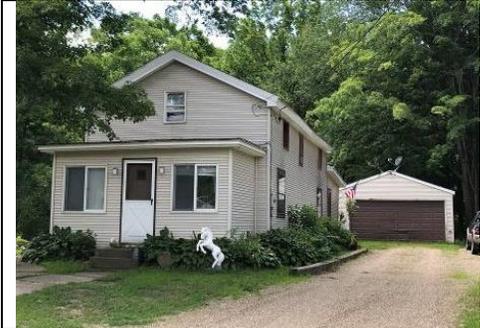
ADDRESS: 13 Water Street	TAX ID: 99.16-1-2	DATE OF CONSTRUCTION: Ca. 1880	SIGNIFICANCE: D (local) - Contributing
CONDITION: Good		NAME:

DESCRIPTION: 1½-story front-gabled roof National Folk single-family frame house; stone foundation, vinyl siding, and asphalt roofing. 1/1 double-hung and sliding vinyl windows. Full-width enclosed front porch; flat roof.	
ADDRESS: 14 Water Street	TAX ID: 99.16-1-17	DATE OF CONSTRUCTION: Ca. 1865	SIGNIFICANCE: I/D (local) - Contributing
CONDITION: Good		NAME:

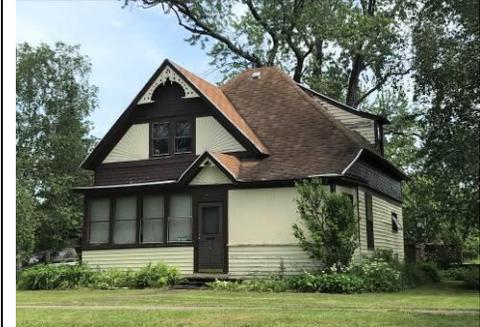
DESCRIPTION: 1½-story hipped roof with cross gables vernacular Queen Anne single-family frame house; parged foundation, clapboard siding, asphalt roofing, and gable detailing. Paired and ribbon 1/1 double-hung windows.	
ADDRESS: 17 Water Street	TAX ID: 99.16-1-4	DATE OF CONSTRUCTION: Ca. 1880	SIGNIFICANCE: D (local) - Contributing
CONDITION: Good		NAME:

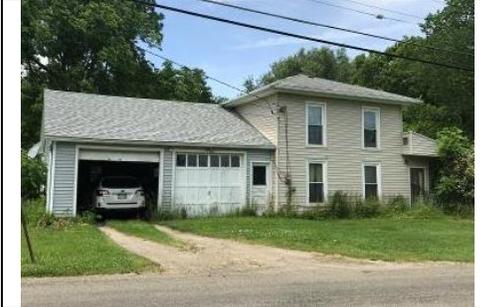
DESCRIPTION: 2-story hipped roof National Folk single-family frame house; stone foundation, vinyl siding, asphalt roofing, and wide overhanging eaves. 1/1 double-hung windows. 1-story hipped roof wing. Attached garage.
