Artspace Buffalo

BLOCK ANALYSIS

Best Street

Observations, Conditions, Opportunities

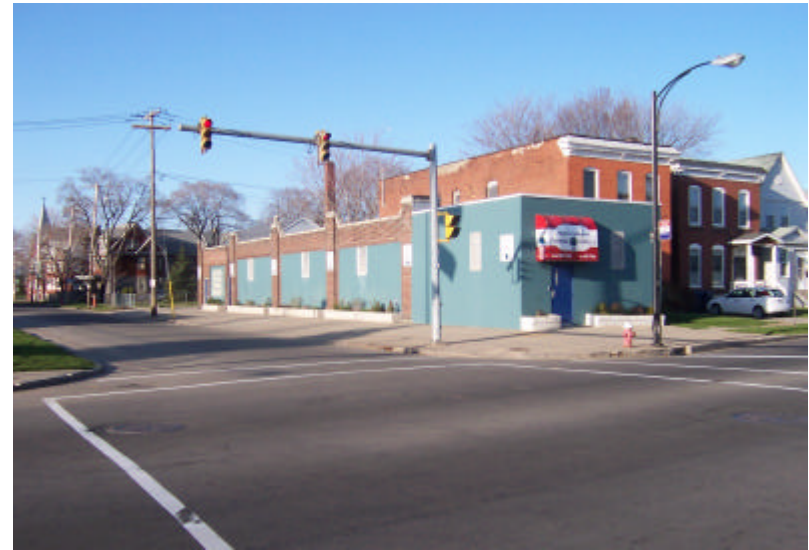
The corner of Ellicott and Best streets, crowned by the Multicultural Potential Center and two character brick houses.

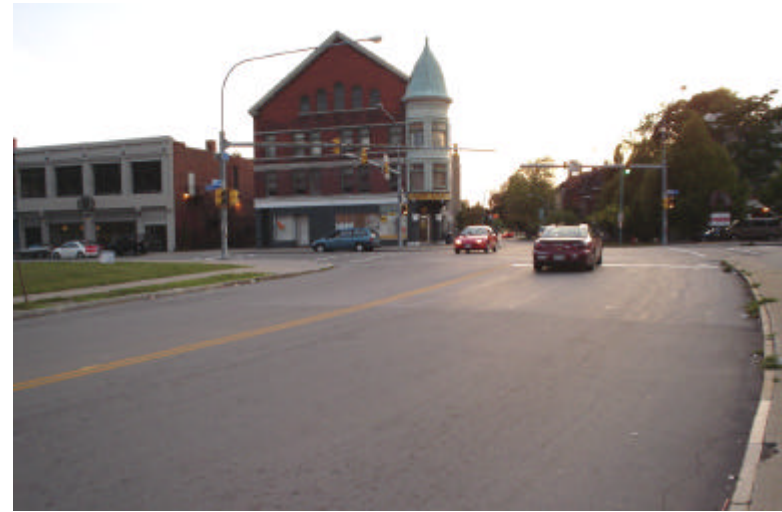
Wide lanes and excessive asphalt degrade a pedestrian-focused environment. Imagine a landscaped median humanizing the street and contributing to its beauty.

1. Create a landscaped median on Best Street between Ellicott and Main streets

- Instead of calling for the narrowing of Best Street as a whole, install of a 20-foot-wide center landscaped median to calm traffic
- Reduce the number of vehicle lanes
- Provide a new venue for tree plantings that would otherwise be limited along the unusually slender planting strips of either side of the street
- No turning lanes on Best Street as there are now (this will markedly calm the pace of traffic and improving the safety of both pedestrians as well as drivers)
- Two vehicle lanes, each about 14.5 feet in width, would provide enough room for both buses and cars
- The use of a median would emphasize Best Street as a *boulevard*, not a thoroughfare (these are two phrases that describe streets containing roughly equal traffic volumes but evoking different levels of comfort, calm and beauty)

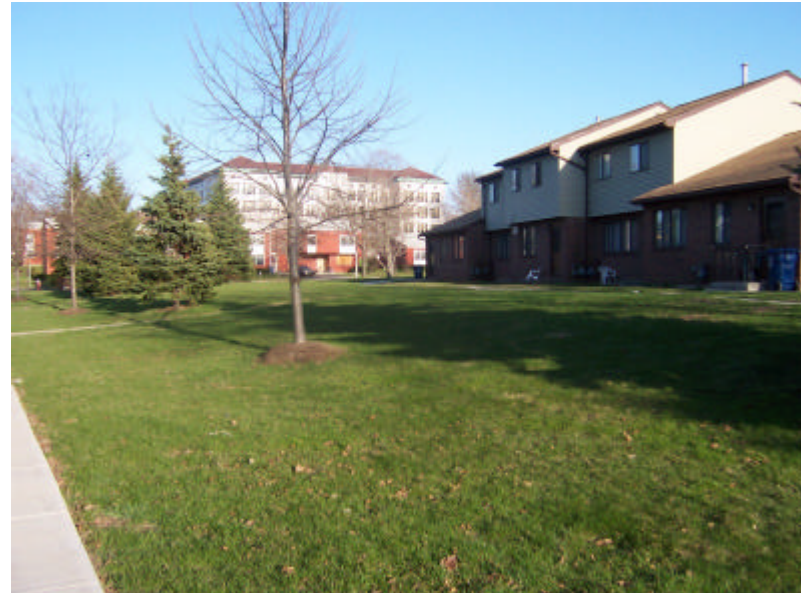
The Pilgrim Village apartments along the south side of Best Street are nicely landscaped, but the buildings themselves are poorly designed, turning their back on the city's public realm.

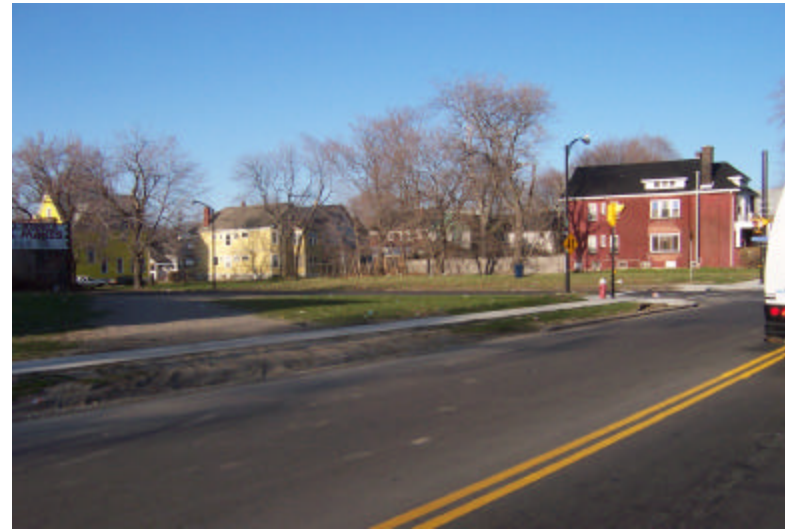
The lack of a quality public realm, with a unified tree canopy and well-maintained sidewalks, only reinforces negative trends on the block.

Repair streetscape and treewall from Ellicott to Michigan

- Providing tools to residents for improvement of the few problem properties along this two-block stretch
- Retaining City-owned vacant parcels, closer to Michigan, for new housing that complements the existing housing stock
- An aggressive tree replanting initiative that provides a counterpoint to the well-maintained greens of Pilgrim Village
- Applying a landscape treatment on the north similar to a prevailing 32-foot distance between trees along the south side of Best Street
- Replacing the standard cobrahead streetlamps and bland stoplights on the northern half of Best with quality, pedestrian-oriented ones that emphasize the street's importance as a landscaped boulevard
