Coe Place

Artspace Buffalo

Observations, Conditions, Opportunities

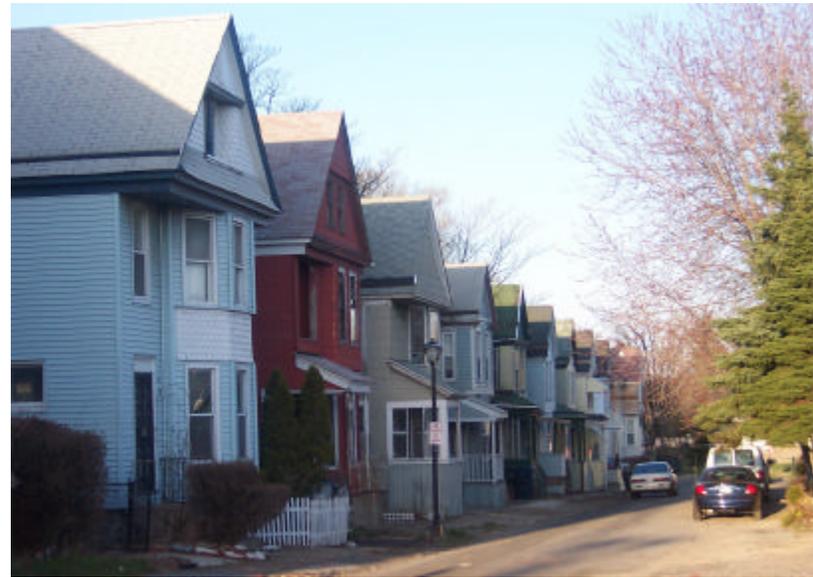
The cozy Queen Anne's of Coe Place form a striking urban silhouette.

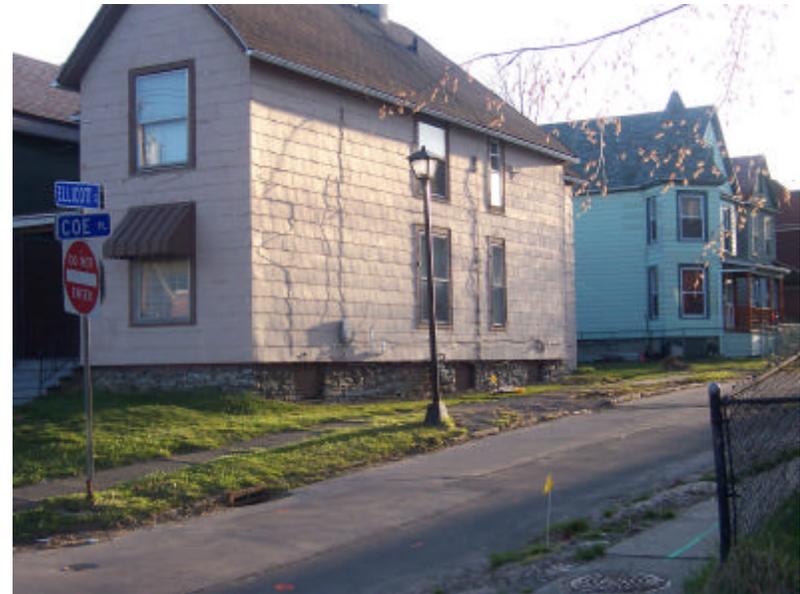
The entrance of Coe Place at Ellicott Street: imagine the asphalt replaced with brick.

Repave street in brick

- Repaving it in brick using a unique and inviting pattern, such as diagonal herringbone, to emphasize the street's charming and historic character, to slow traffic, and to provide a needed aesthetic boost to the block.
- Creating a brick pedestrian footpath to encourage nontraditional wayfinding, whereby biking would be encouraged and pedestrians feel invited to reclaim it as a safe zone for relaxation and children's play, a pastime documented by historical photographs from the period before the street was repaved.

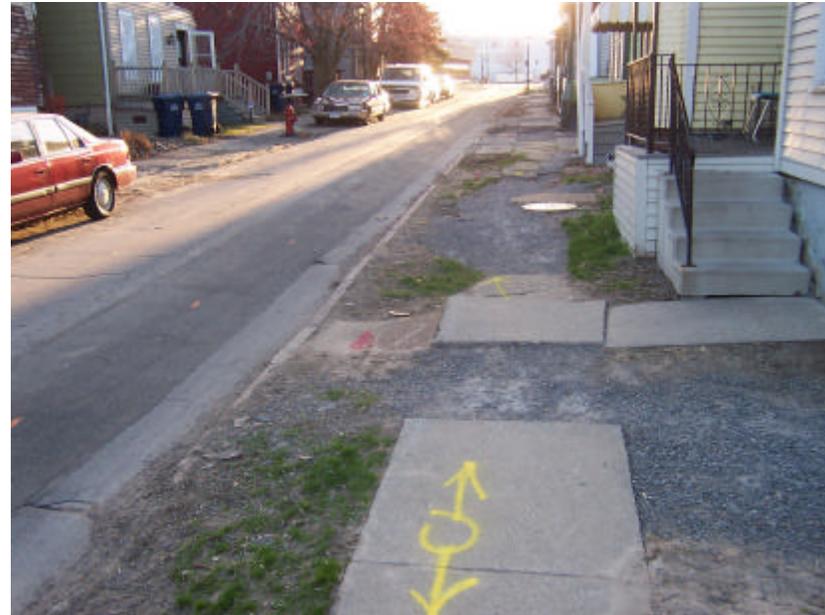
Up until recently, the city’s neglect of the public right-of-way probably reinforced a climate of disinvestment in the block. The City had reportedly never made any major repairs to the street’s infrastructure since 1928, when it was converted to a public street. Up until mid-2005, its sidewalks had all but crumbled away

Coe Place, early 2005: Are these the kind of sidewalks you would have let your grandmother walk across? Sadly, these sidewalks are more or less typical to Midtown.

into gravel and fine powder. The vehicle lane remains in deplorable condition, an unsightly patchwork of makeshift repairs.

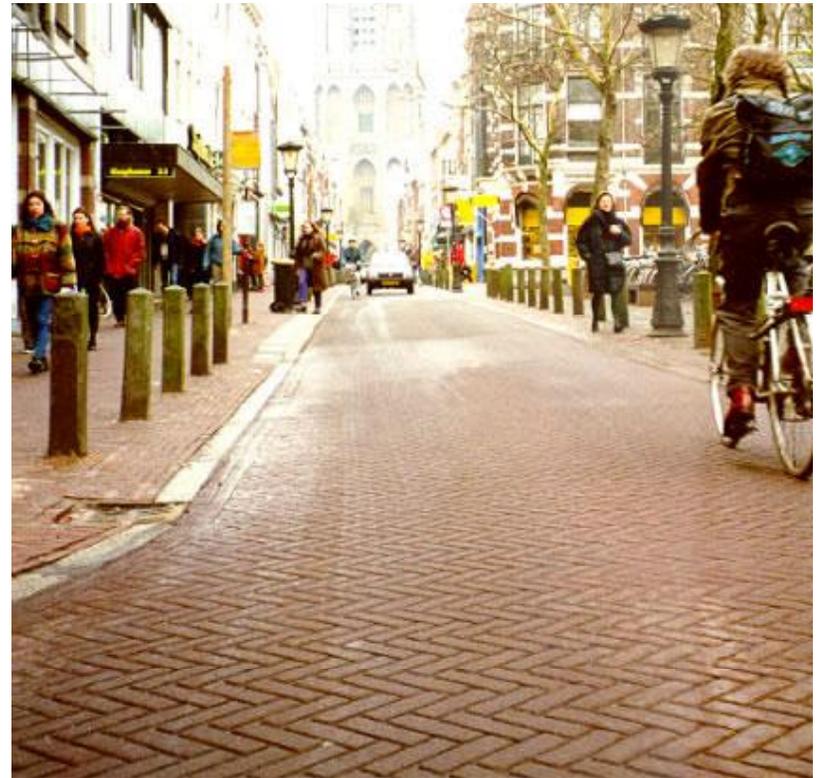
Utrecht, the Netherlands: A diagonal herringbone pattern shows the way for the brick repaving of Coe Place.

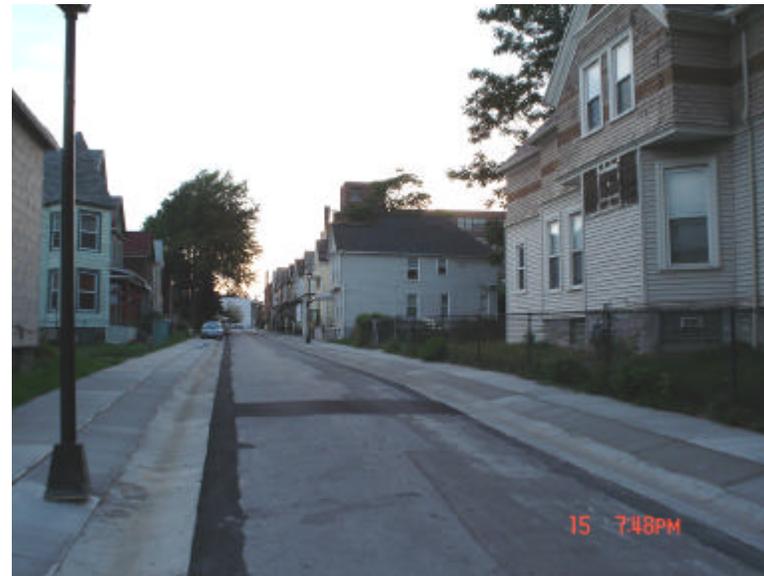
The City did commence a street repaving effort in 2005 that was thankfully halted mid-way. New sidewalks installed, the street almost took on the look of a widened suburban drive. Granite curbs, an essential division between pedestrian and vehicle zones, were removed and replaced with curbs-and-gutters typical to suburban subdivisions, robbing the street of its historic charm as well as the built-in safety of a defined barrier. The vehicle lane repaving was halted as planning was underway to reconstruct the street in its original brick.

New curved gutters, typical to the suburbs, were sloppily and hideously installed in mid-2005. They should be removed and replaced with granite curbs during its repaving in brick.

Reestablish granite curbs, narrow street to original 15-foot width

- A low-lying curb that delineates between pedestrian and vehicle zones but effectively redesigns the street a Dutch-style *Woonerf*, like a pedestrian mall but vehicle-accessible
- A six-inch high curb evoking the one that existed prior to the installation of the suburban-style curb-and-gutter, retaining Coe's design as a traditional American street with vehicle and pedestrian zones placed at different elevations
- There are advantages and disadvantages to both arrangements, but it was determined that the current curb-and-gutter installed in 2005 should be removed and replaced

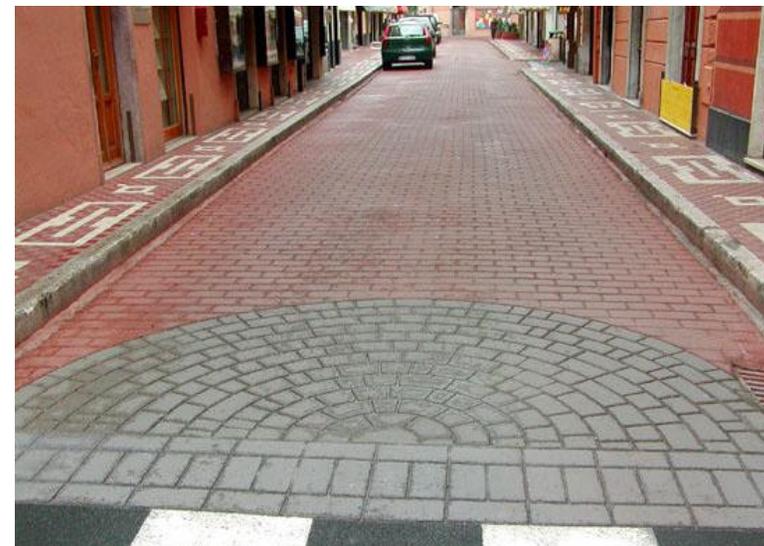
An offset brick accent pattern illustrates another wayfinding method that could be used to distinguish the Midtown Neighborhood as a special destination.

the name of Coe Place at either end of the street this would supplement street signs, and would accomplish their task in much more place-defining and place-enhancing way

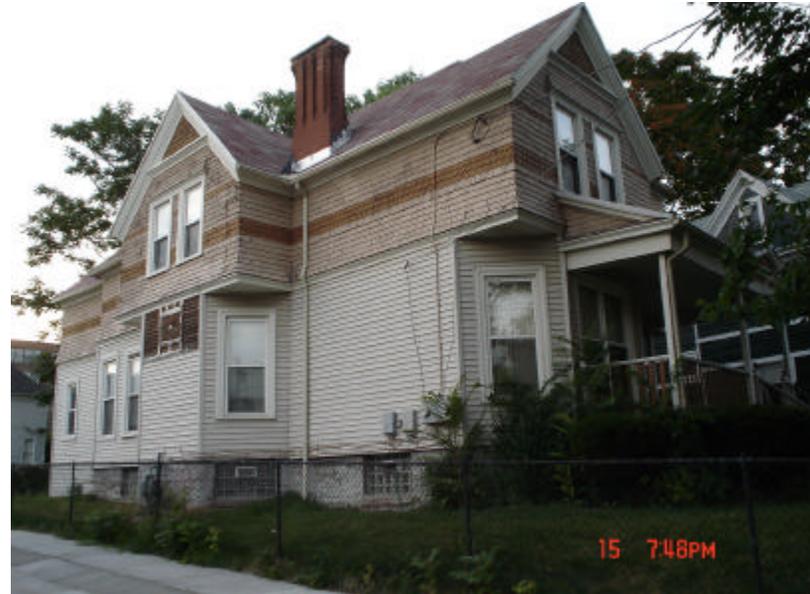
The gorgeously renovated cottage at 1050 Ellicott, on the corner with Coe Place, should be the ideal for restoration efforts along the rest of Coe.

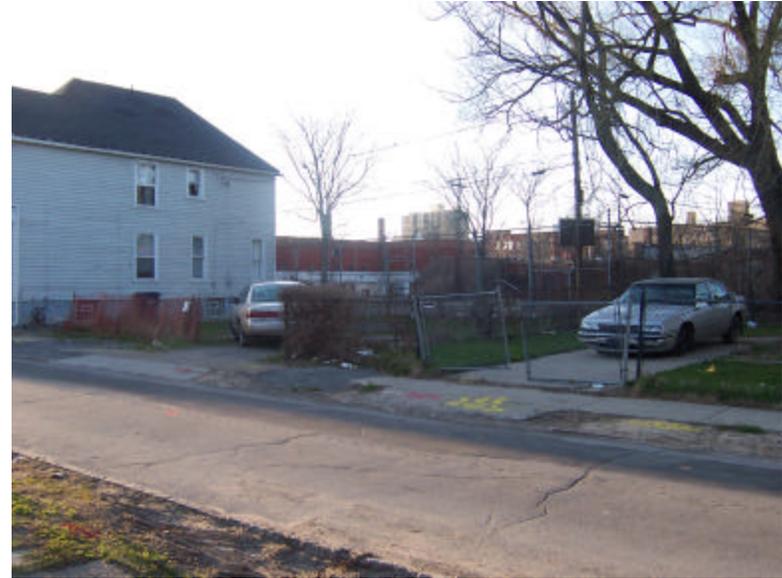
The parcel at 40 Coe Place could be reclaimed as a dramatic stairway entrance into the Artspace project area.

Reclaim 40 Coe for an entryway into Artspace

space, is located strategically in a site that could be reclaimed as a stairway entrance into the rear portion of the Artspace area, where a grouping of rowhouse-style live/work units are planned. The lot serves a purpose per se, as private parking for a house on Coe Place, but will be less than its most ideal use once the Artspace project is completed which is:
